# Office of Highway Safety

## Road Safety Audit Review

<b>Town:</b>	Newfane	<b>Date Reviewed:</b>	November 29, 2018
<b>Route:</b>	Dover Rd	<b>Mile points:</b>	S0106 MM 0.00-5.55

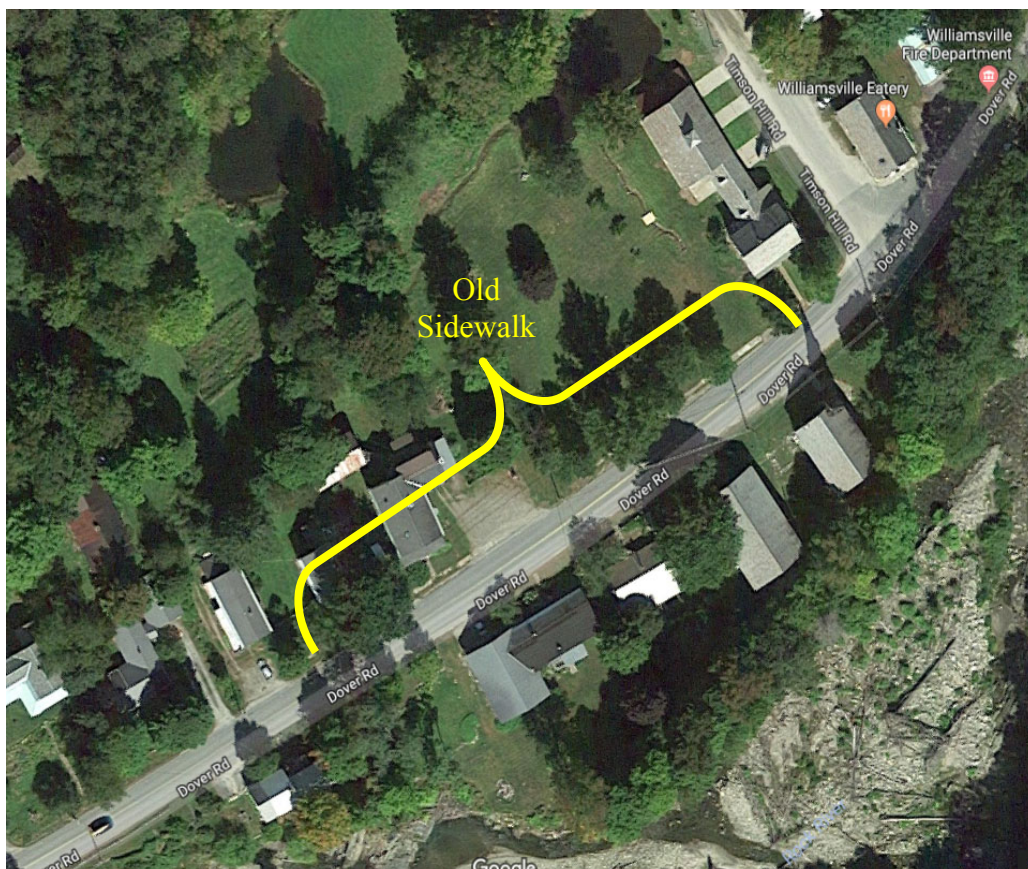
There is an old and short section of sidewalk in Williamsville on the north side of Dover Road that extends from across the church westward for about 440 feet. This sidewalk is on private property and is not maintained by the Town. It is also not ADA compliant from many standpoints, such as width, surface condition and proper curb ramps.

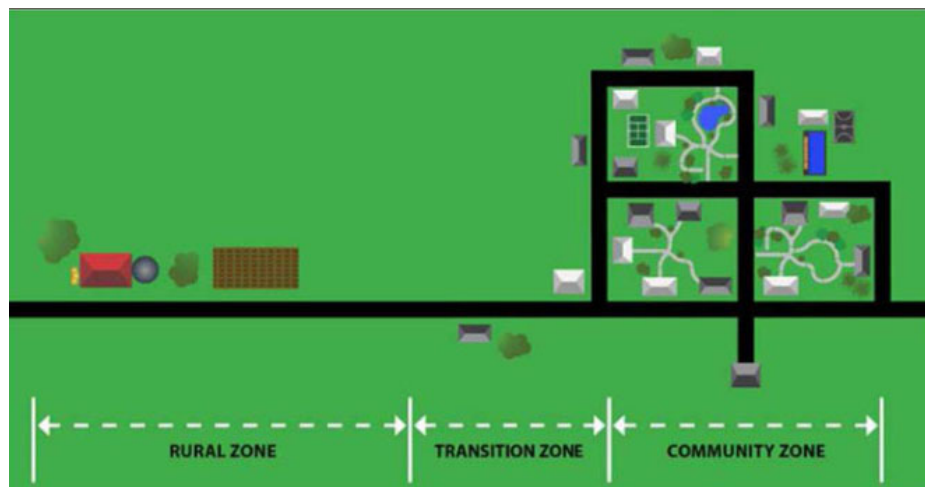
The audit team observed that most of the existing Reduce Speed Ahead signs were located too far from the beginning of the speed zones. For deceleration from 45 mph to 35 mph and from 35 mph to 25 mph, Table 2.C4 of the MUTCD indicates that the placement for this sign would be adequate if it was between 100 to 200 feet in advance of the speed limit sign.

The audit team also observed that many of the existing signs that are informing motorists of an upcoming change in speed limits were the older Reduced Speed Ahead regulatory signs (R2-5A). This sign is no longer in use in the current edition of the MUTCD and has been replaced with the Reduced Speed Limit Ahead warning sign (W3-5). This sign is a yellow diamond shaped warning sign which displays the upcoming speed limit on it.

- Relocate all the Reduce Speed Ahead/Reduced Speed Limit Ahead signs to 100 feet to 200 feet in advance of the beginning of the corresponding speed zones.
- Replace all the “regulatory” Reduce Speed Ahead signs with Reduced Speed Limit Ahead warning signs.
- Review the locations of intermediate speed limit signs within each speed zone. Ensure that intermediate signs are present following major intersections in each direction and that there are intermediate signs every 0.3 to 0.4 miles for 25 to 30 mph speed zones and every 0.5 to 0.8 miles for 35 to 45 mph zones.
- Ensure that all speed limit signs are 24” x 30” and that all Reduced Speed Limit Ahead warning signs are 36” x 36”. Consider using an oversized (30” x 36”) speed limit sign for the first speed limit sign at the beginning of a zone.

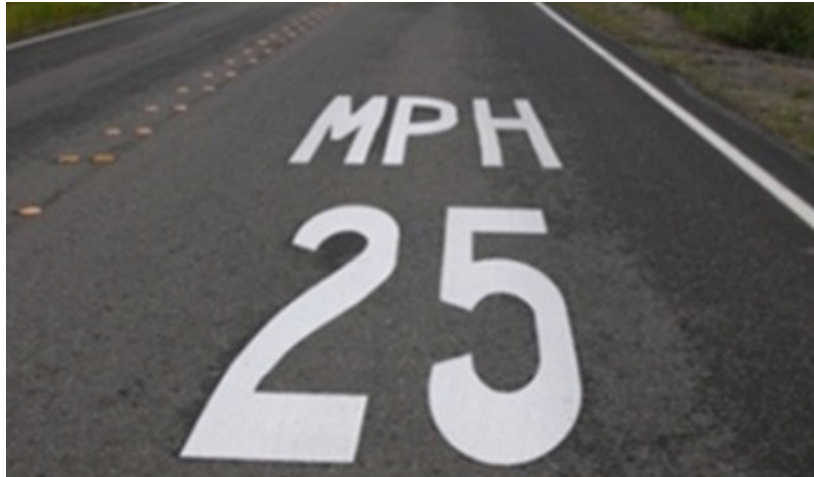
The audit team observed vehicles traveling around this curve at what seemed to be inappropriate speeds.

- Consider the installation of 25 MPH word pavement markings at the location of the eastbound 25 mph speed limit sign that is just before the Baker Brook Road intersection to create additional emphasis<sup>3</sup>. This type of treatment is referred to as horizontal signing.

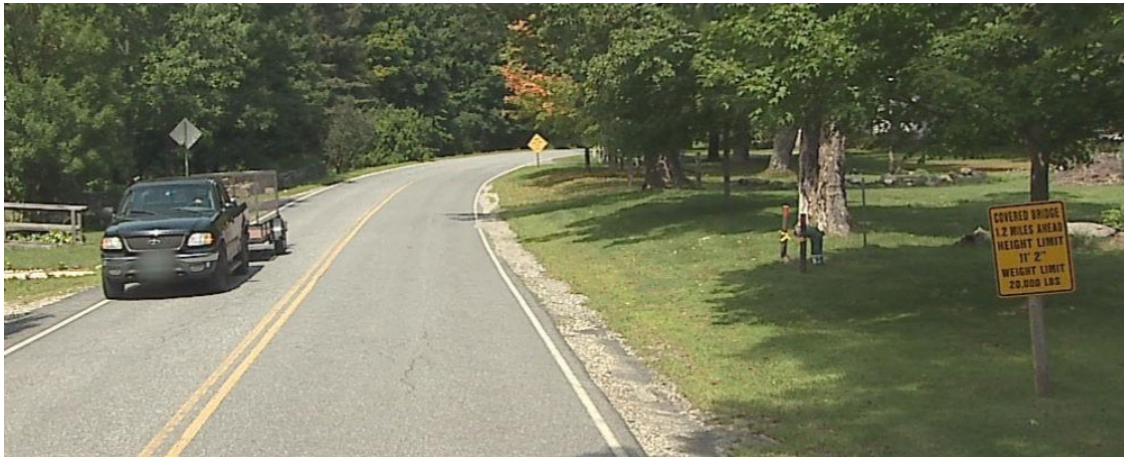
There have been reported issues of tractor trailer operators approaching the bridge and realizing that it was impassable.

The audit team noticed that there were signs warning of the height restriction in both directions but that these signs were unconventional and that they were installed on short posts and were not very visible.

- In the westbound location in Williamsville, replace the existing rectangular height limit sign with a Low Clearance sign (W12-2) and a 1/2 mile Distance Plaque (W16-3aP).
- In the eastbound direction, remove the existing rectangular height limit sign and find a location for a Low Clearance sign (W12-2) and a XX miles Distance Plaque (W16-3aP) near a location where a tractor trailer could turn around.
- Potentially install a second Low Clearance sign (W12-2) eastbound before the covered bridge parking area with a 600 FEET Plaque (W16-2P).

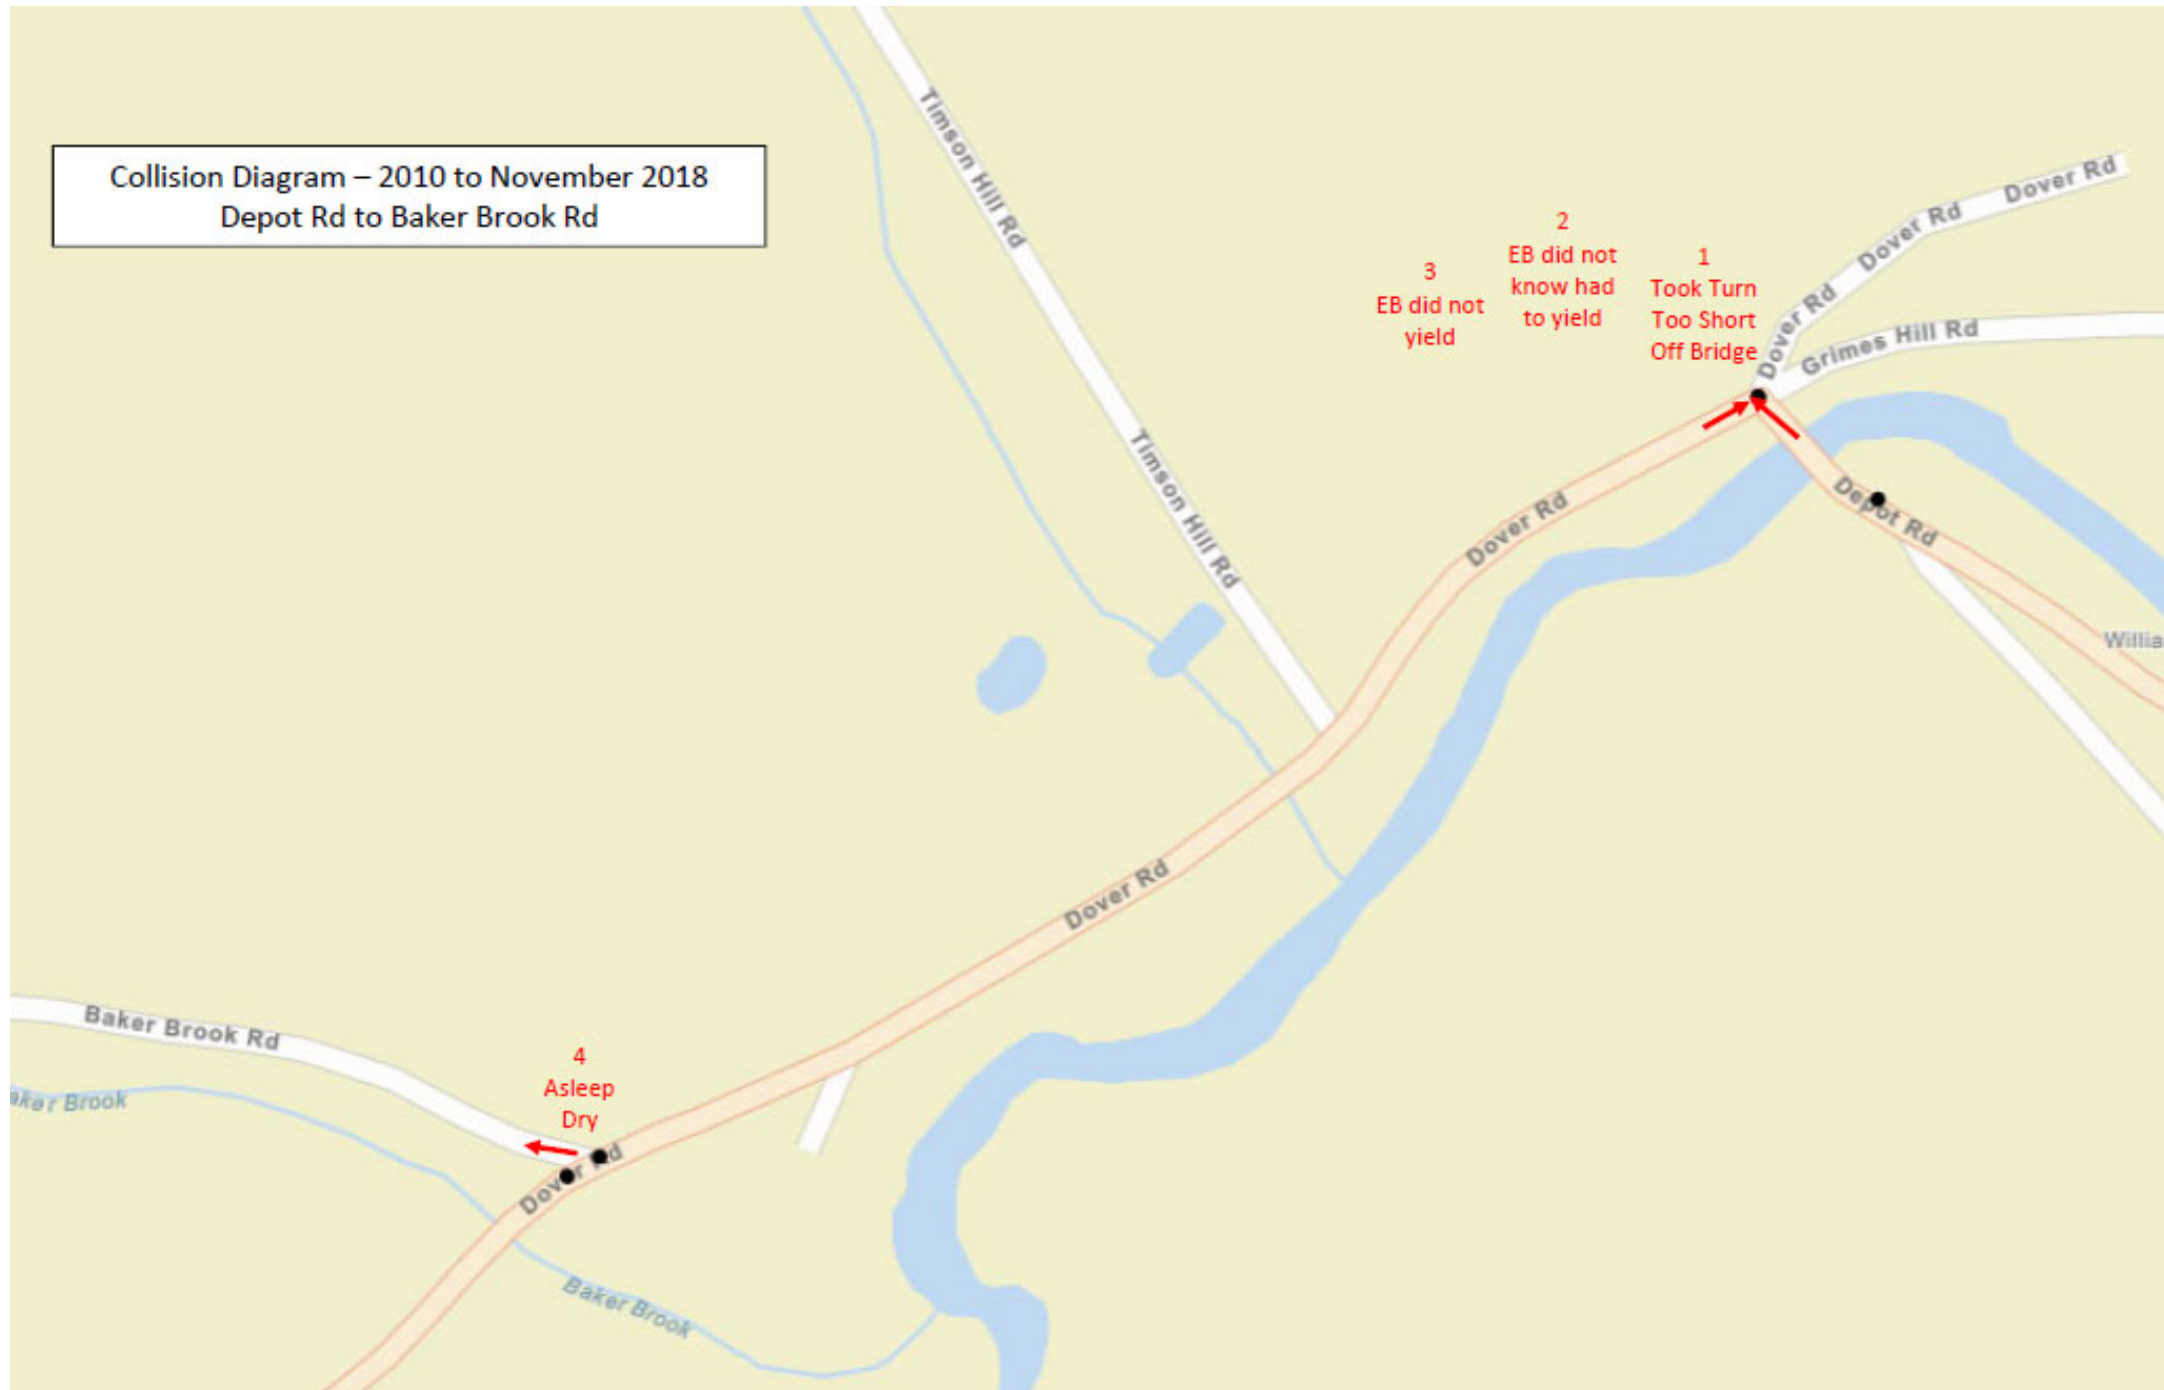
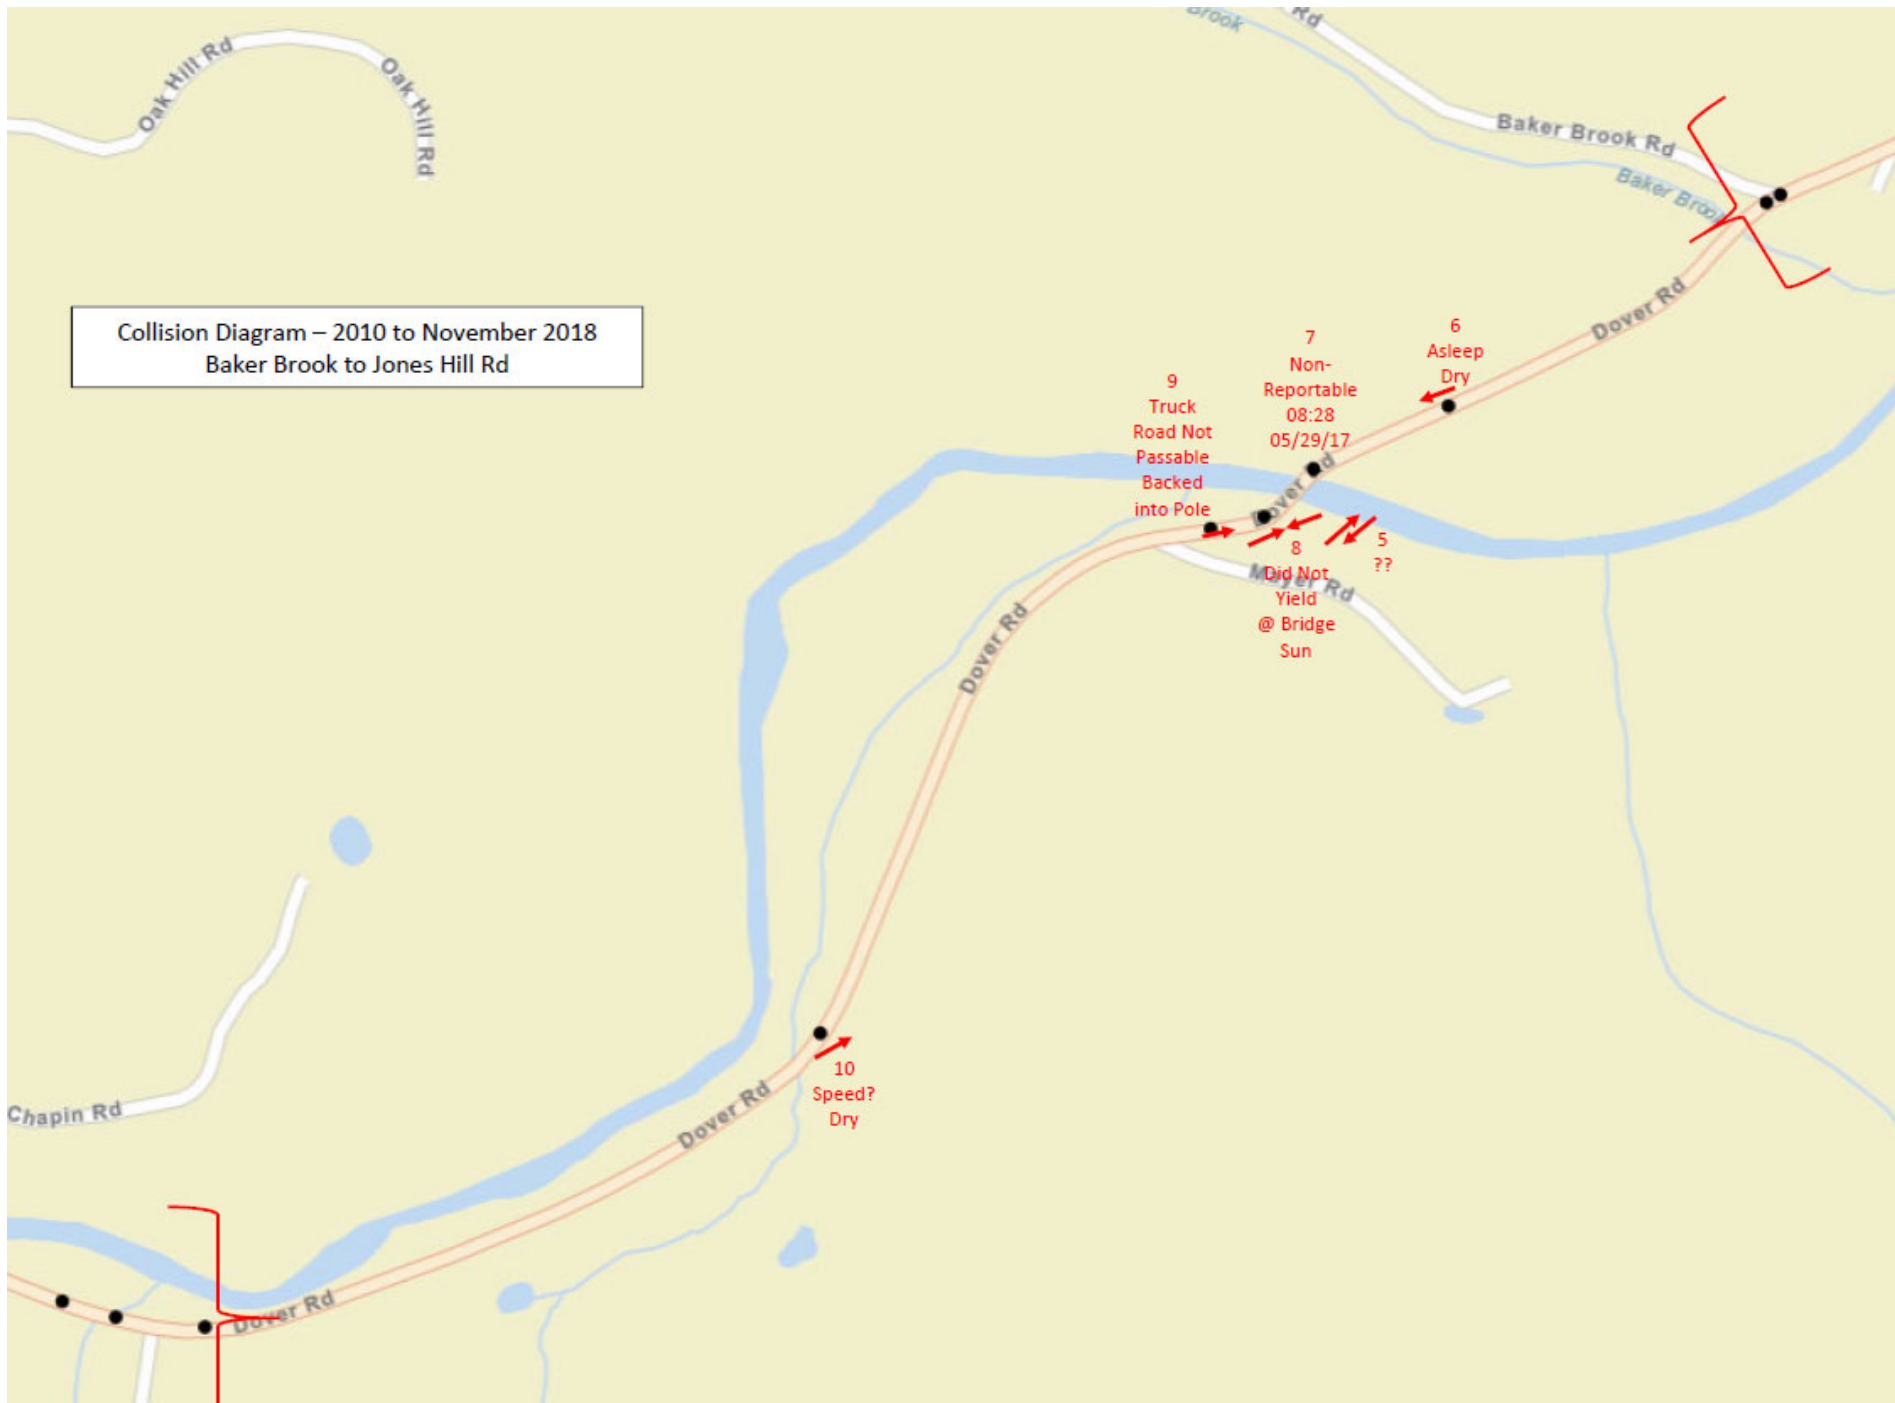
Collision Diagram – 2010 to November 2018  
Depot Rd to Baker Brook Rd

There were four crashes from 2010 to about November 2018 between Depot Road and Baker Brook Road.

Of these four crashes, three took place at the intersection with Depot Road. These crashes were broadside crashes with a vehicle on eastbound Dover Road and a vehicle northbound on Depot Road. In two of the cases, the motorists on Dover Road failed to see the yellow warning sign (Yield to Bridge Traffic).

The other crash in this section took place near the Baker Brook Road intersection. It was a single vehicle crash in which the driver who was westbound fell asleep and missed staying on Dover Road.

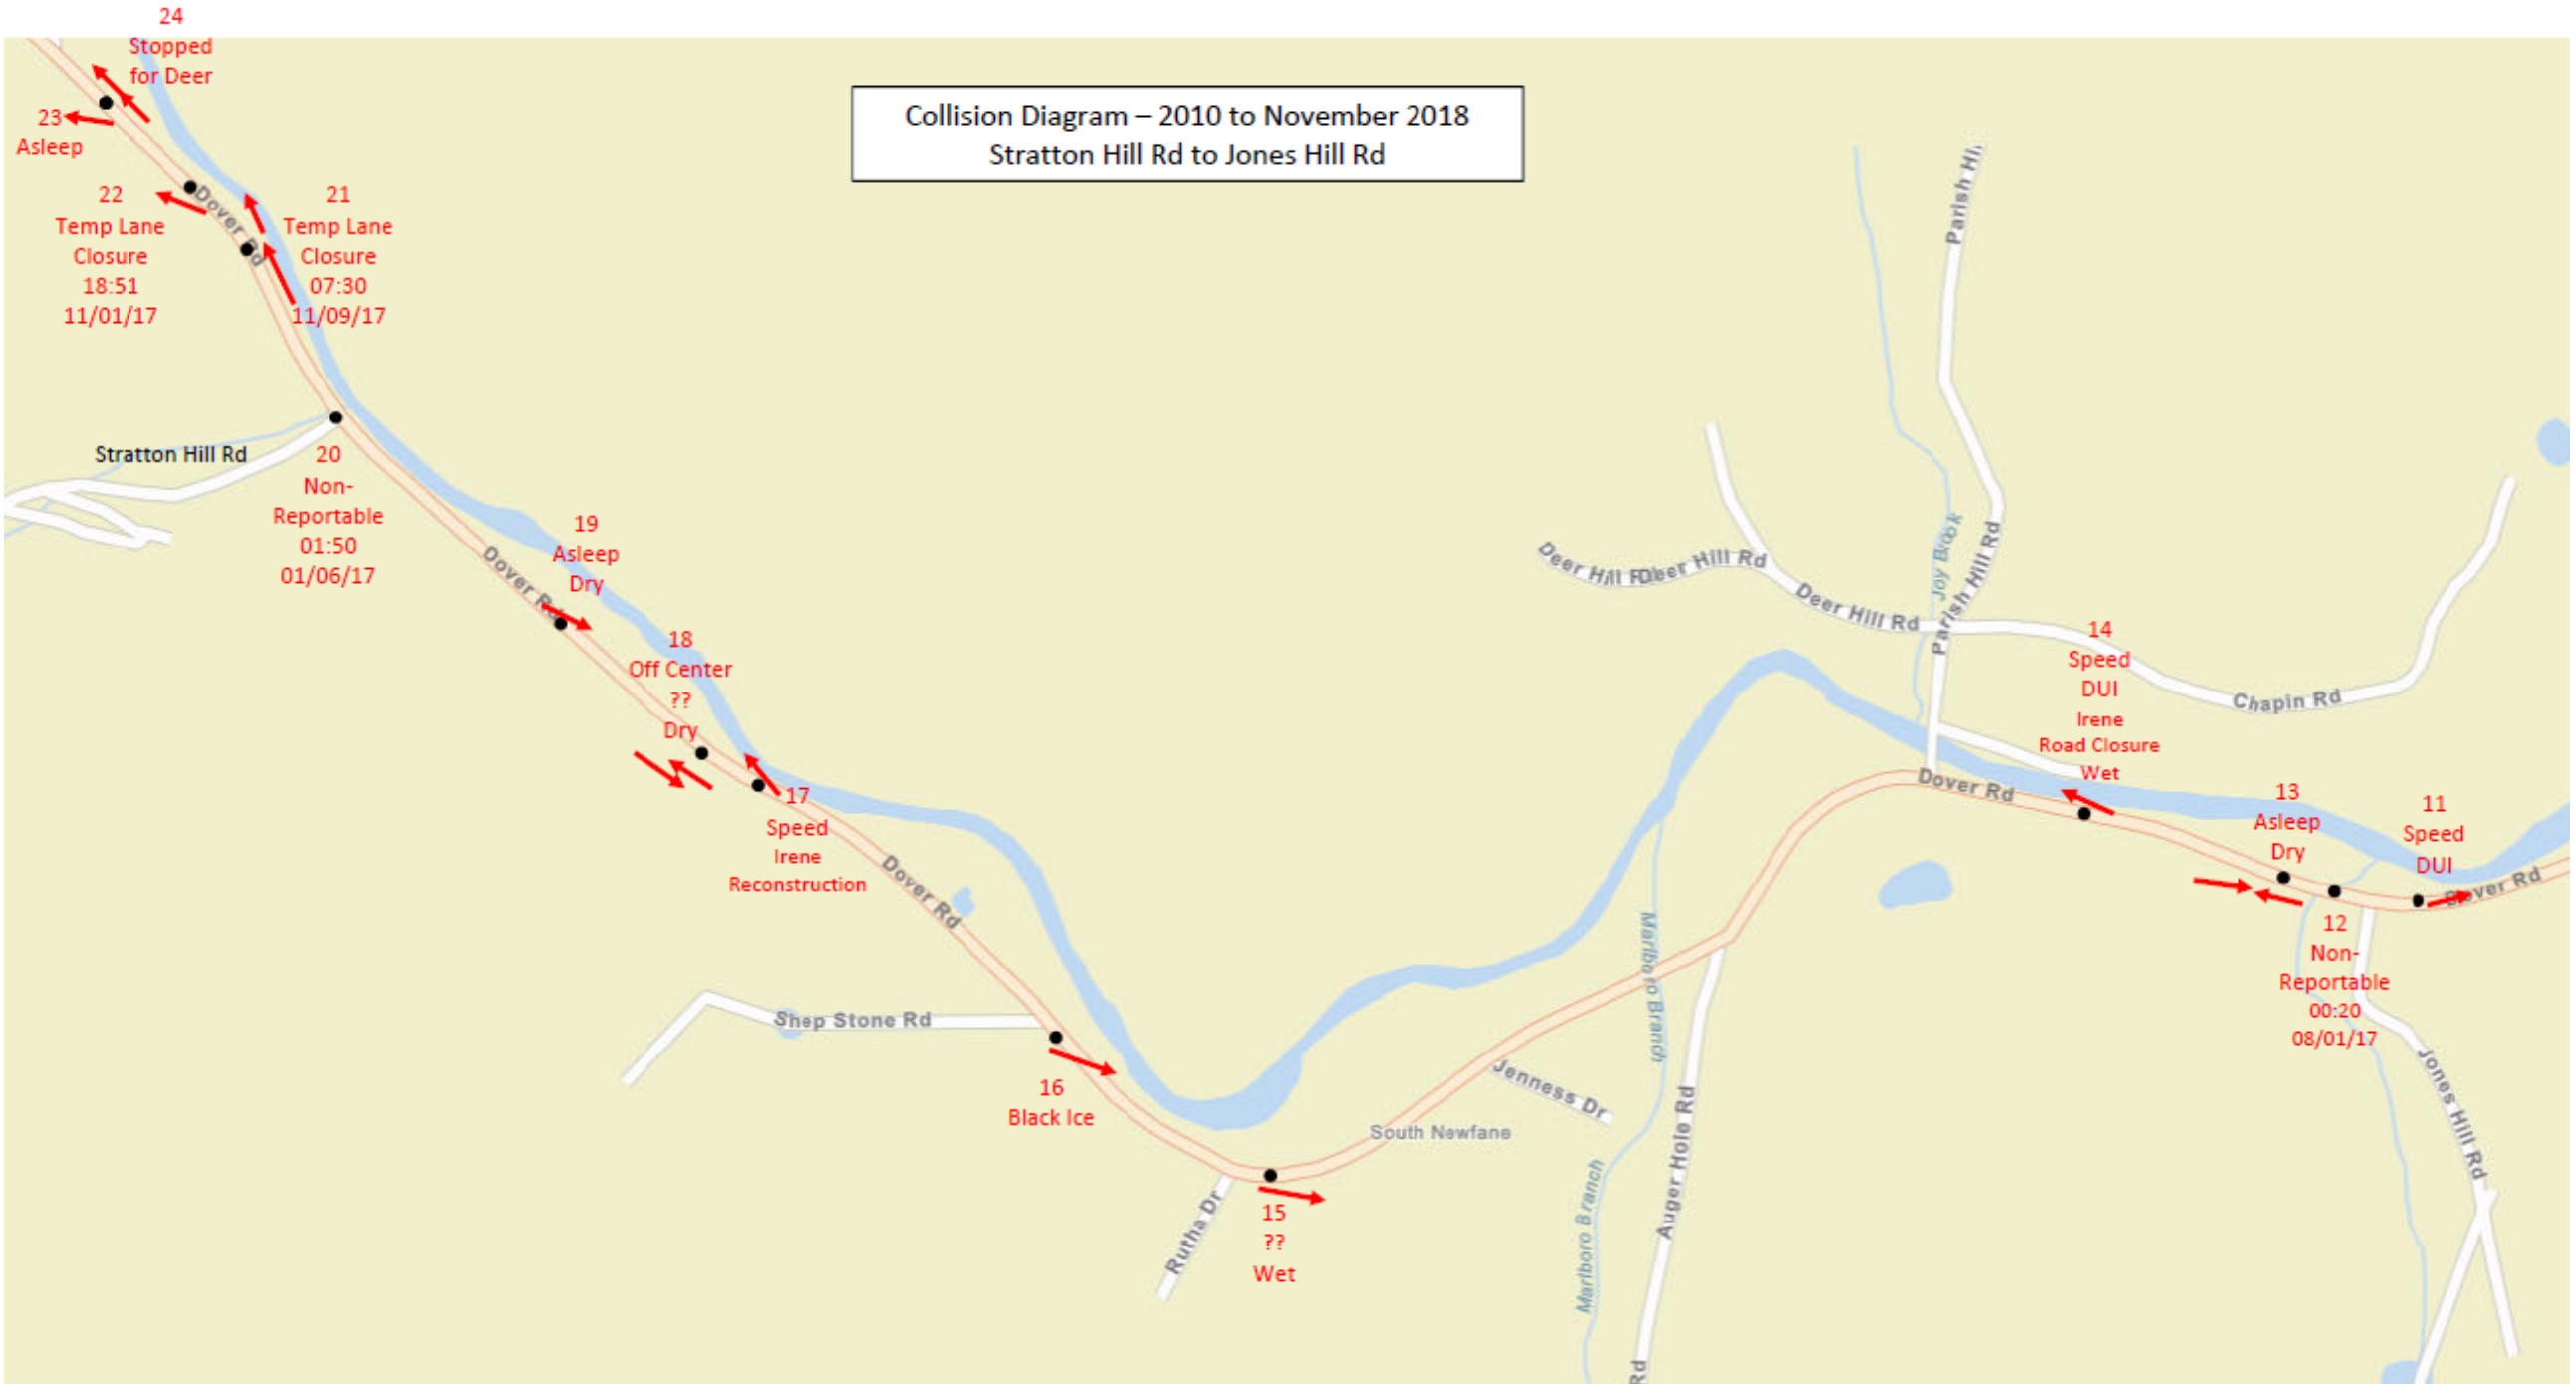
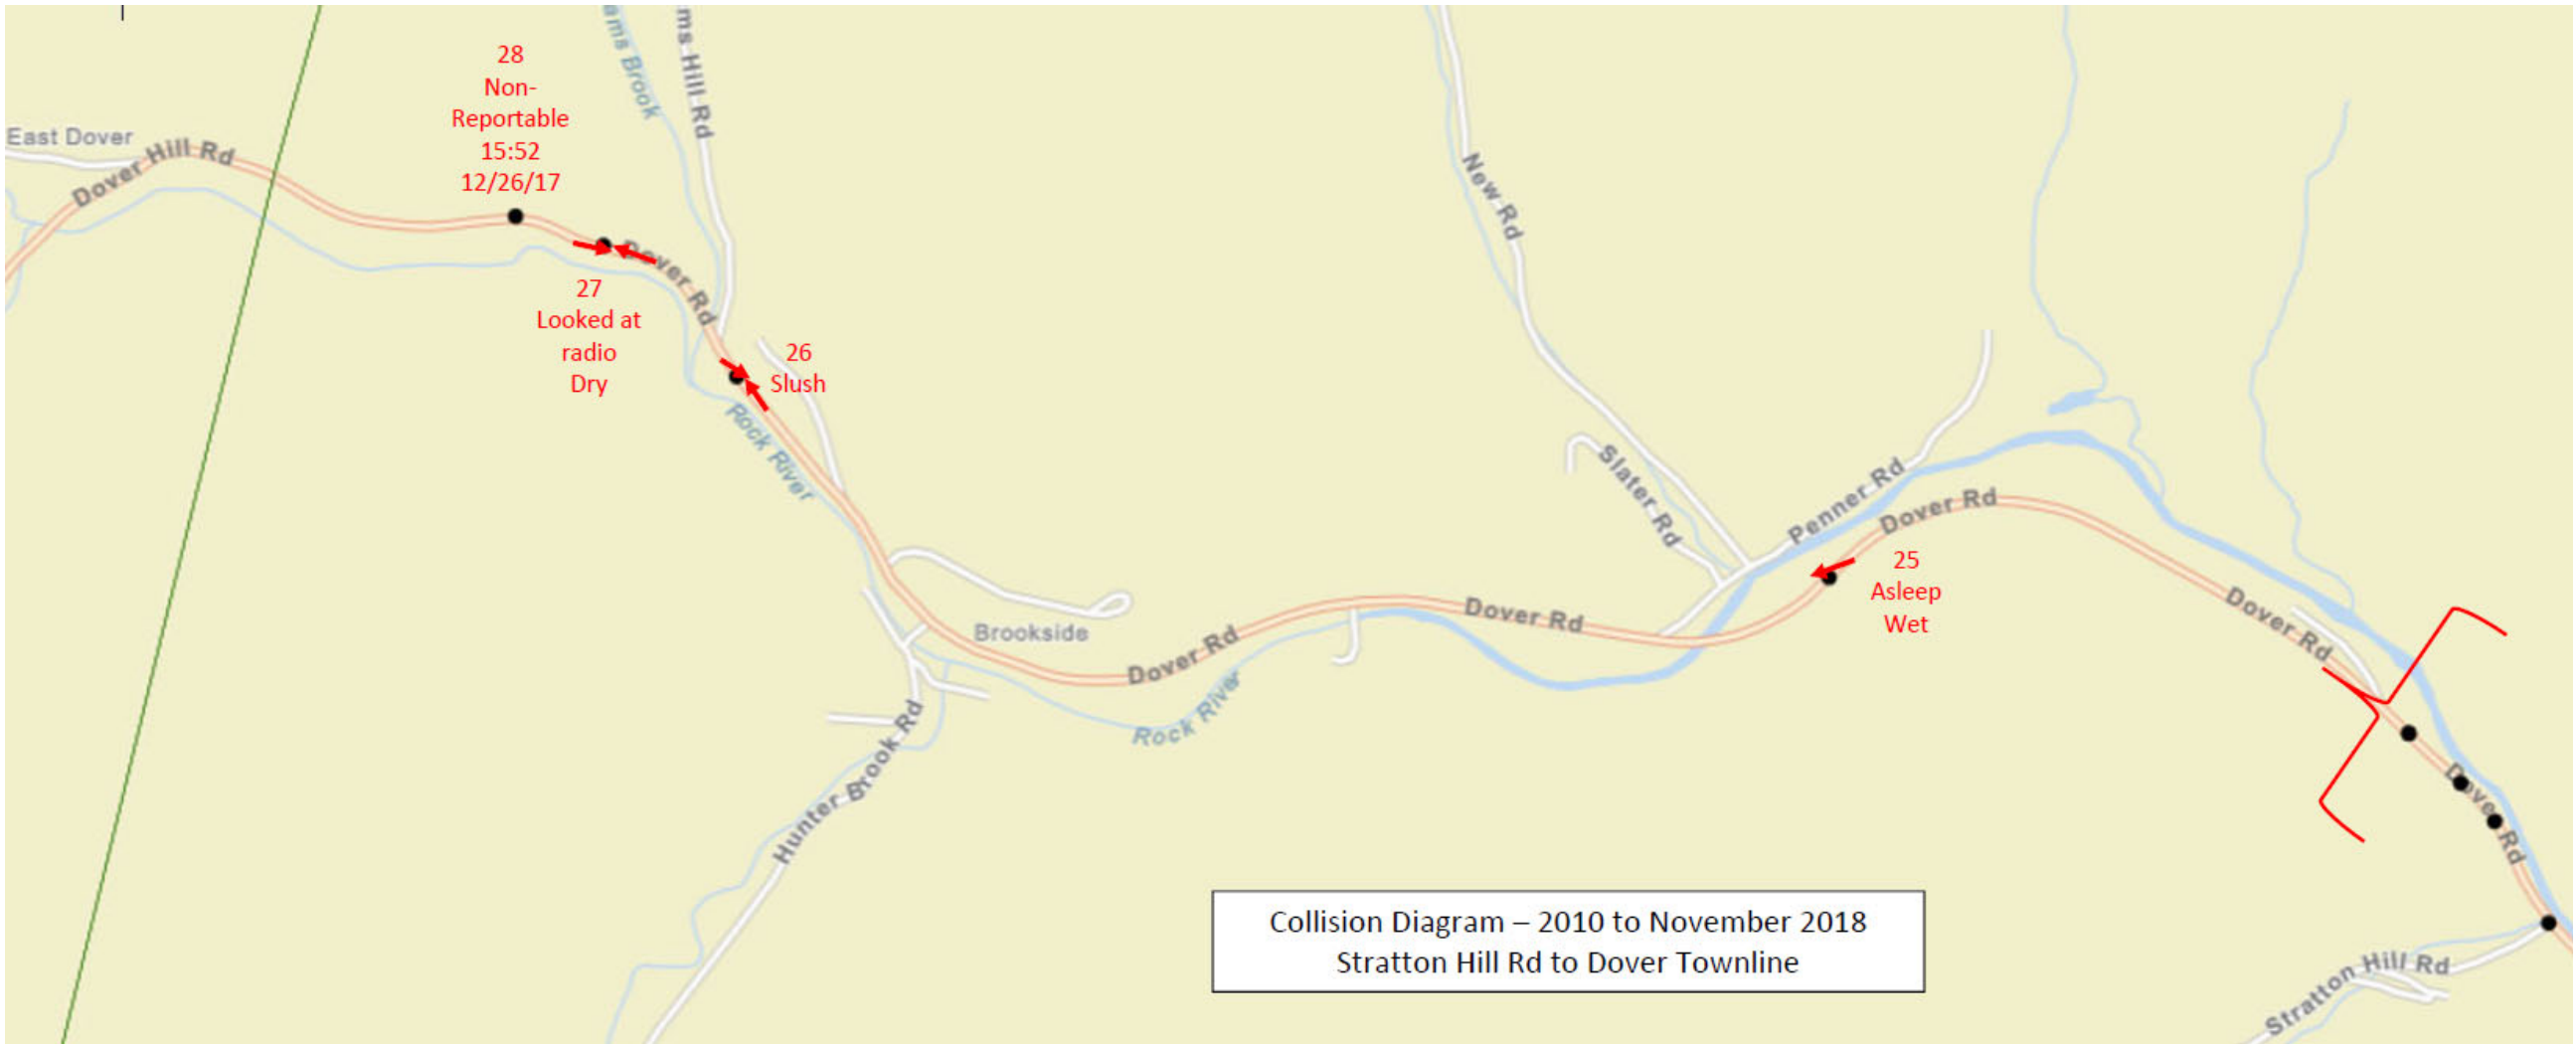
Collision Diagram – 2010 to November 2018  
Stratton Hill Rd to Jones Hill Rd

There were thirteen crashes from 2010 to about November 2018 between Jones Hill Road and Stratton Hill Road.

Four of these crashes happened when the road was closed following the aftermath of Irene (9/2011) or when the westbound lane was closed due to erosion (11/2017). There were two crashes in each of these time periods.

Of the other nine crashes, seven happened between the hours of midnight and 06:00 am, when the light conditions were dark.

For those nine crashes, the most important crash pattern is a single vehicle crash (six cases). For these same nine crashes, the most recurring crash cause is falling asleep (three cases).
