Road Safety Audit Review

Town:	St Albans Town	Date Reviewed:	September 7 2016
Route:	VT 36 and Georgia Shore Rd (Min 0764) Intersection	Mile points:	VT 36 MM 0.75 - 0.8 Georgia Shore MM 1.3

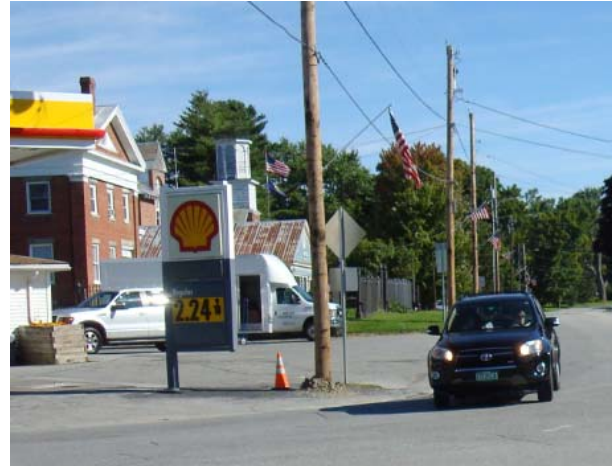
The geometry of this intersection and traffic flow create confusion among motorists and in particular among the unfamiliar drivers. This is a wide intersection and there is an overall lack of definition. Access control to the adjacent restaurant and store is absent and contributes to the confusion. Parked vehicles prevent motorists from seeing oncoming vehicles or block the view of traffic control devices such as the stop sign on Georgia Shore Road.

Modify the “gas” sign and relocate it outside of the right-of-way so that it does not block the view of motorists.

On Georgia Shore Road, move the centerline to the south to better align the approach, control access by the Bay Pavilion by curbing with a green strip. Put the stop sign inside the island.

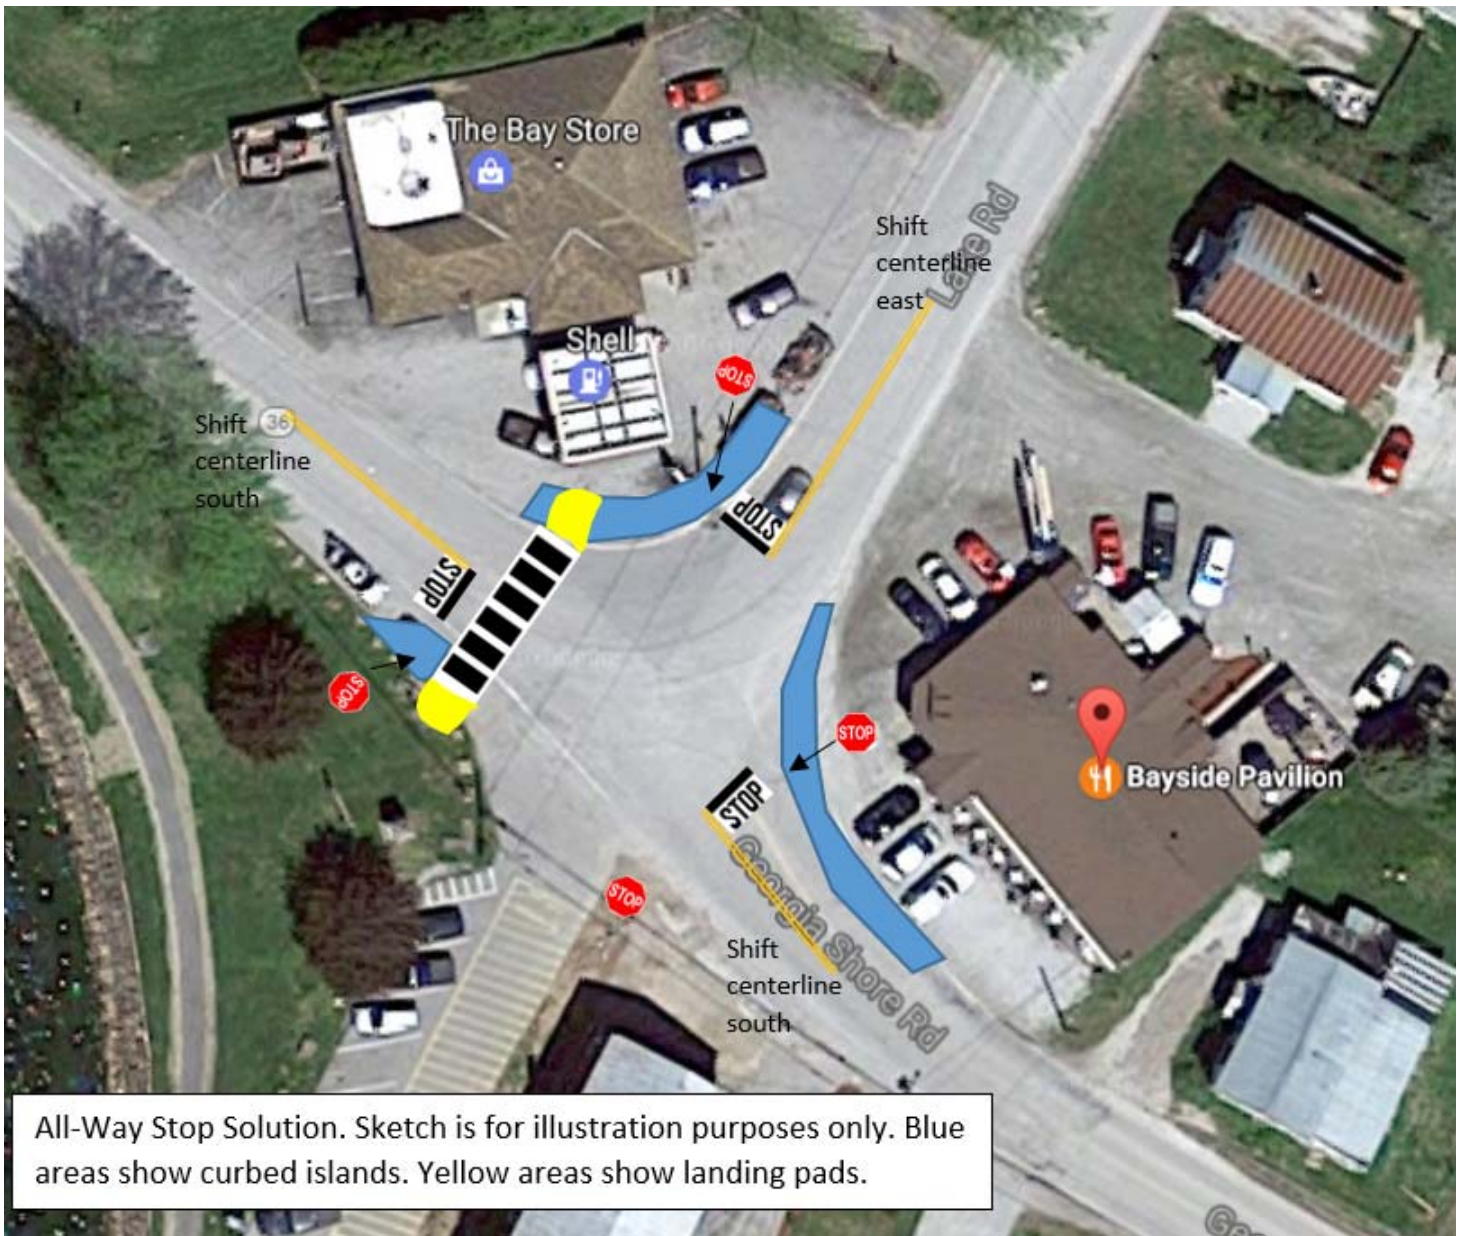
Furthermore, with the intersection operating under all-way stop control, the VT 36 crosswalk will now be one or two car lengths behind what will be the new stop bar. The VT 36 crosswalk needs to be relocated to the intersection. This will, in turn, require some modifications to the pedestrian facilities and require creating a new landing pad on the Bay Store side. These changes could fit well with the new walkway that is proposed with the new Marina.

Implement an All-Way Stop

This option consists of installing new stop signs on the two VT 36 approaches to make this a three-way intersection. Access control is required to implement this option¹. Each stop sign must be installed inside an island.

1. On Georgia Shore Road, move the centerline to the south to better align the approach, control access by the Bay Pavilion by curbing with a green strip.
2. On the VT 36 west approach, move the centerline away from the store.
3. On the VT 36 east approach (north side of the intersection), move the centerline to the left and control the access to the store by curbing.

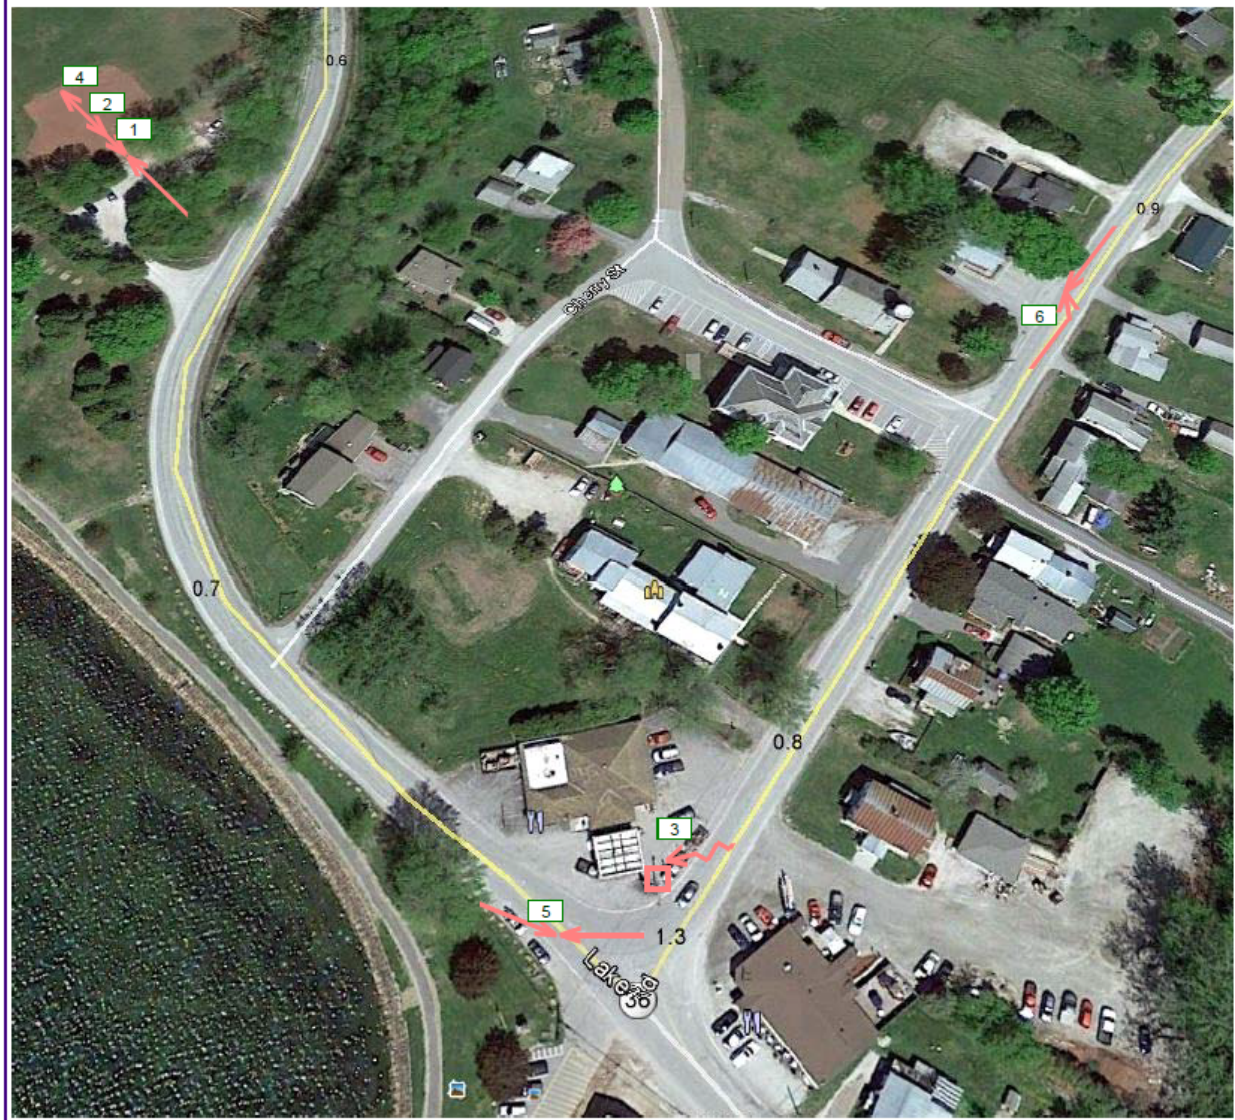
COLLISION DIAGRAM

The crash history was reviewed at the intersection for the six-year period covering the years 2010 to 2015. Only two crashes occurred at this intersection during this period.

These two crashes were of different types. One was a single vehicle crash and the other one was a head-on crash. The head-on crash happened on VT 36 and was caused by one of the motorists crossing the centerline to avoid pedestrians in the shoulder.
