Office of Highway Safety

Road Safety Audit Review

Town:	Cambridge	Date Reviewed:	June 26 2018
Route:	VT 15, VT 104 and Old RTE 15	Mile points:	VT 15: 1.75 – 1.88 VT 104: 0.00-0.08

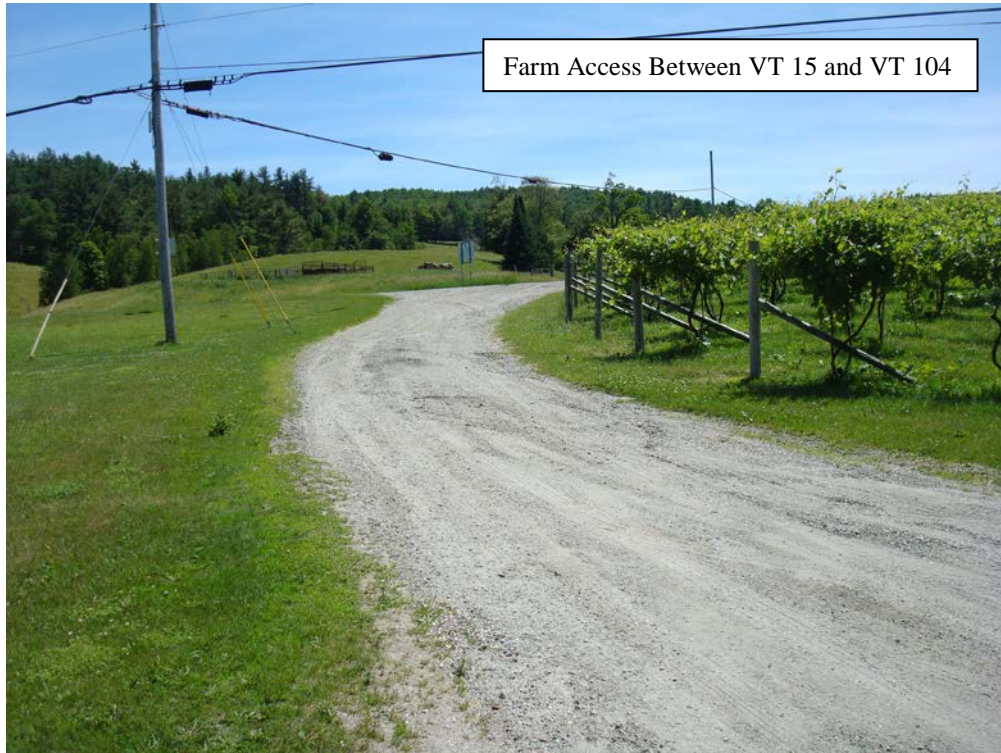
There is a 200-foot long farm access approximately 200 ft north of the intersection on VT 104 and approximately 170 ft west of the intersection on VT 15. This access forms a triangle with VT 15 and VT 104.

It was explained that the farm access between VT 15 and VT 104 was being used at times by motorists and that this created conflicts with the normal traffic on these two roads.

- Research if this access is permitted, suggest that it be closed off at the VT 15 end or gated.

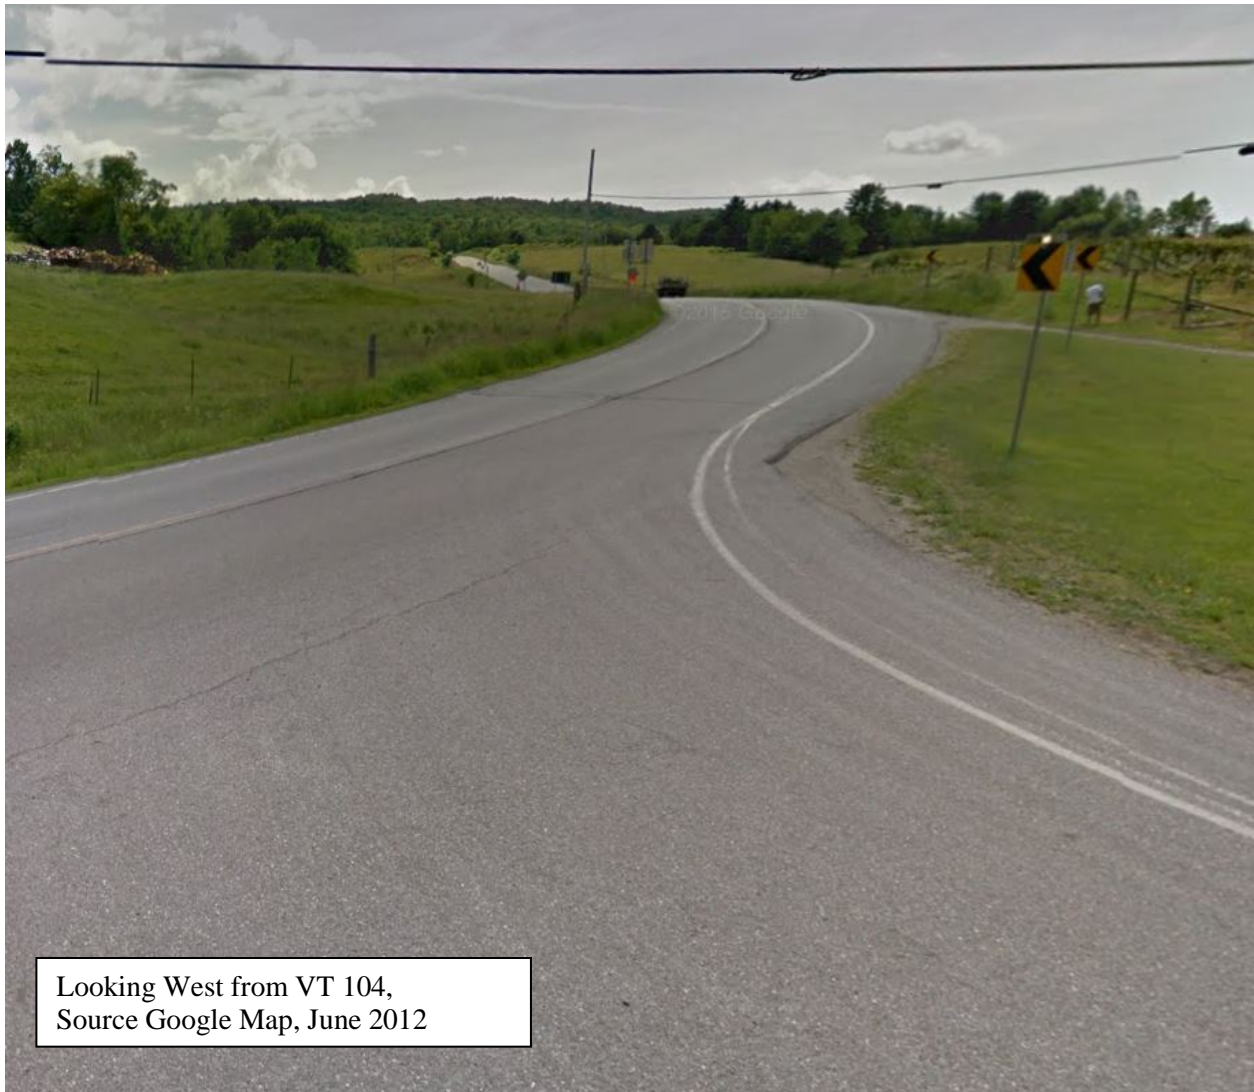
A rough estimate of available corner sight distance from VT 104 when looking to the left is about 650 ft, while a rough estimate when looking to the right is about 500 ft (the corner sight distance to the right is limited because of a dip in the road west of VT 104). The AASHTO corner sight distance guideline is 555 feet for a speed of 50 mph.

There is a dip in the road on VT 15 west of the intersection. This causes eastbound vehicles to disappear for a few seconds from the view of motorists waiting on VT 104. Vehicles on VT 15 are perceived to be traveling above the 50 mph speed limit and above the 30 mph advisory speed for this area. Motorists on VT 104 are said to have less time than they expect when entering VT 15. Motorists on VT 104 were also reported to misjudge whether a westbound vehicle on VT 15 was turning right or continuing westbound on VT 15.

- Evaluate the possibility of removing the dip in the road on VT 15.
- Evaluate the possibility of relocating the intersection to provide better corner sight distance.
- Evaluate the possibility of converting the existing right turn lane to an offset right turn lane².

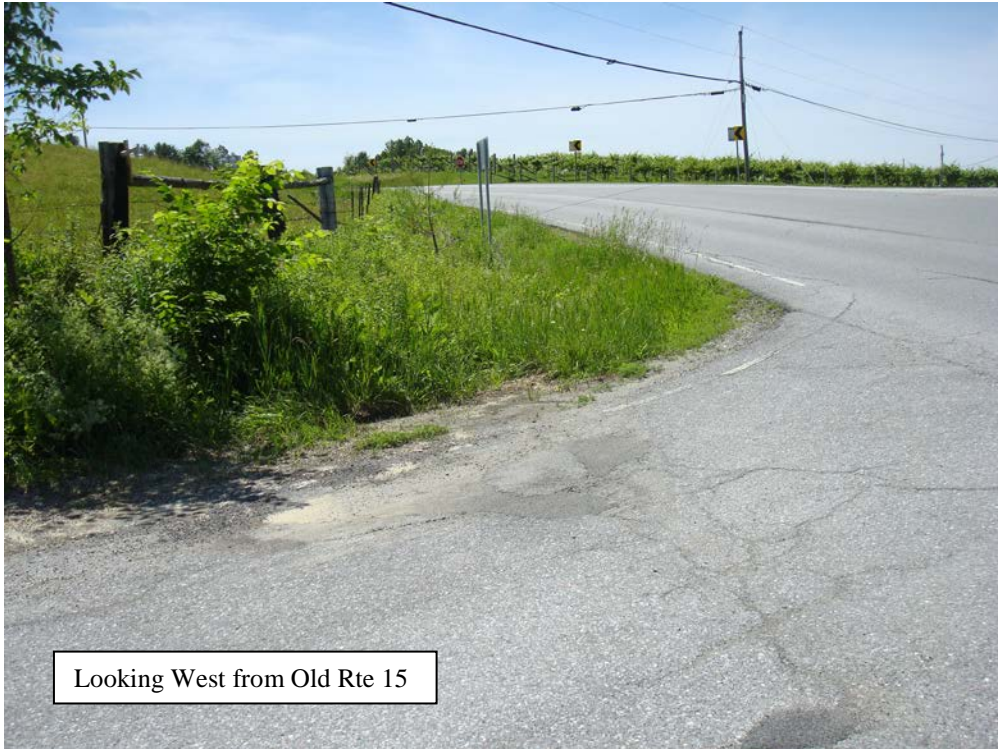
When looking from Old Route 15, the corner sight distance was observed to be relatively poor in both directions (approximately less than 200 feet looking west and about 300 ft looking east).

Entering VT 15 from Old Route 15 at this intersection is difficult due to the poor corner sight distance in either direction.

- Consider making Old Route 15 one-way eastbound (towards Angelino's).

- Evaluate closing off Old Route 15 at the VT 104 intersection.

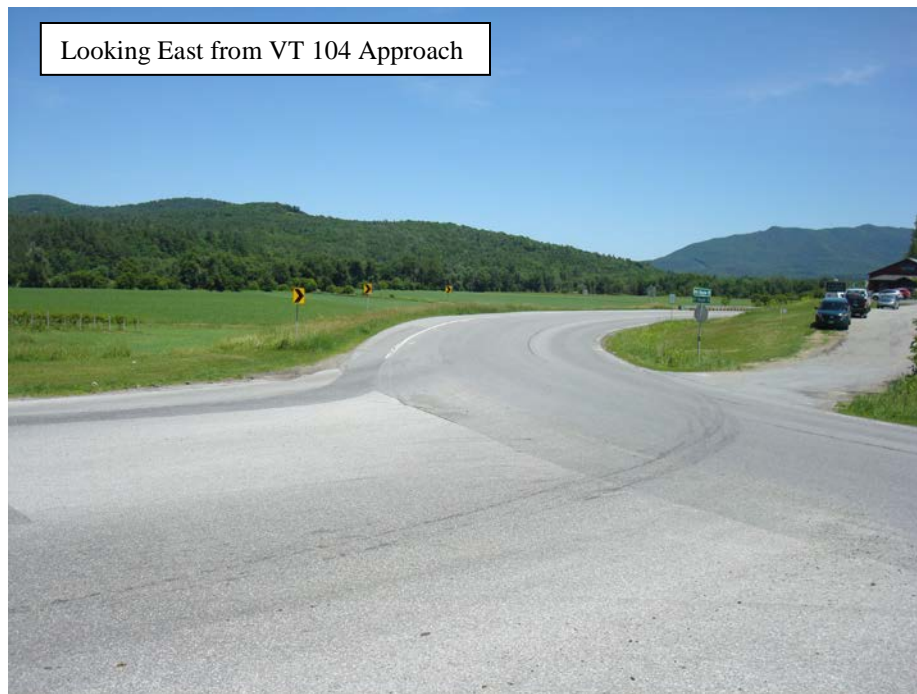
Pavement markings were faded at the time of this site visit as can be seen in the following picture.

The VT 15 westbound approach has a through lane and an auxiliary right turn lane. However, the markings are faded and the right turn lane is not visible.

- Refresh the lane markings at this intersection.

- Consider using recessed markings.

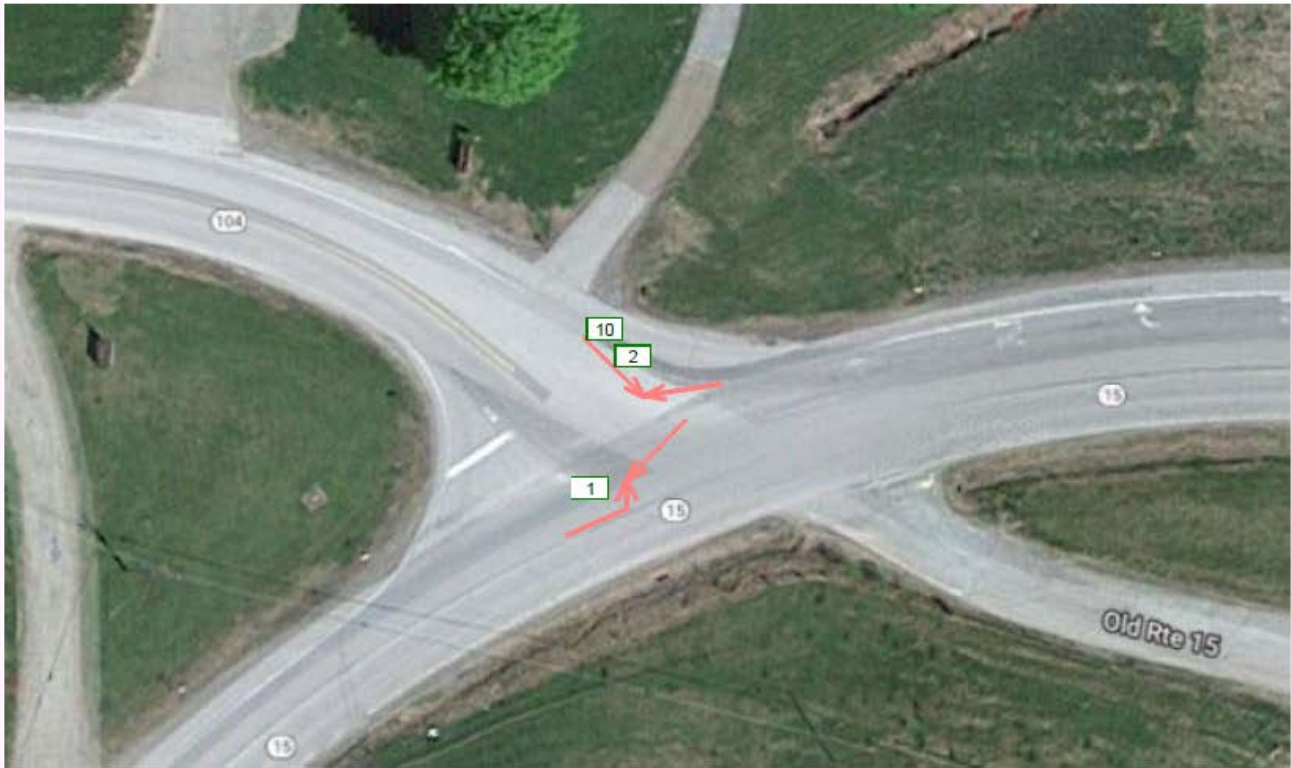
COLLISION DIAGRAM

For the crashes with an available narrative (including the 2018 fatal crash), the manner of crash was some form of a right angle crash. For these crashes, a common factor was that the roads were snow covered.

For at least four crashes, the vehicle at fault skidded on the snow. For the three non-fatal crashes, the light conditions were dark.

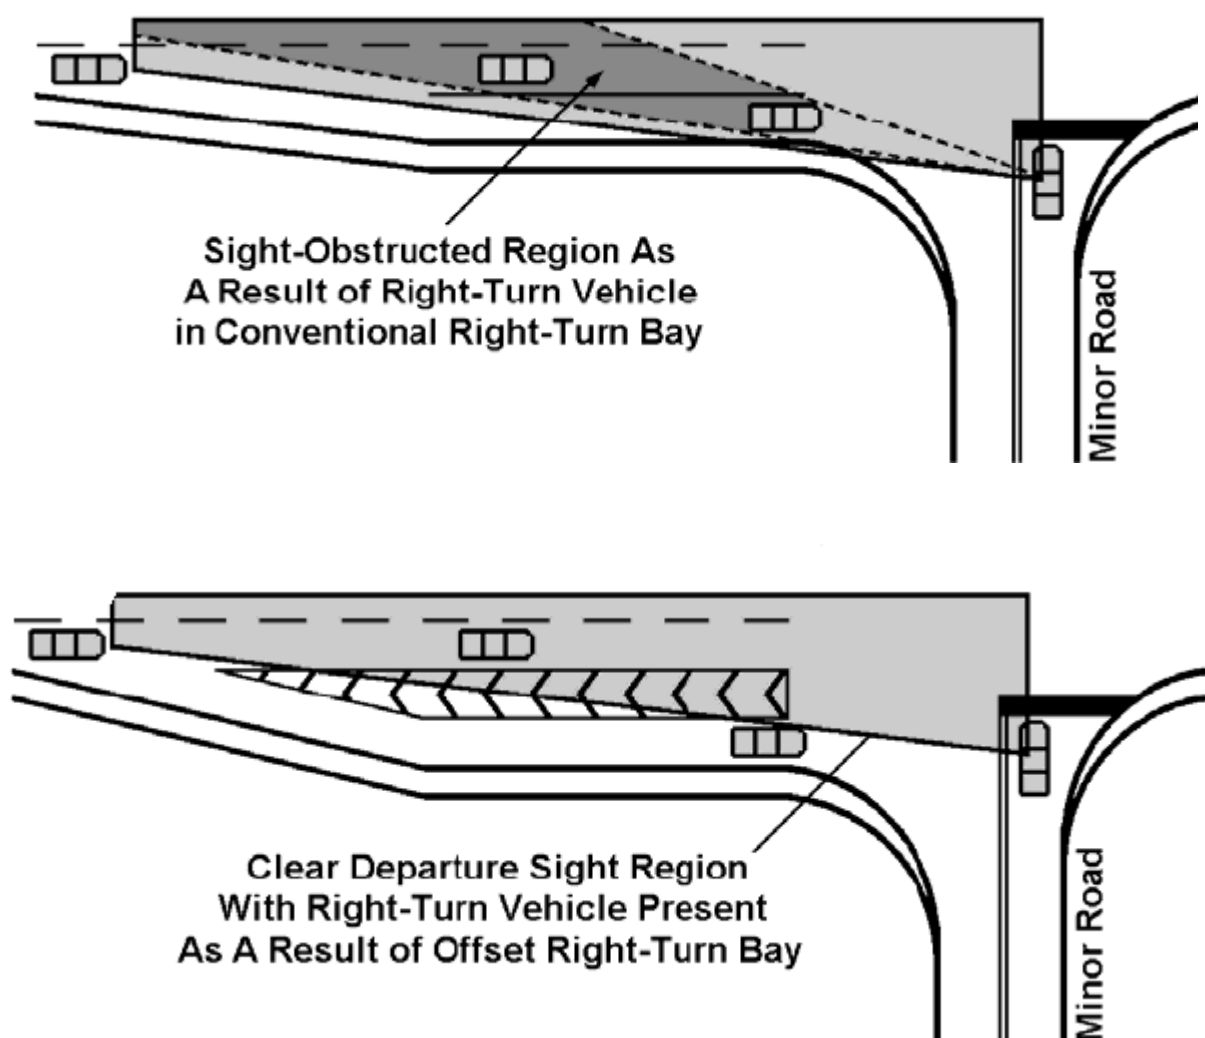
Appendix B Offset Right Turn Lane Concept

An offset right turn lane is a right turn lane that is constructed outside of the intersection sight distance triangle for minor road traffic. This concept is illustrated in the figure⁷ below. The top intersection shows a conventional right turn lane and how the right turning car prevents the motorist on the minor road to see the through vehicle on the main road. The second intersection shows an offset right turn lane and how its design provides the motorist on the minor road a clear view of the oncoming through vehicle.
