# Office of Highway Safety

## Road Safety Audit Review

<b>Town:</b>	Norwich	<b>Date Reviewed:</b>	May 24, 2017
<b>Route:</b>	VT 10a, I-91 NB exit, McKenna Rd	<b>Mile points:</b>	VT 10a MM 0.21 – 0.26

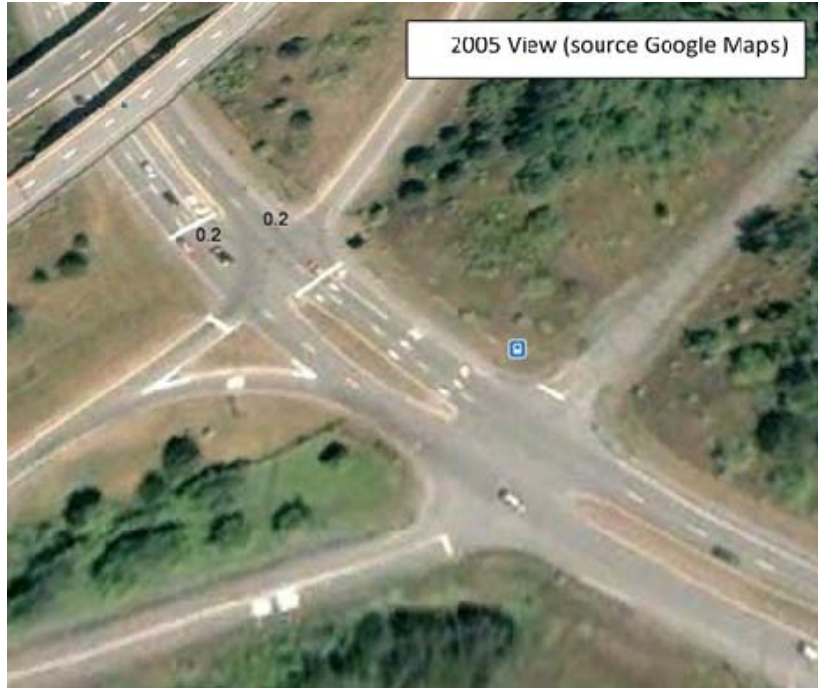
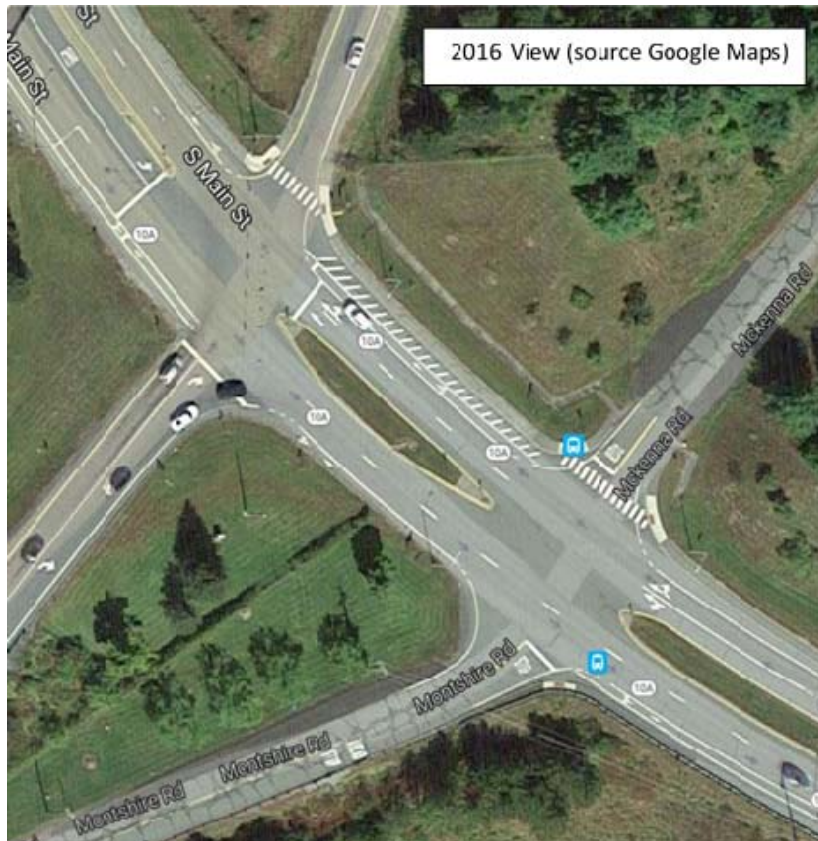
The next figure shows an aerial view from 2005 and one from 2016. It can be seen that the I-91 exit ramp used to have a slip lane and that there also used to be an exclusive right turn lane for traffic to get on the I-91 northbound on ramp. The space for this exclusive right turn lane is now being used for a bike lane.

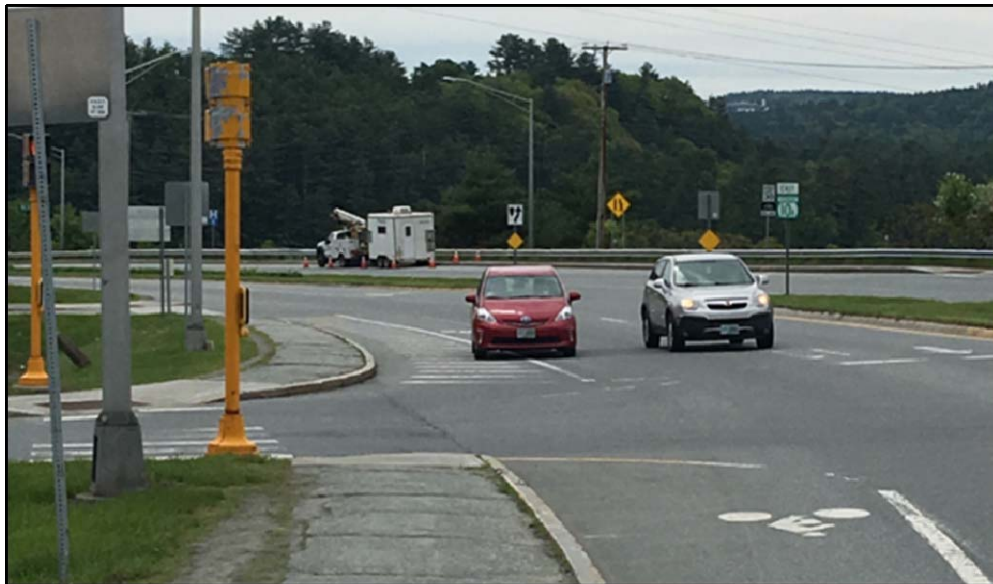
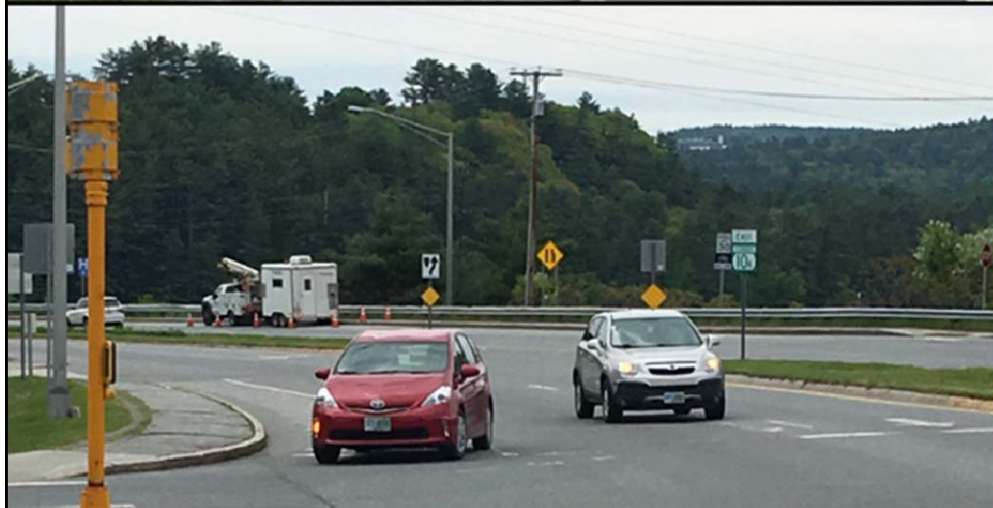
Concern: The Right Turn onto I-91 Northbound Creates Conflicts

People have been observed to drive in the crosshatched shoulder to make a right turn onto the I-91 on-ramp. Conflicts and near misses occur when a vehicle that is in the correct lane initiates a right turn and a vehicle is also making a right turn but from the shoulder.

Safety Enhancements:

Short Term

Install rumble stripes inside the shoulder to deter motorists from continuing through the shoulder to make a right turn.

Consider installing flexible delineators from May 1 to October 1 of each year.

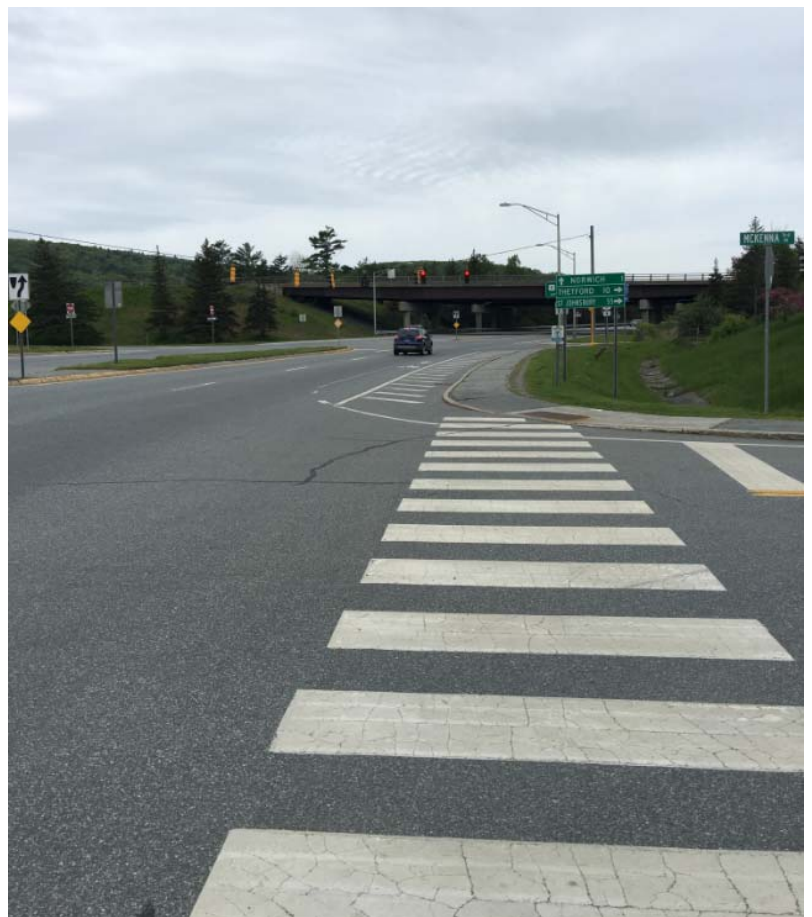
Concern: Motorists confuse McKenna Road for the I-91 Northbound on Ramp

As stated, some motorists that are traveling westbound turn right onto McKenna Road, thinking that this is the I-91 on ramp.

Short Term

Increase the size of the McKenna street name sign to a 12-inch tall sign.

Install an additional No Outlet sign on the south side of McKenna Road
