Office of Highway Safety

Road Safety Audit Review

Town:	Dorset	Date Reviewed:	August 9, 2017
Route:	US 7 and Mad Tom Road	Mile points:	1.9 to 2.3, Int @ 2.10

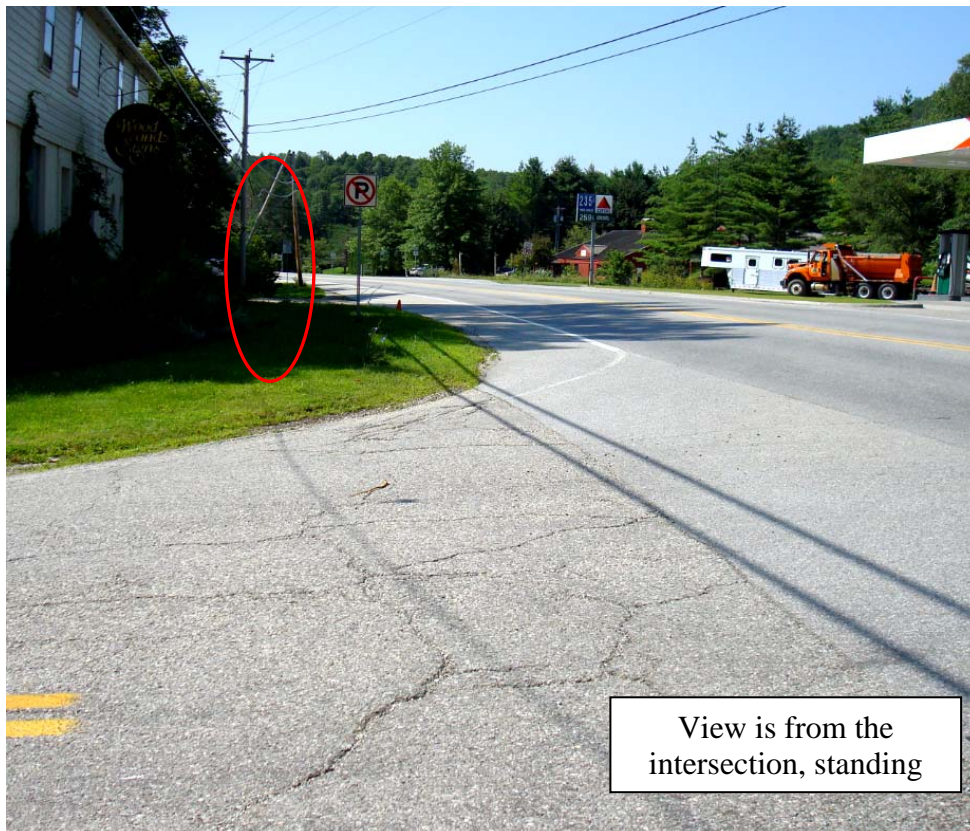
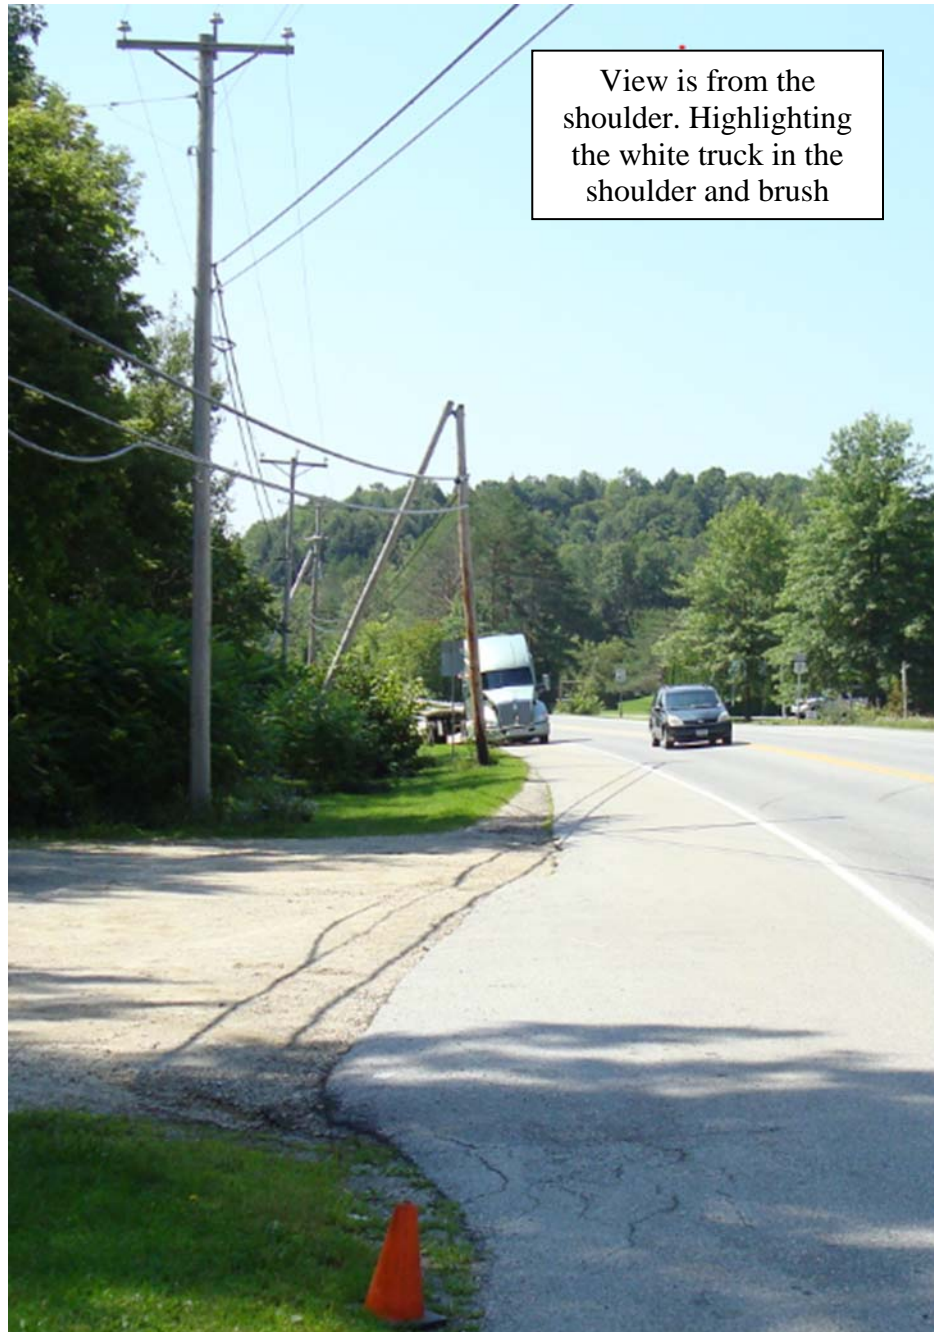
Concern: Limited Corner Sight Distance To The Left On US 7 From Mad Tom Road

A pedestrian who looks to the left on Mad Tom Road does not see fully oncoming northbound vehicles, due to brush in the inside of the curve and due to large vehicles that are parked occasionally beyond the no parking zone.

Cut brush on the inside of the curve on the east side of US 7.

Consider extending the No Parking Zone on the east side of US 7 to the south.

Install a stop bar on Mad Tom Road, four feet from the edge of pavement (It would be good practice to install a stop bar on Lower Squirrel Hollow Road as well).

Elevate Mad Tom Road to improve the visibility that motorists on US 7 have of cars and pedestrians on Mad Tom Road (BCRC or the Town should initiate the conduct of a scoping study to understand what geometric changes would be possible and determine how much they would cost).

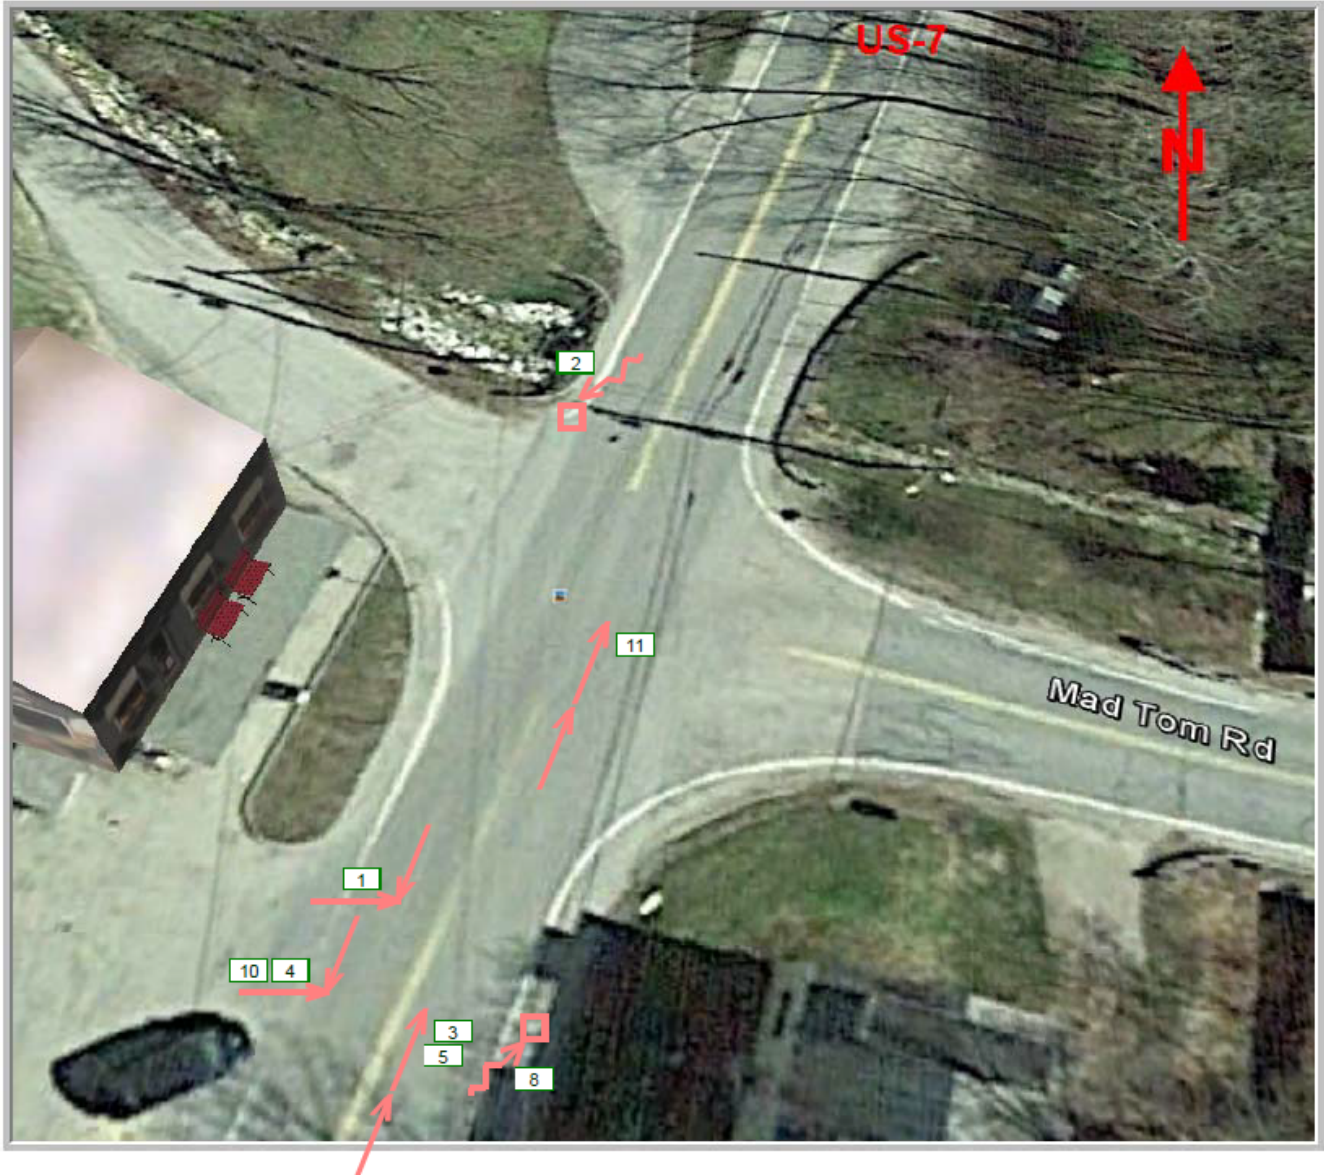
COLLISION DIAGRAM

The primary crash pattern at the store involved a vehicle that was coming out of the store parking lot with the intention of making a left turn onto US 7 northbound and which collided with a southbound vehicle. In all cases, it appears that the driver at the store did not see the southbound vehicle. In one instance, the operator mentioned having a hard time seeing over the snow banks that were at the edge of the parking lot. Two-thirds of these crashes happened when the island in front of the store was only delineated with paint while the other third took place when the island was delineated with delineators. There have been no crashes of this type since the installation of the raised island.

A second crash pattern at the store were rear-end crashes with one operator waiting to turn left into the parking lot and being rear-ended by a northbound vehicle.
