Office of Highway Safety Road Safety Audit Review

Town:	Marshfield	Date Reviewed:	August 22, 2017
Route:	VT 215 (Cabot Road)	Mile points:	VT 215 MM 0.0 – 0.26

Road Safety Audit Review

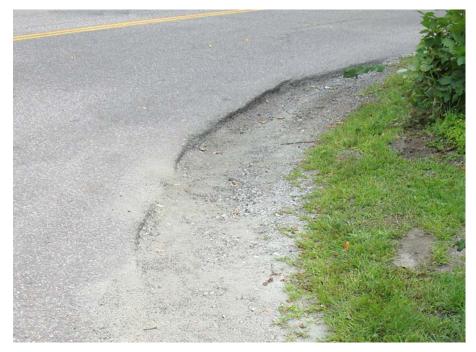
Concern: Pavement Edge Drop Off on the Southeast Corner of US 2 Slip Lane Creates a

Hazard for Pedestrians

Pedestrians are walking along the road. This drop off presents a hazard.

Backfill the area with materials, groundings if available.
