# Office of Highway Safety

## Road Safety Audit Review

<b>Town:</b>	Lowell	<b>Date Reviewed:</b>	September 10, 2015
<b>Route:</b>	VT 100 and VT 58 Intersection	<b>Mile points:</b>	VT 100: 4.39, VT 58:0

The location of this RSAR is the intersection of VT 100, VT 58 and Hazen's Notch Road in Lowell.

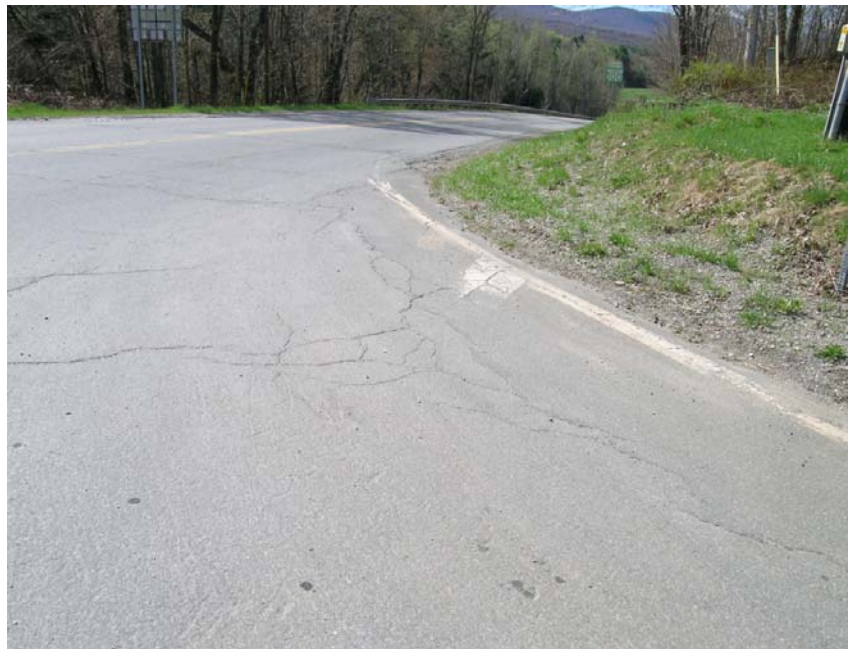
#### Concern: Corner Sight Distance Issue, Southwest Quadrant

The corner sight distance when stopped on Hazen's Notch Road and looking to the right (south) is marginal (*it was measured at about 380 feet. This is about right for the 35 mph posted speed limit, but the 85<sup>th</sup> percentile speed is 46 mph, and about 500 feet is required at that speed*). The embankment on the west side of VT 100 contributes to this issue.

Evaluate what gain in corner sight distance could be achieved by cutting back the bank on the west side.

Note, Intersection Sight Distance (ISD) for 35 mph is 390 ft, for 40 mph, 445 feet and 555 ft for 50 mph as per AAHSTO.

Ensure that the stop bar and the STOP word markings are located four feet from the edge of the road to maximize corner sight distance and that they are visible and refreshed on a yearly basis as needed.

Install permanent stop bar and STOP word markings as part of the upcoming paving project.

Conduct recurring speed limit enforcement campaigns for the high-risk drivers who are traveling northbound and approaching the intersection.

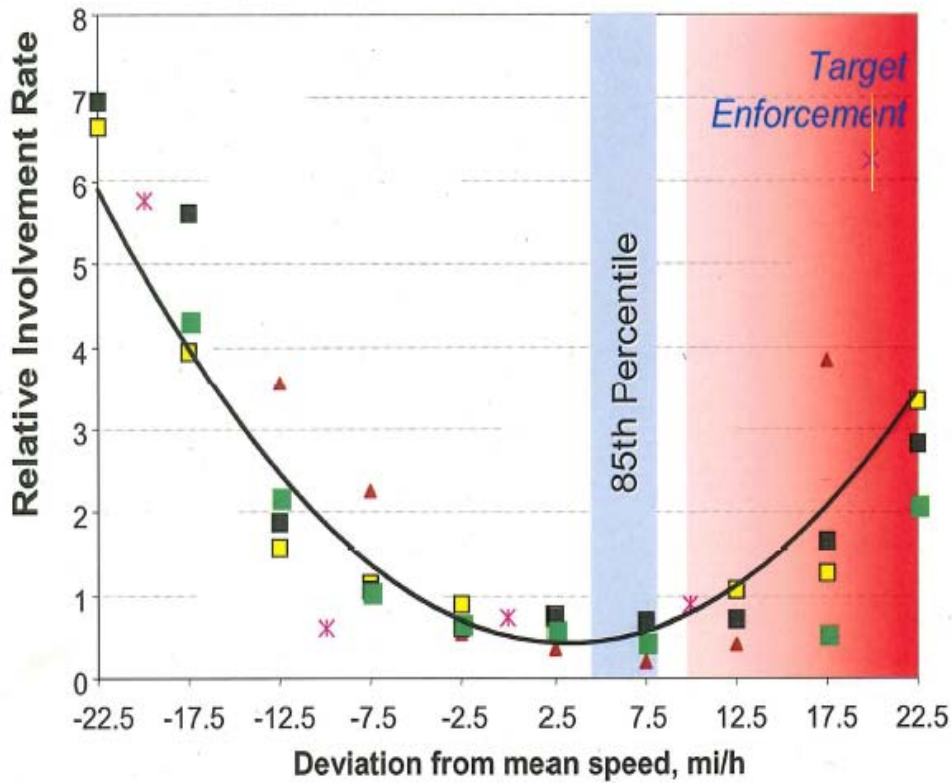
Targeted Enforcement Concept

In doing this, consider targeting drivers who are traveling at or above the 90<sup>th</sup> percentile speed as per the following concept suggested by NHSTA. The next graph shows that the crash involvement rate increases as traveling speeds deviate from the 85<sup>th</sup> percentile speed. This means that targeting motorists that are traveling above the 85<sup>th</sup> percentile speed will apprehend motorists that are more likely to cause a crash. Crash involvement starts to increase more drastically 5 mph above the 85<sup>th</sup> percentile speed or around the 90<sup>th</sup> percentile speed. Applying this concept to this section of VT 100 in the northbound direction just south of the intersection means that the focus should be put on vehicles that are traveling above 47 mph (90<sup>th</sup> percentile).

Install a radar speed feedback sign south of the intersection where the 35 mph speed zone begins.

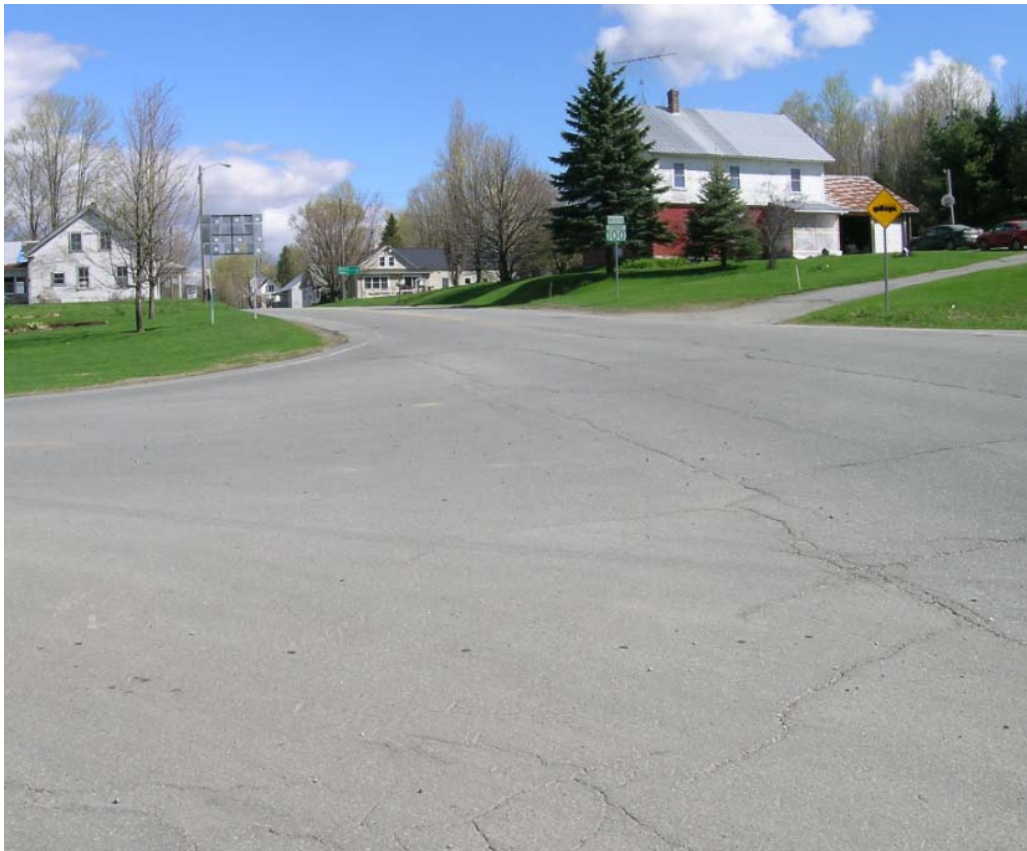
Concern: Corner Sight Distance Issue, Northwest Quadrant

The corner sight distance when stopped on Hazen's Notch Road and looking to the left (north) is poor (*measured at 300 feet, which is below the required 390 feet value for the 35 mph posted speed limit and below the value needed for the 85<sup>th</sup> percentile speed of 44 mph*). The crest of the road on VT 100 contributes to this issue.

Evaluate what gain in corner sight distance could be achieved by lowering the road.

Evaluate if a roundabout or a mini roundabout could be constructed at this intersection.

Install a radar speed feedback sign north of the intersection with a new 35 mph speed limit sign (*a location could be by the utility pole at about mile marker 4.534, just north of the white church*).

Conduct recurring speed limit enforcement campaigns for the high-risk drivers who are traveling southbound and approaching the intersection. As per the concept explained previously, target vehicles that are traveling southbound towards the intersection above 45 mph (90<sup>th</sup> percentile).

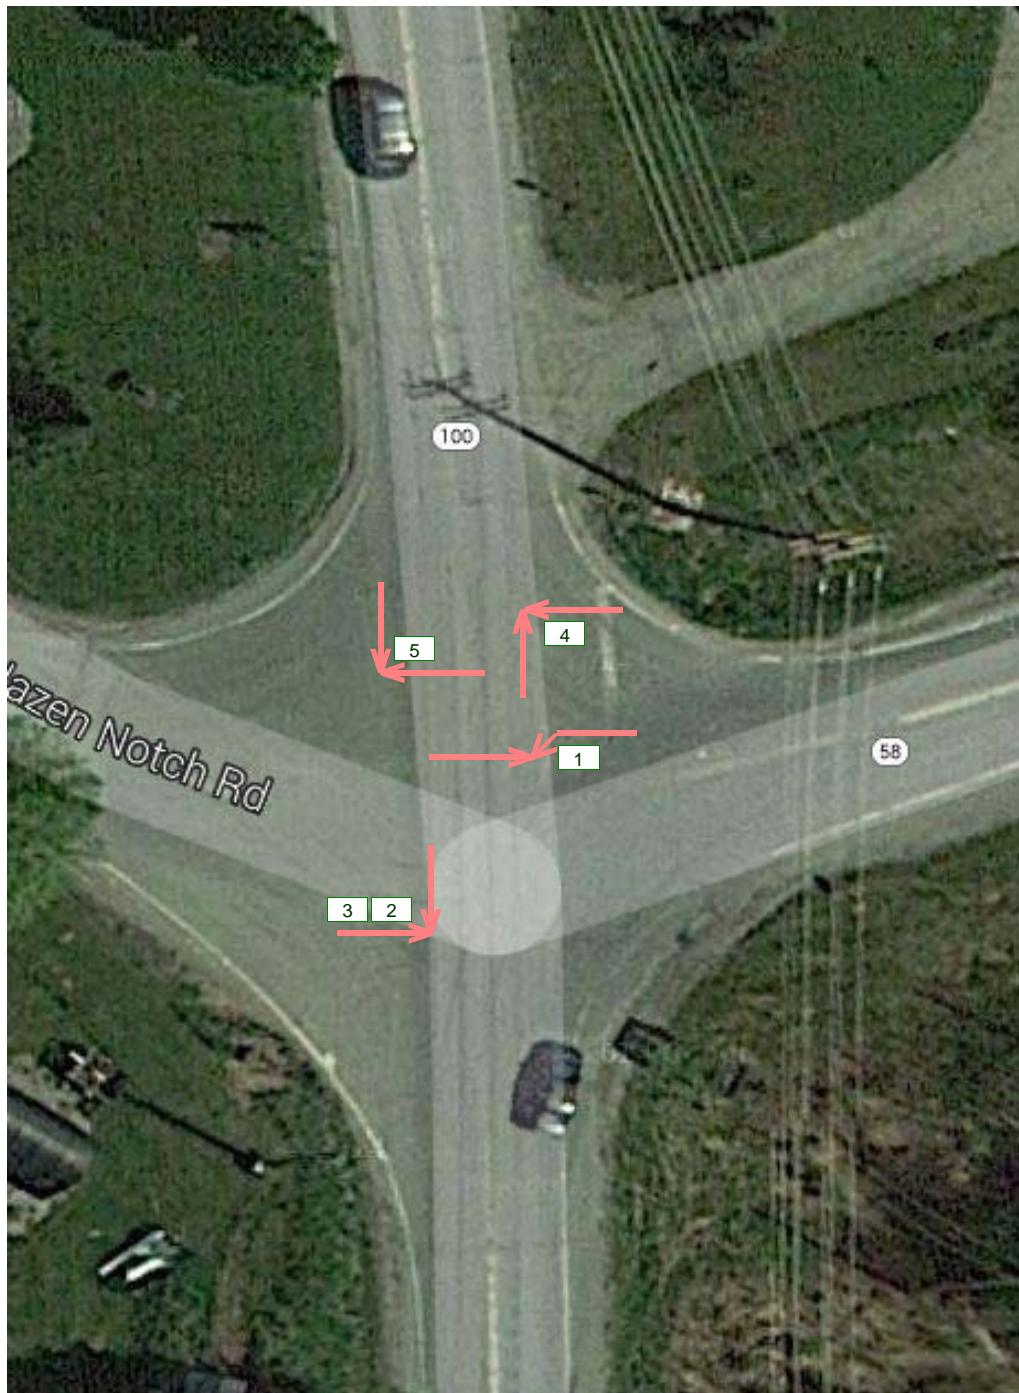
# COLLISION DIAGRAM

Five crashes occurred at this intersection between 2010 and 2014. All five crashes were right angle crashes.

Three of the five crashes involved a vehicle that was traveling southbound. Three of the crashes also involved a vehicle that was crossing VT 100 from Hazen's Notch Road.

Three of the five crashes involved a motorist that ran the stop sign. One crash involved a motorist who said he had stopped but had not seen any oncoming vehicles.
