Office of Highway Safety

Road Safety Audit Review

Town:	St Albans Town	Date Reviewed:	May 31 2016 2017
Route:	VT 36 @ Rugg Road and Kyle Rd (private road)	Mile points:	VT 36 MM 4.84

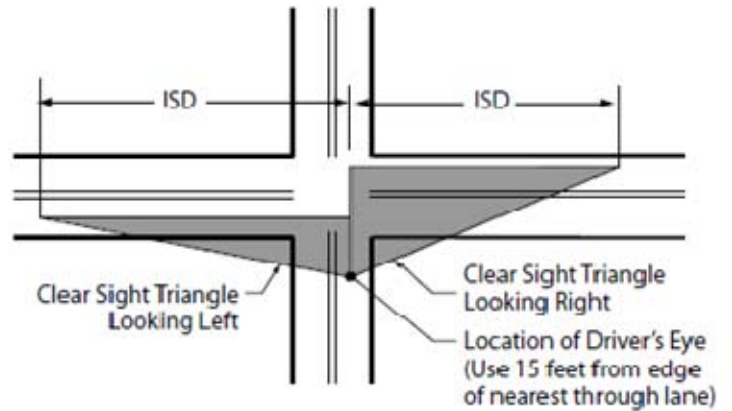
The corner sight distance (ISD) for a motorist that is stopped on Kyle Road and who is looking to the right (west), towards ST Albans, is inadequate and below standards. The recommended corner sight distance for the actual posted speed limit of 50 mph is 555 feet.

The available corner sight distance was measured to be 273 feet.

The embankment on the north side of VT 36 and the horizontal/vertical curve combination west of the intersection contribute to this issue.

Improve the advance curve signage as mentioned previously by relocating the signs closer to the intersection and by replacing them with new Type IX sheeting signs.

Evaluate what gain in corner sight distance could be achieved to the west by cutting back the bank on the north side of the road.

Install a dynamic warning system (like the one at Russell Road in Sheldon) that would inform motorists on Kyle Road that a vehicle is approaching from the right. Alternatively, install a

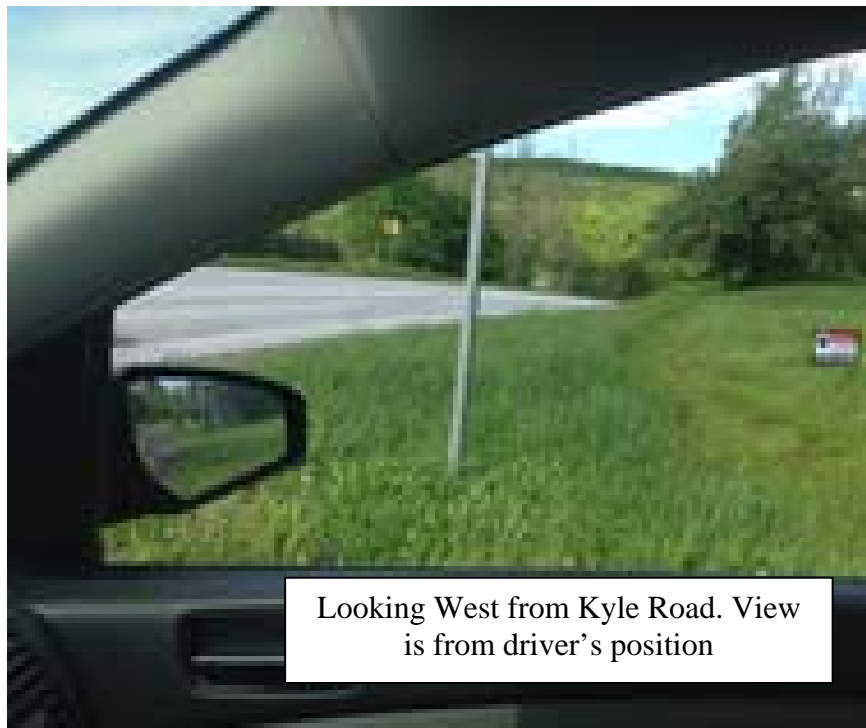
Looking West from Kyle Road. View is from driver's position

system west of the intersection that would warn traffic traveling eastbound on VT 36 that a vehicle is stopped on Kyle Road.

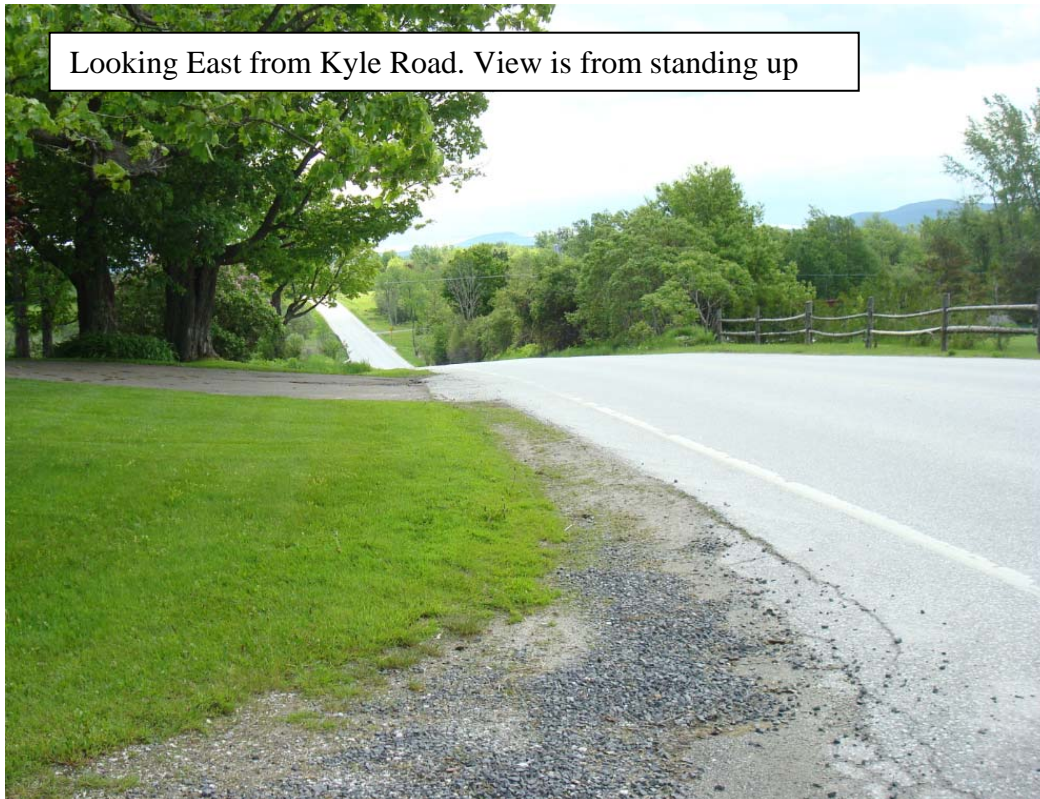
Besides the poor visibility to the west, there is also a low spot in the road on VT 36 when looking towards Bakersfield that makes it hard sometimes for a motorist on Kyle Road to see vehicles that are traveling westbound. This contributes to the difficulties of making a left turn to the east out of Kyle Road.

Evaluate how to address the low spot on VT 36 east of the intersection.

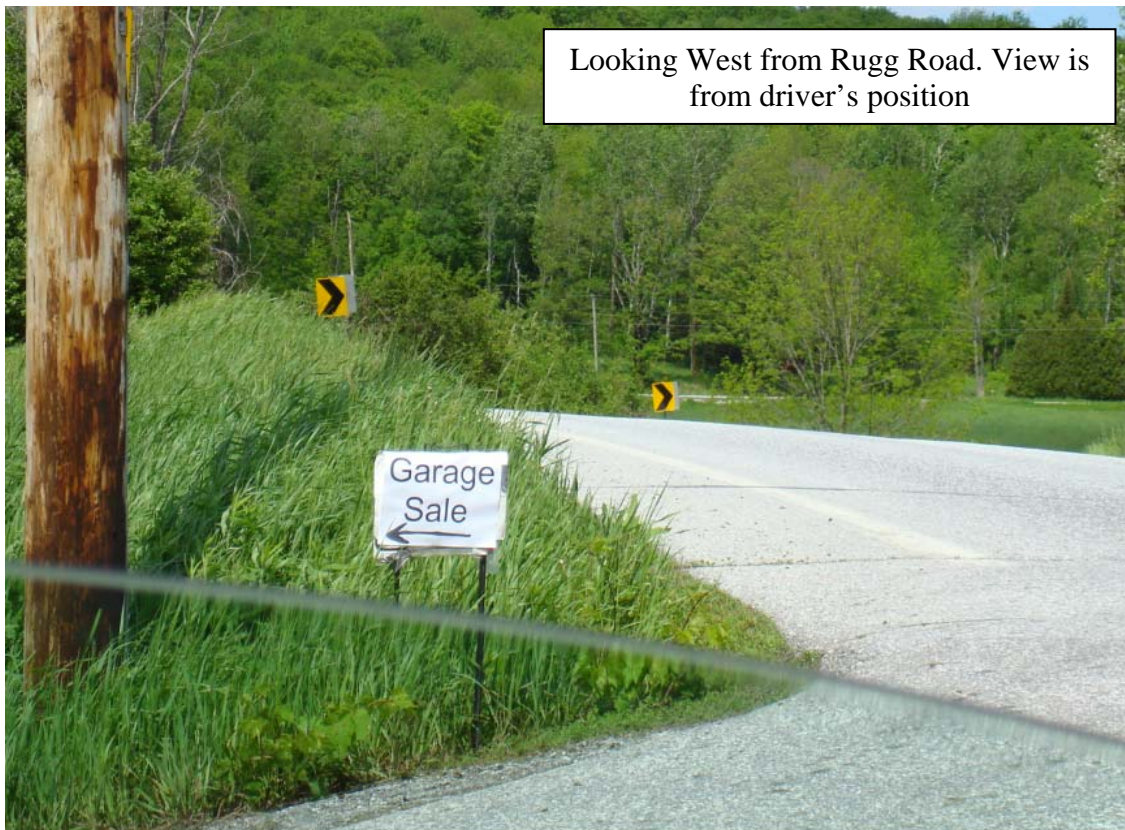
Concern: Corner Sight Distance Issue, Southwest Quadrant (Rugg Rd)

The corner sight distance for a motorist that is stopped on Rugg Road and who is looking to the left (west), towards ST Albans, is inadequate and below standards. The recommended corner sight distance for the actual posted speed limit of 50 mph is 555 feet.

The berm and tall grass (possibly snowbanks as well during winter), the lower approach grade on Rugg Road and the horizontal/vertical curve combination on VT 36 contribute to this issue.

Remove the berm (looks mostly like tall grass from the picture)

Keep the grass low (by mowing twice a year in this area).

Evaluate what gain in corner sight distance could be achieved by rising the approach on Rugg Road.

Install a dynamic warning system (like the one at Russell Road in Sheldon) that would inform motorists on Kyle Road that a vehicle is approaching from the left. Alternatively, install a system west of the intersection that would warn traffic traveling eastbound on VT 36 that a vehicle is stopped on Rugg Road.
