Road Safety Audit Review

VT 11, Londonderry North Village

September 22, 2020

Vermont Agency of Transportation
Operations & Safety Bureau

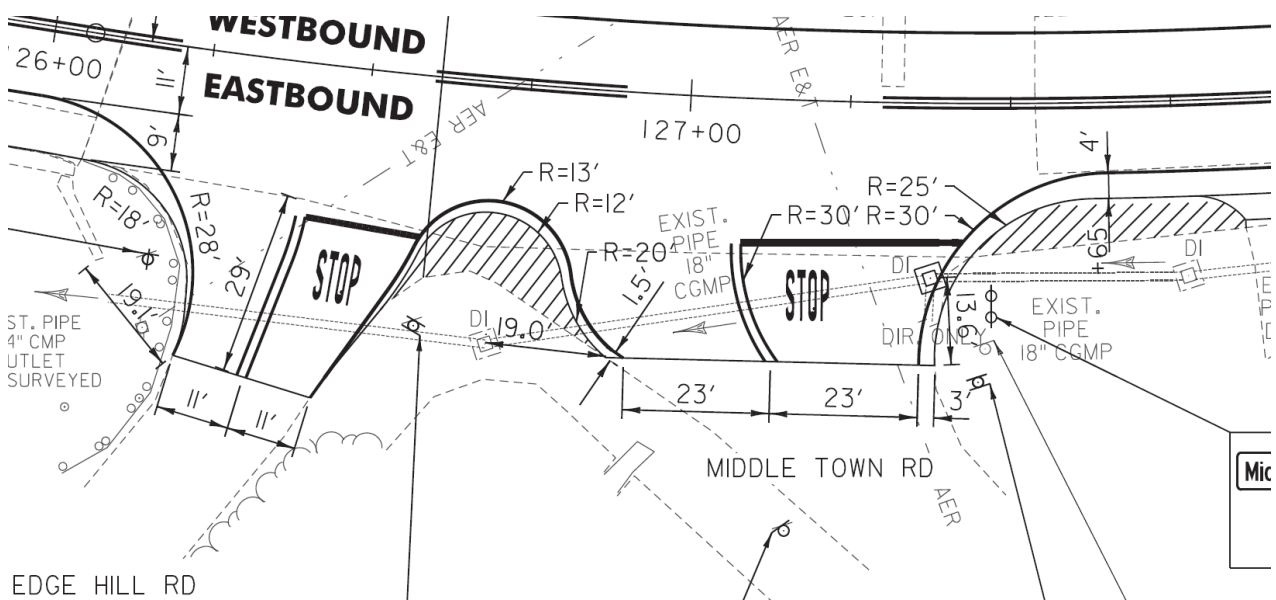
Local representatives mentioned that at the wide-open access to Middletown Rd was encouraging traffic turning onto Middletown Rd to maintain high speeds.

Pavement markings will be installed with the paving project (STP PS19(10)) to help make the approach to Middletown Rd less of a “straight shot”.

- Monitor and evaluate the pavement markings improvement at the Middletown Rd intersection.

The Town and the District could compile comments received from citizens. Crash data could be evaluated yearly up to three years following the placement of the markings by VTrans.

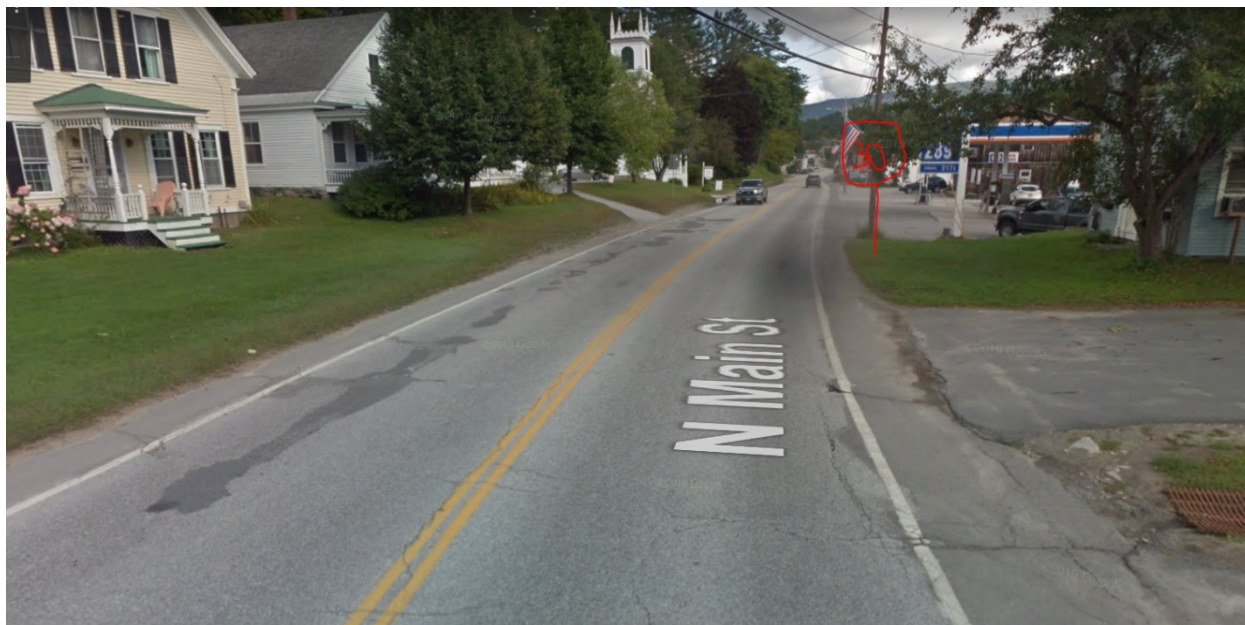
Site A:

The eastbound speed limit sign located east of bridge #27 is not very visible due to its positioning around the curve and brush.

- As part of paving project STP PS19(10) consider relocating the eastbound speed limit sign near bridge #27 further to the east.

Ideally, a new location could be just west of the gas station, near the utility pole (site A below). The sign would be more prominent at this location. Placing the sign there will require potentially trimming the branch that is hanging down.

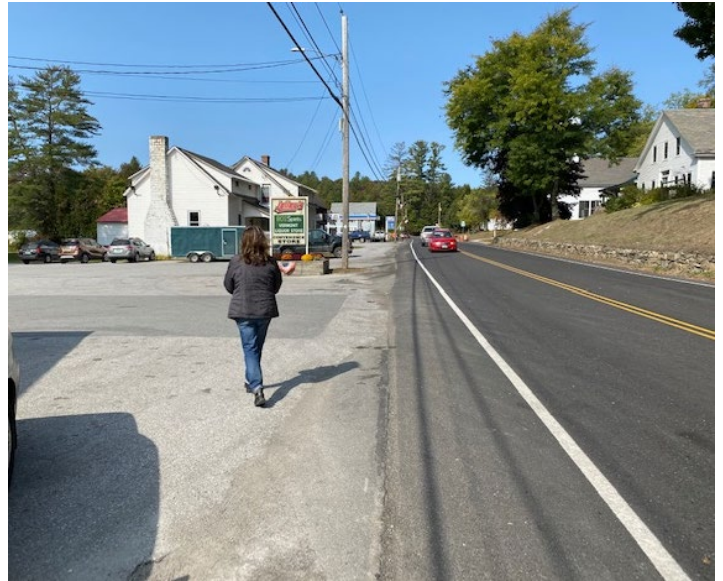
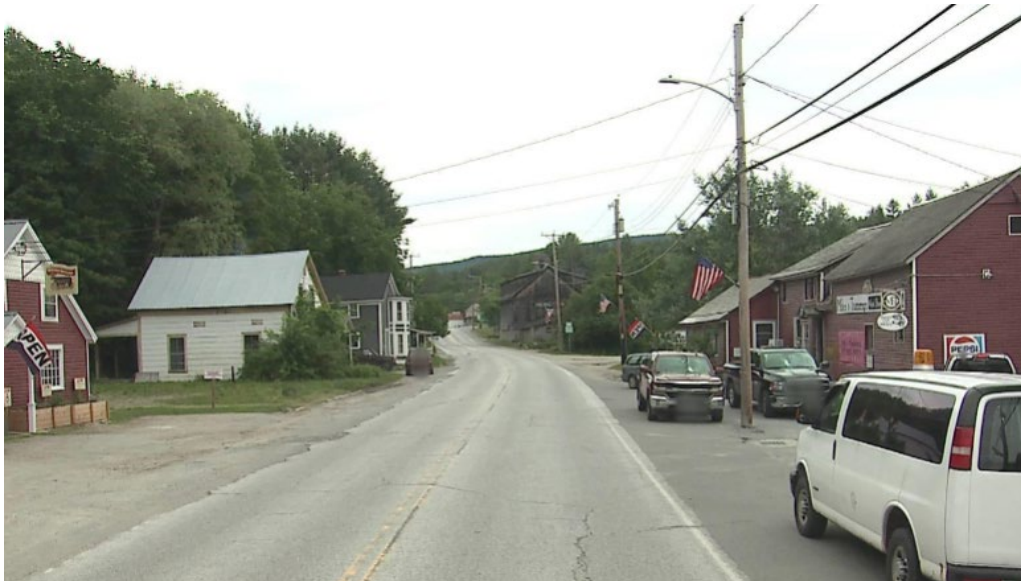
Vehicles are coming in and out of businesses at unpredictable locations due to the wide-open accesses.

Parked vehicles in front of businesses may block the view of pedestrians. Parked vehicles in the shoulder may force pedestrians to step in the road or to walk around parked and moving vehicles.
