Road Safety Audit Review

Town:	Chester	Date Reviewed:	May 20, 2019
Route:	VT 103	Mile points:	VT 103 mm 1.7 - 2.0

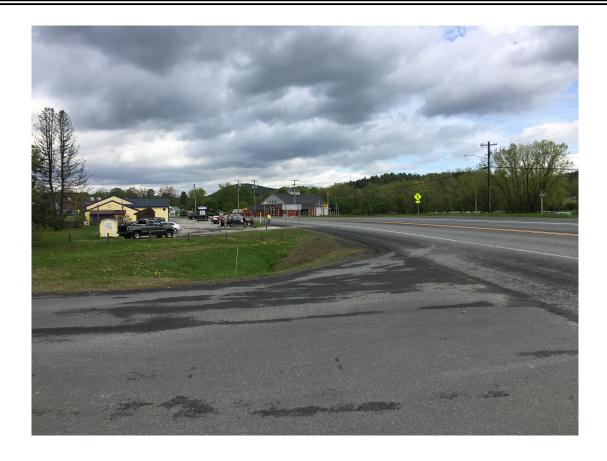
The corner sight distance to enter VT 103 when looking to the left and when there are no vehicles parked at the Heritage Deli & Bakery (Corner of bakery building is the approximate cutoff point) is about 650 feet. When there are vehicles parked at the Heritage Deli & Bakery, the estimated corner sight distance available from the left is about 400 feet. The picture below shows an example of the available corner sight distance when there is an obstruction (i.e., parking lot at the Heritage Deli & Bakery is full and obscuring sight lines).

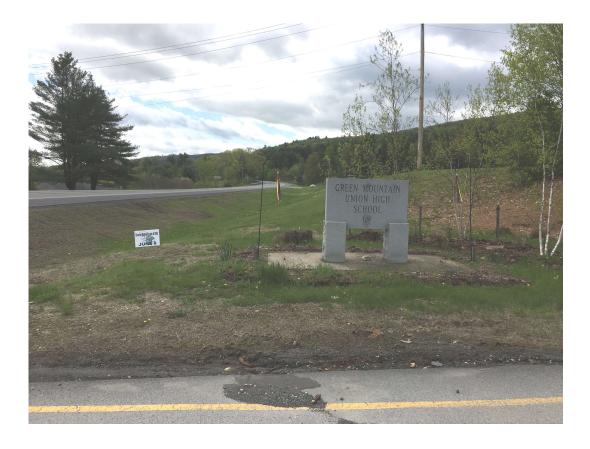
The existing sign is not very conspicuous by its design and location (as illustrated in the picture below).

Consider reviewing and revising the design and location of the existing sign at the entrance of the high school within the limits of zoning and other permitting regulations.

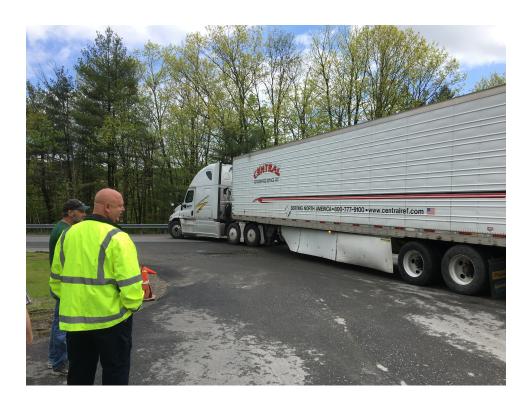
The number of tractor trailer trips in and out Drew's Organics has increased from 16 to 32. Local representatives reported that truckers had to use a wide berth to get in and out, at very low speeds.

Install a truck entering sign in both directions.

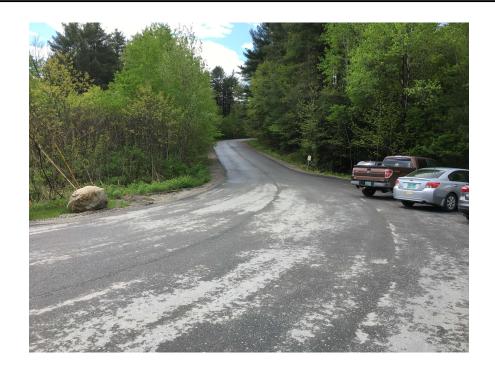
Local representative mentioned that many truck drivers did not know how to get to Drew's Organics. They mentioned that these truckers had to park on the side of the road and\or had to back up in order to eventually access the drive that leads to Drew's Organics. Drew's Organics is not visible from VT 103 and a separate drive that is tucked in on the left side of the main access needs to be used (this drive is not obvious when coming from the south).

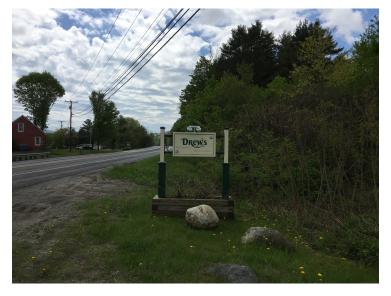
The existing sign is not very conspicuous and does not provide the necessary information to get to the site, especially when traveling from the south.

Consider reviewing and revising the design⁶ and location of the existing Drew's Organics on-premise sign within the limits of zoning and other permitting regulations.
