Office of Highway Safety

Road Safety Audit Review

Town:	Burlington	Date Reviewed:	October 19, 2016
Route:	Main St and Battery St intersection	Mile points:	Main, S5022 (0.00-0.01) Battery, S5008 (0.22-0.24)

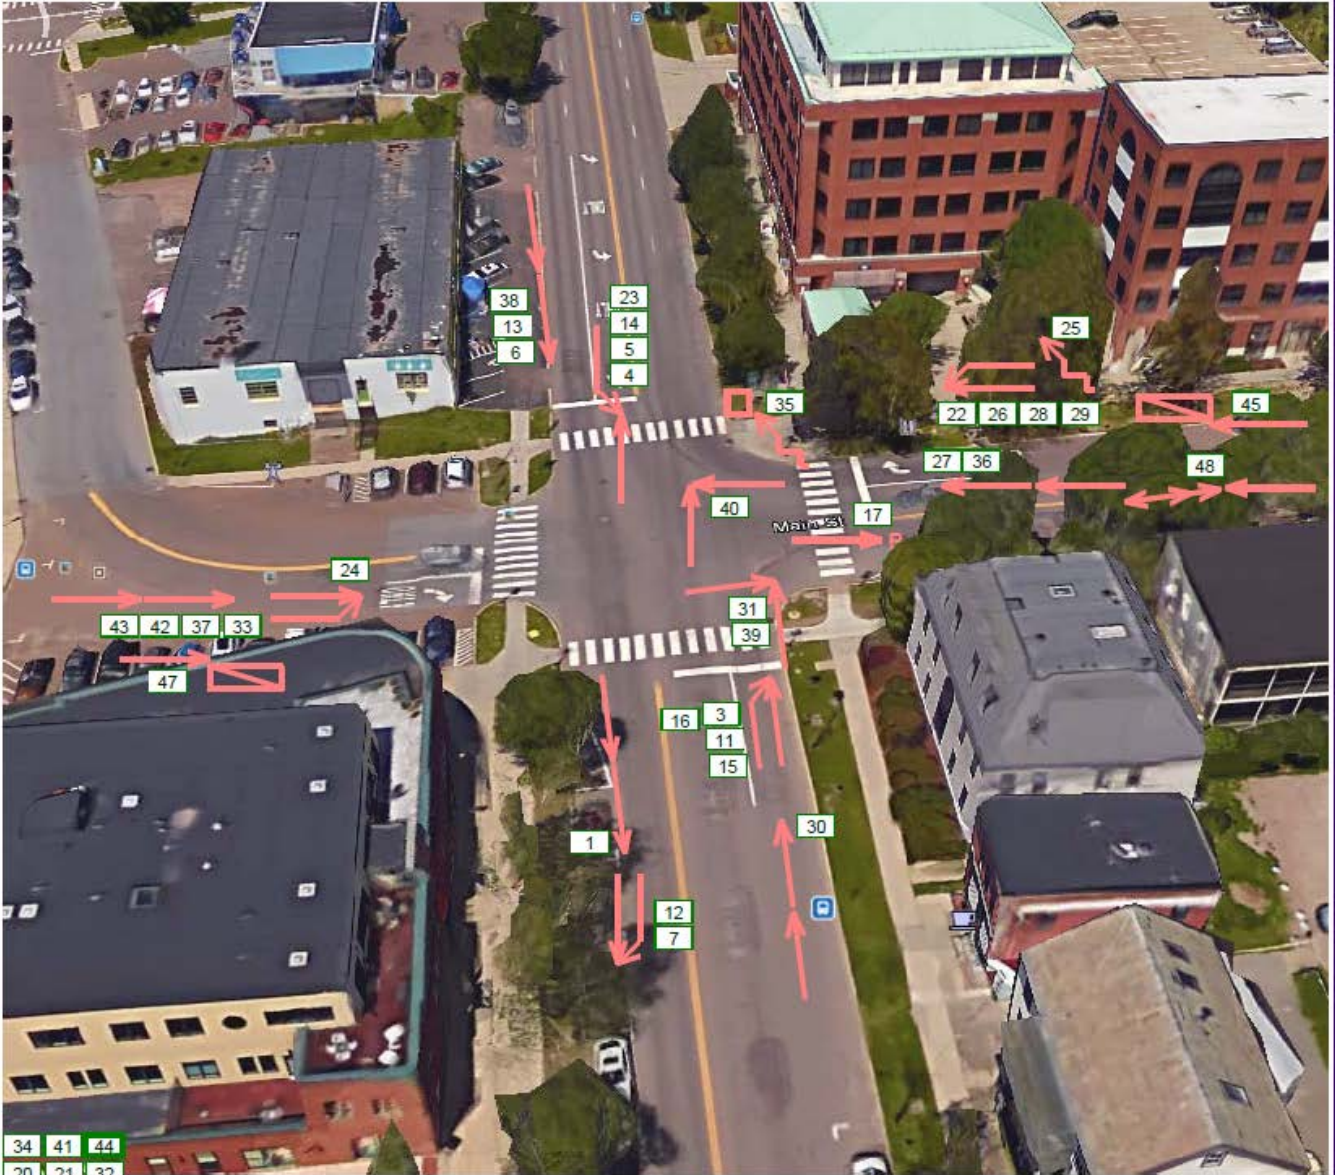
COLLISION DIAGRAM

The crash history was reviewed at this intersection for the five-year period covering the years 2011 to 2015. There were forty-six crashes at this intersection during this period. Crash narratives are provided at the end of this report along with a collision diagram. Note that ten crashes could not be plotted on the collision diagram due to lack of information in the crash reports.

One of the crash patterns involves southbound traffic that is making a left turn onto Main Street and a through vehicle continuing north on Battle Street. This represents about eleven percent of the crashes at this intersection. These crashes are happening when the left turners are facing a solid green indication or when they have a yellow indication.

Same direction sideswipe crashes on the Main Street approach in the westbound direction represent another crash pattern with about eleven percent of all crashes. In some of these instances, large trucks were involved as they were proceeding to make a right turn onto Battery Street. Motorists trying to go around another vehicle was also another reason for these crashes.

On Battery Street, on the northbound approach, there is a same direction sideswipe pattern due to people changing lanes. This represents about eleven percent of all the crashes at this intersection. In one of the crash reports, it was clearly identified that the motorist was in the wrong lane and wanted to turn right onto Main Street.
