Road Safety Audit Review

Town:	Guilford	Date Reviewed:	June 13, 2019
Route:	Guilford Center Road	Mile points:	~ 6.35 – 6.85

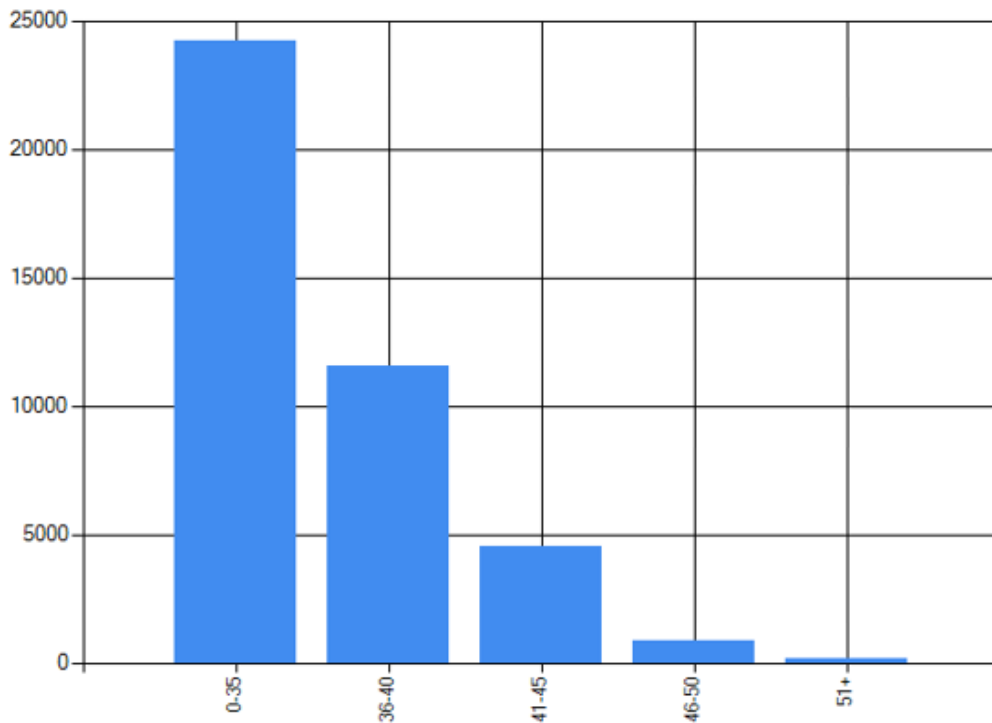
The graph shown above displays the distribution of vehicles by speed ranges. The data shows that the speed that 85% of the traffic travels at in the southbound direction (85th percentile speed) was 40 mph and that the highest speed recorded was 83 mph.

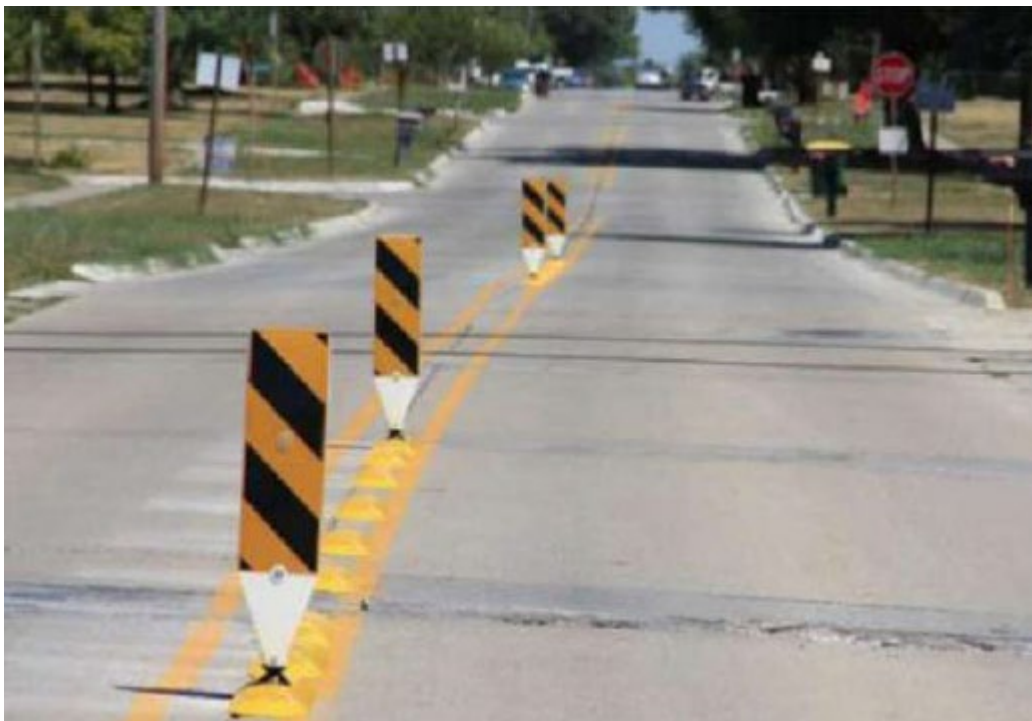
A study in Iowa showed that 85th percentile speeds decreased by 1 and up to 3 mph and that there was a sustained reduction in the percentage of vehicles traveling 10 or 15 mph over the posted speed limit (up to 22- 50 percent for 10 mph and 25 to 57 percent for 15 mph).

- Consider seasonal lane narrowing by using removable traffic control devices such as in the example below to create a sense of narrowed lanes and to provide additional awareness of the transition zone.

The devices would be installed beginning at the Reduce Speed Limit Ahead sign in each direction. The devices would be removed during snow season months to permit for winter maintenance.

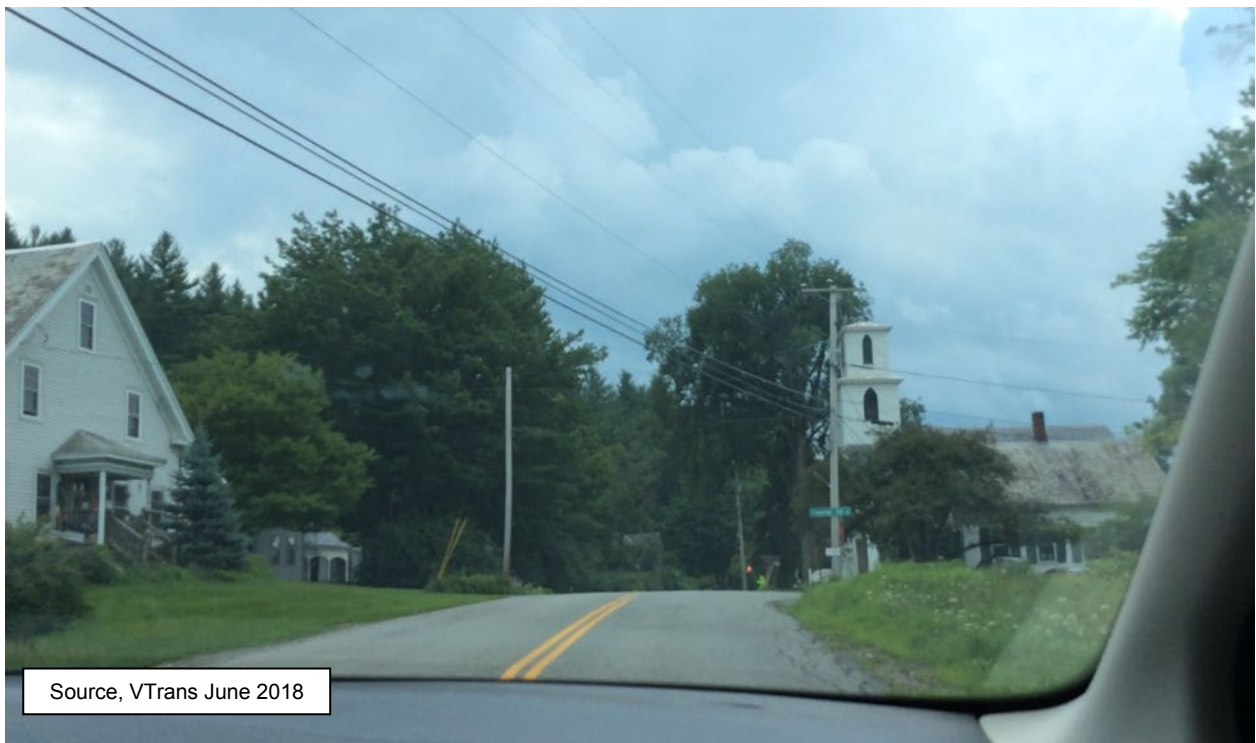
Concern 3: The view to Carpenter Hill Road is hidden when traveling southbound

Trees are currently obscuring Carpenter Hill Rd when traveling southbound. In addition, when traveling northbound, the street name sign is obscured by the utility pole. These issues are illustrated in the picture below.

- Consider installing a side road warning sign (W2-2R, 30" x 30"). Additionally, consider supplementing this sign with a "Carpenter Hill Rd" advance street name plaque (W16-8p)
- Relocate the "Carpenter Hill Rd" street name sign from the southerly side of the intersection, adjacent and obscured by the utility pole, to the northerly side of the intersection, adjacent to the concrete highway marker

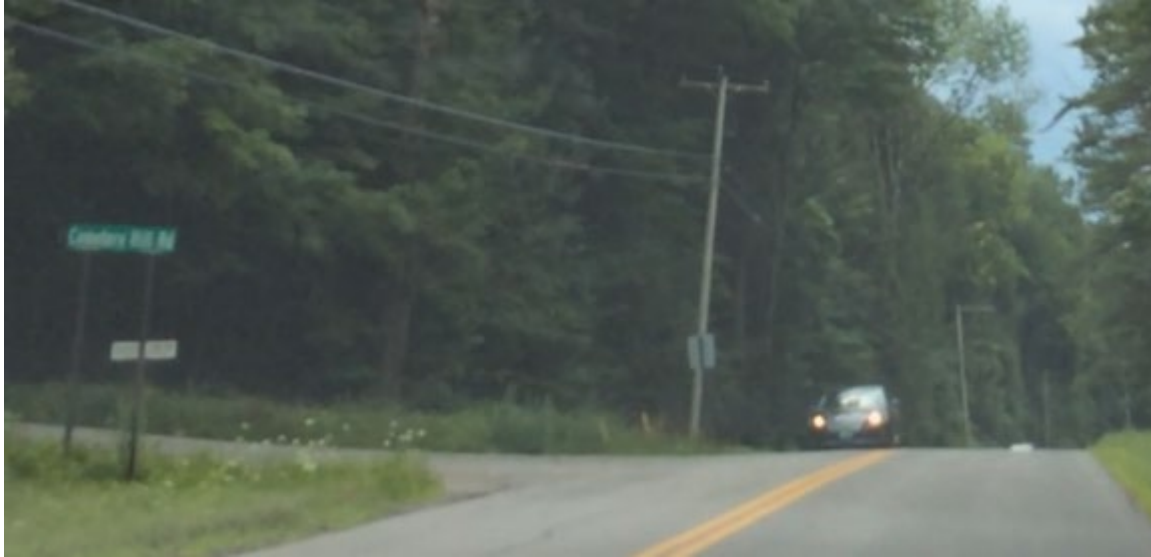
Concern 5: There is no Centerline Break at the Cemetery Hill Road Intersection

It was observed during the conduct of the road safety audit that there was no centerline break at the Cemetery Hill intersection. VTrans Standard 193 indicates that centerline breaks are to be present at all state highways and at town highways that have a stop sign installed. As per the previous concern, there is currently no stop sign at this intersection.

- VTrans to mark in the field for the next time the centerline is painted to create a break (Note that, since the conduct of the road safety audit, the yellow centerline was painted and that a break was created. No further actions necessary).
