Office of Highway Safety

Road Safety Audit Review

Town:	Guilford	Date Reviewed:	June 13, 2019
Route:	US 5	Mile points:	5.80 – 6.57

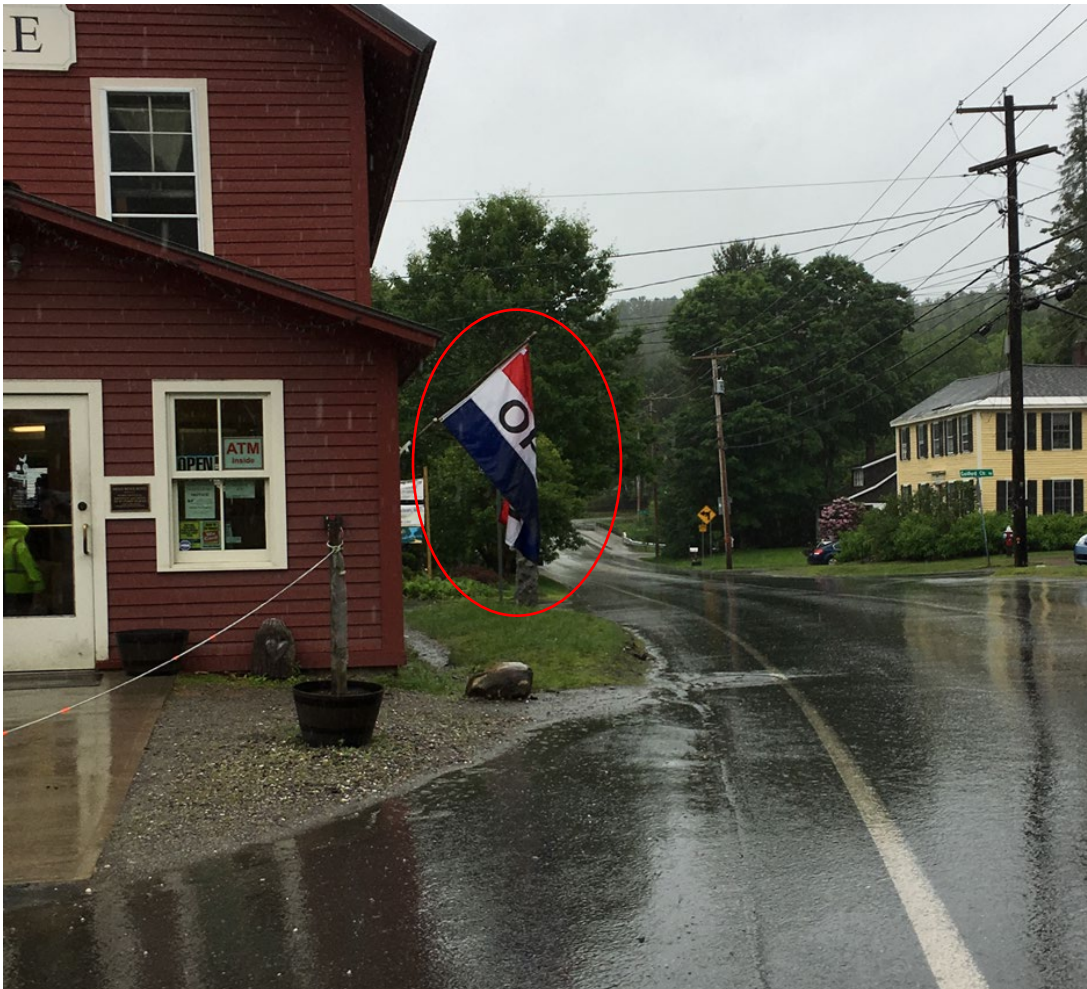
It is was determined that the available northbound stopping sight distance (as well as the corner sight distance when looking to the left) was 190 feet at the Guilford Country Store.

The corner of the building is the primary limiting factor. However, the “Open” flag and low branches also contribute to the issue as shown in the picture below. In addition, it was reported that vehicles that parked in the no parking area added to the problem.

- Crosshatch the shoulder and install no parking stencils within the no parking zone (see below for an example).

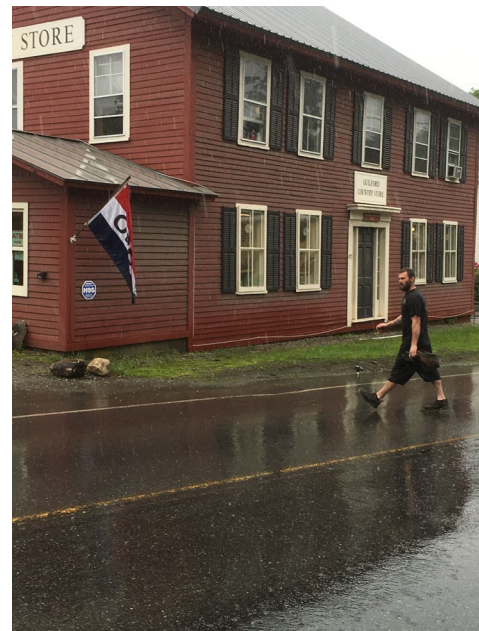
Low hanging branches were observed over the eastbound shoulder.

- Cut brush and branches over the eastbound shoulder

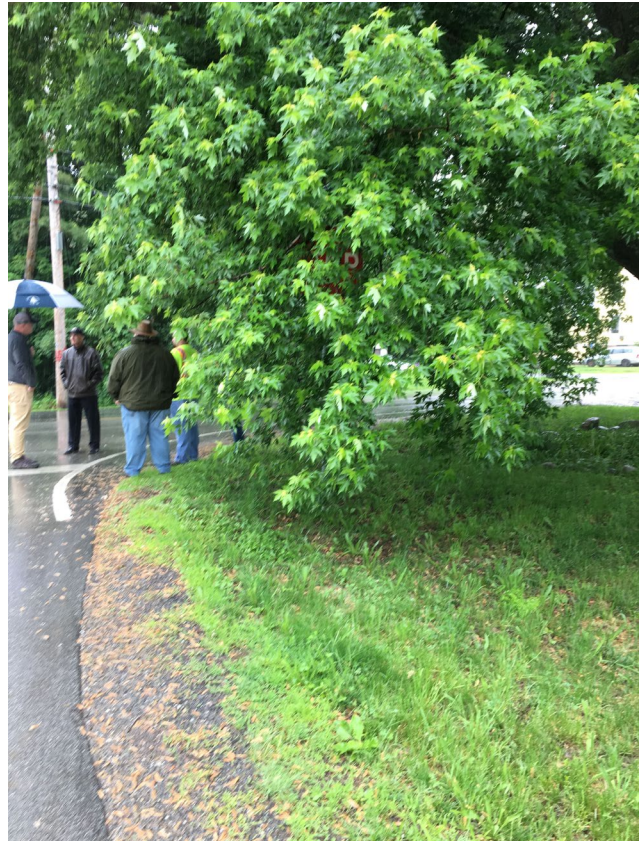
The available northbound stopping sight distance (as well as the corner sight distance when looking to the left) was measured at 240 feet and is below the AASHTO Green Book recommended stopping sight distance of 305 feet for a travel speed of 40 mph.

- Cut brush. Alternatively, move the stop sign in front of the tree (leave the existing street name sign at its current place).

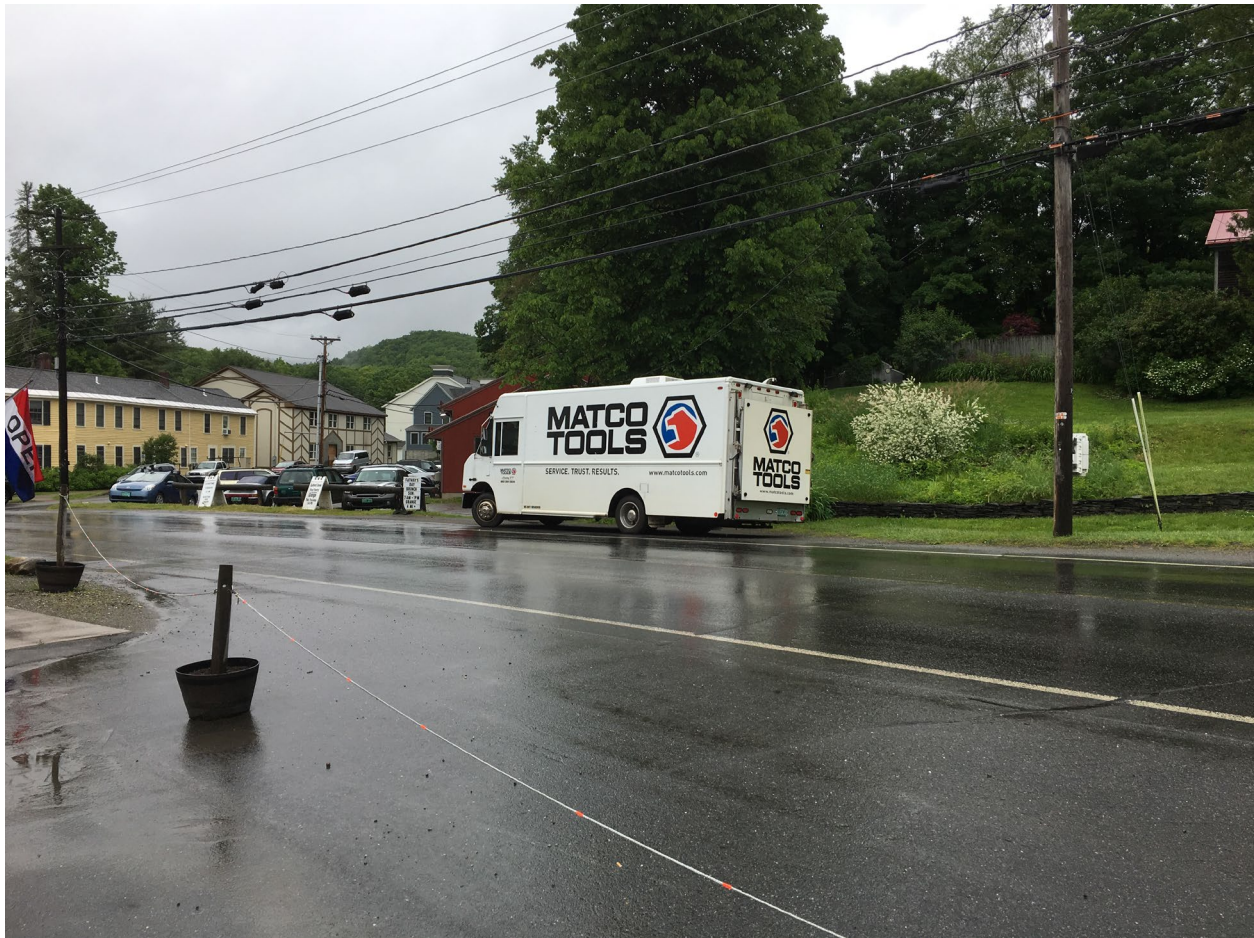
Concern 6: Vehicles are Parking on the Westbound Shoulder in the Northwest Quadrant of the Guilford Center Road Intersection

The Town reported that it was common for vehicles to park on the westbound shoulder of US 5. When this happens, the corner sight distance at Guilford Center Road is reduced.
