# Office of Highway Safety

## Road Safety Audit Review

<b>Town:</b>	Coventry	<b>Date Reviewed:</b>	October 27, 2016
<b>Route:</b>	VT 105	<b>Mile points:</b>	VT 105 MM 0.792-1.092

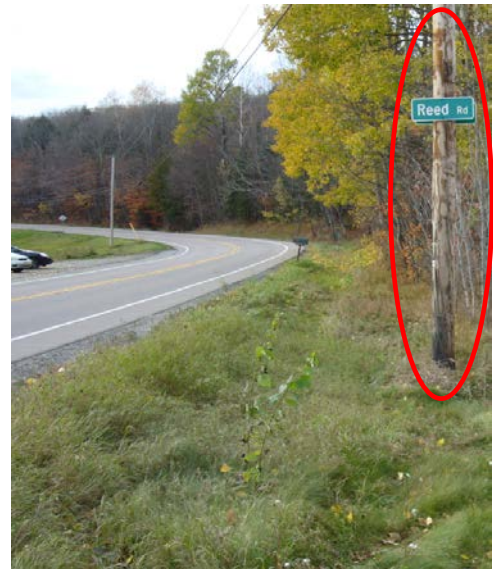
Concern: Substantively<sup>1</sup> Unsafe Curve

There is a clear run off the road crash pattern attributable to the presence of the horizontal curve in this section of VT 105. While this 0.3-mile section of VT 105 is a high crash location, the crashes are concentrated at the curve. Most of the crashes are in the eastbound direction. Note, however, that the majority of these crashes took place before Project STP 2802(1) which resurfaced VT 105 and corrected superelevation deficiencies. Note also that a common condition in several of the crashes was a snow or ice covered road surface.

Monitor crashes since significant changes were made to the road. If the utility pole (*VT Elec Coop 115 C 42 20 13 VZ*) is hit again in a crash, have it relocated (this pole has been hit 3 times already).

Review winter maintenance practice.

Keep monitoring and install 6" x 8" white delineators if crashes continues.
