# Office of Highway Safety

## Road Safety Audit Review

<b>Town:</b>	South Burlington	<b>Date Reviewed:</b>	June 19, 2018
<b>Route:</b>	VT 116 and Cheese Factory Rd	<b>Mile points:</b>	VT 116 MM 0.16-0.32 (int 0.24), S5209 MM 0.75-0.79 (end)

The location of this RSAR is the intersection of VT 116 and Cheesefactory Road in South Burlington and its approaches.

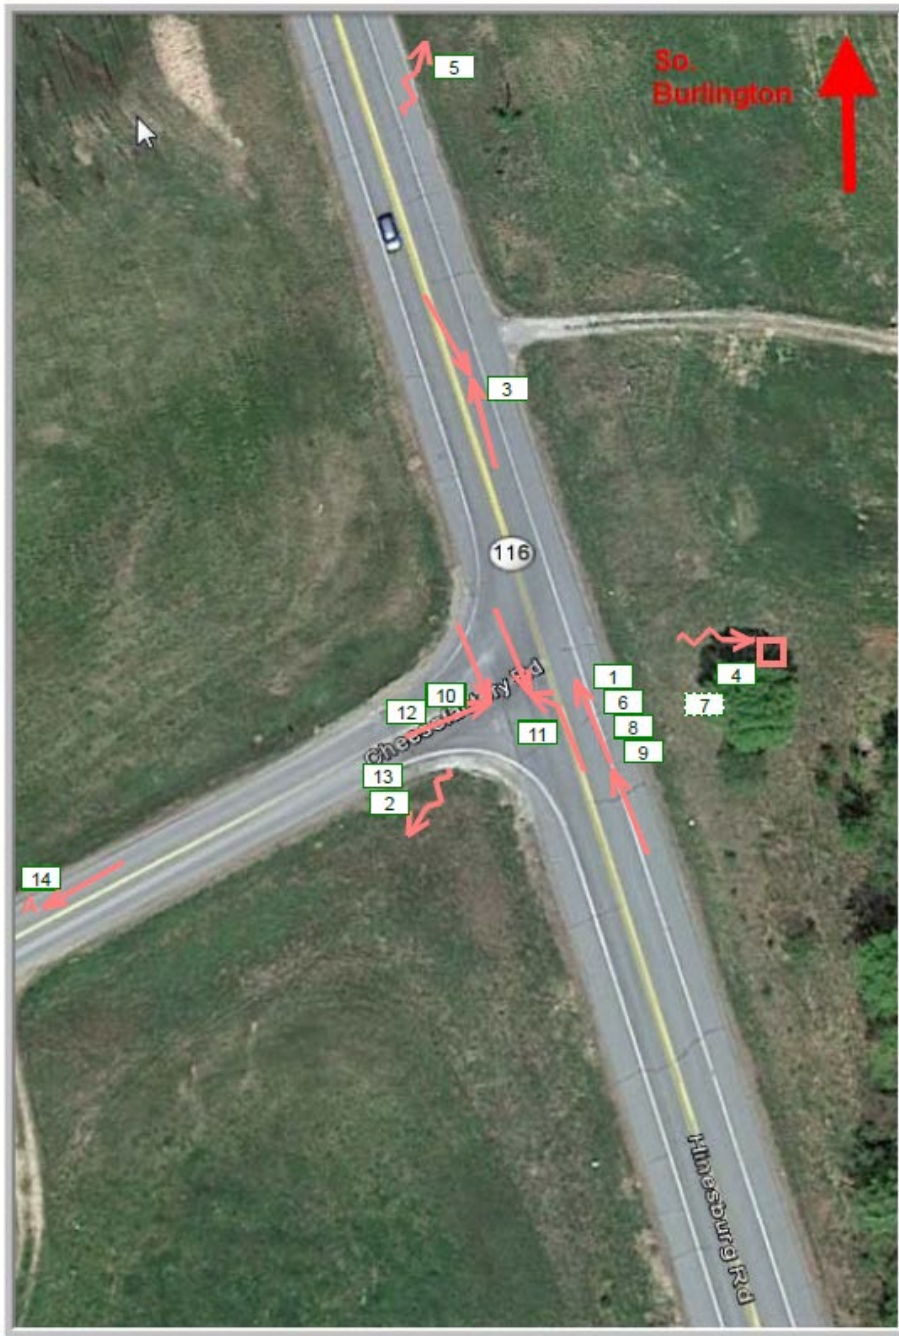
# COLLISION DIAGRAM

The principal crash pattern at this intersection is a read-end crash in the northbound direction (four cases). In this situation, a northbound vehicle is about to make a left turn onto Cheeseactory Road and is rear-ended by a through vehicle. Two of the four cases happened under dark conditions.

The first secondary crash pattern involves a vehicle that does not stop for the stop sign (driver does not see it) and that continues eastbound across VT 116 into the ditch (two cases). These crashes are typically happening under dark conditions.

The second secondary crash pattern involves a motorist who is stopped on Cheesefactory Road and who is intending to make a left turn onto VT 116 to travel northbound (two cases in five years, one more case in 2017). In these cases, there are southbound vehicles that are turning right onto Cheesefactory Road. These right turning vehicles are shadowing the presence of southbound through traffic. The motorist who is making the left turn does not see the southbound through vehicle and collides with it. These are taking place during the day in late afternoon.

The third secondary crash pattern involves vehicles that are traveling southbound on VT 116 and that lose control on VT 116 (two cases). These vehicles then continue across Cheesefactory Road.

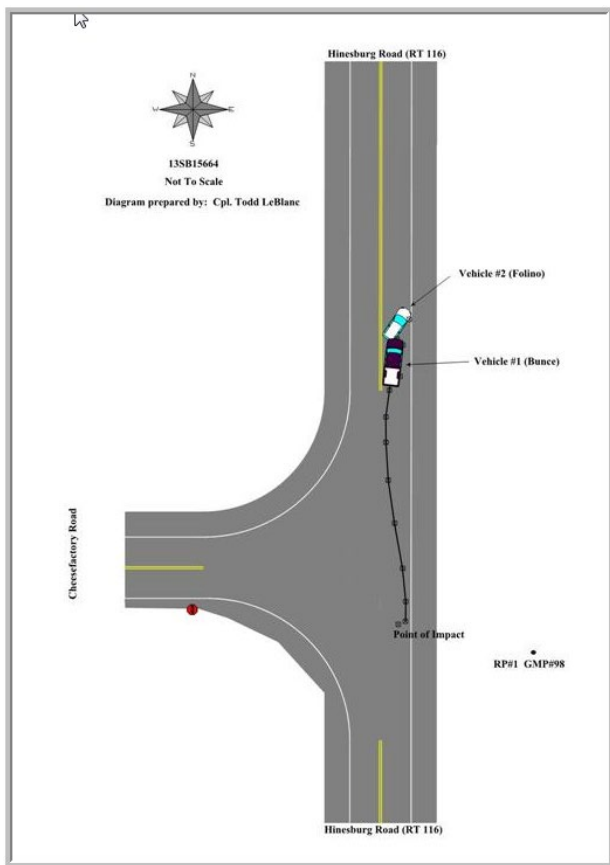
Vehicle #1 had come to rest with its severely damaged front end up against the rear end of Vehicle #2. Vehicle #2 sustained extremely heavy rear end and roof damage. Both front seat backs in Vehicle #2 were broken.

Witness advised Veh 1 ran into the rear end of Vehicle 2, which was apparently stopped and trying to turn left on to Cheesefactory Road.

Op 2 advised me she was driving on Route 116 taking Passenger to a doctor's appointment. Op 2 advised she was turning left onto Cheesefactory Road, at which time she was struck from behind by Vehicle #1. Op advised she believed she was using her turn signal when she was struck, and was talking on the telephone with her daughter. Op 2 also advised she was rolling forward slightly at the time of impact. Op 2 advised she sustained facial injuries to include at least a broken nose. Op 1 admitted to have been driving the pickup truck.

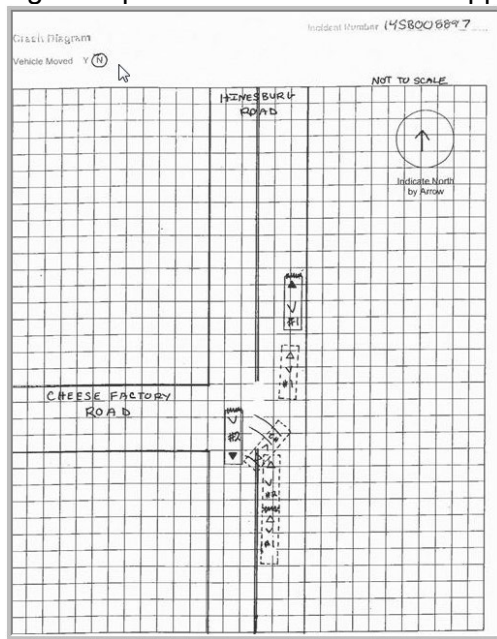
Vehicle 1 was located in the breakdown lane on the east side of Hinesburg Road just north of the Cheese Factory Road intersection and was facing north. It appeared to have come to a controlled rest. It sustained significant impact damage to the front end and its airbags had been deployed. It was towed from the scene.

Vehicle 2 was located on Hinesburg Road at the intersection with Cheese Factory Road and was facing south. Veh 2 appeared to have come to an uncontrolled rest in this position. Several yaw marks were present indicating Vehicle #2 spun approximately 180 degrees as a result of the impact. It sustained significant impact damage to the rear end and was towed.

Op 2 stated he was traveling from Hinesburg to a location in South Burlington on Hinesburg Road. As he approached the intersection with Cheese Factory Road, he slowed his vehicle down and activated his turn signal. Op 2 did not see Vehicle 1 approaching the rear of his vehicle before the crash occurred.

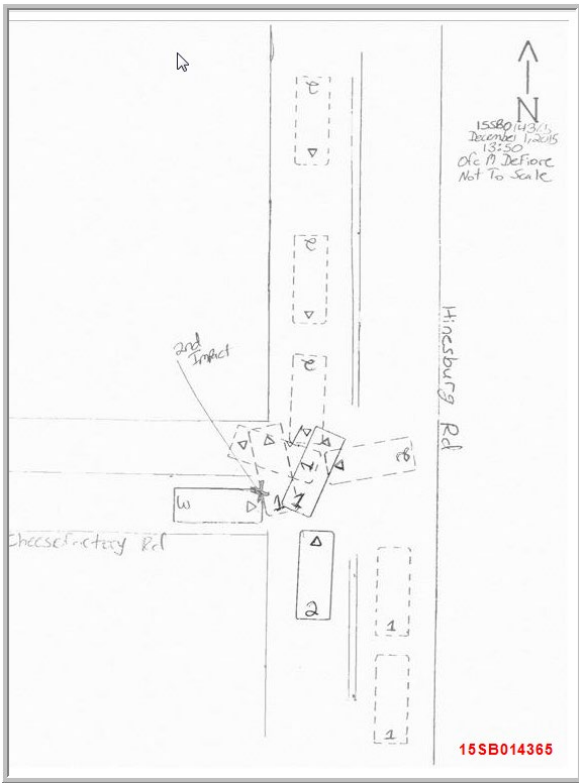
Investigation: Vehicle #1 had been traveling north on Hinesburg Road in the eastern most lane of continuous north bound travel. Vehicle #2 had been traveling south in the westernmost lane for continuous southbound travel. Vehicle #3 was approaching the stop sign on Cheesefactory Road at its intersection with Hinesburg Road. Vehicle #1 just prior to impact with Vehicle #2 attempted to turn left on to Cheesefactory Road in front of Vehicle #2 which was coming the opposite direction. The front right of vehicle #2 struck the right rear of Vehicle #1. Vehicle #1 and Vehicle #2 both began to spin causing the collision between vehicle #1 and vehicle #3. Vehicle #2 continued forward and came to a position of uncontrolled rest facing north in the southbound lane. Vehicle #1 also came to a position of uncontrolled rest facing northeast in the southbound lane. At the scene there were no signs of braking by Vehicle #2. The only marks on the roadway were from the vehicle's tires as they spun from the impact.

Conclusion: It is the opinion of the Officer that operator #1 is at fault for this crash. Operator #1 was turning left from Hinesburg Road onto Cheesefactory Road. Operator #1 failed to yield the right of way to vehicle #2 causing the crash and subsequent collision with Vehicle #3.

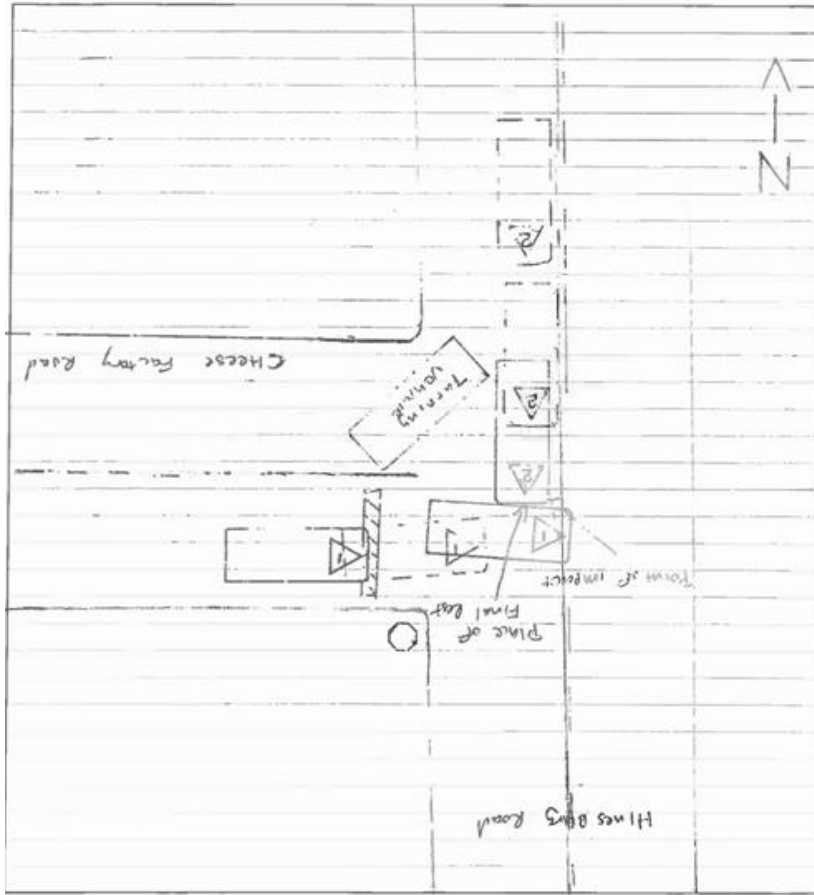
Operator #2 stated he was traveling south on Hinesburg road. As he was approaching the intersection with Cheese Factory Road he was in a line of traffic where the vehicles in front of him were turning right onto westbound Cheese Factory Road. The turning vehicles blocked his vision of vehicle #1 which had proceeded on the southbound lane of Hinesburg Road after stopping at the stop sign. Vehicle #1 stopped in the southbound lane in front of him at such a time where he did not have the reaction time to avoid crashing into vehicle.
