Office of Highway Safety

Road Safety Audit Review

| Town: | Montgomery | Date Reviewed: | May 6, 2019 |
| Route: | VT 118 and VT 242 | Mile points: | VT 118 MM 5.58-5.66 VT 242 MM 0.00-0.04 |

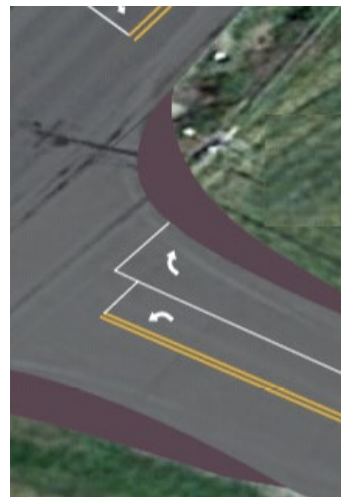
- Consider recessing all markings at this intersection
- Consider mountable surfaces to improve the geometry of the intersection by reducing pavement area and the intersection width. (See the diagram to the right as an example).

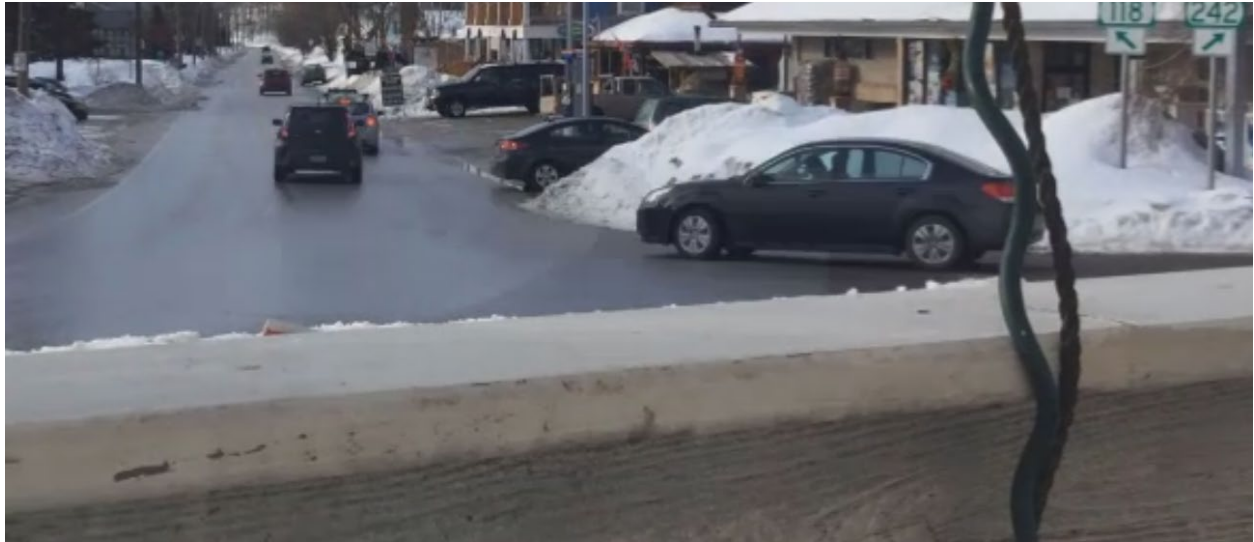
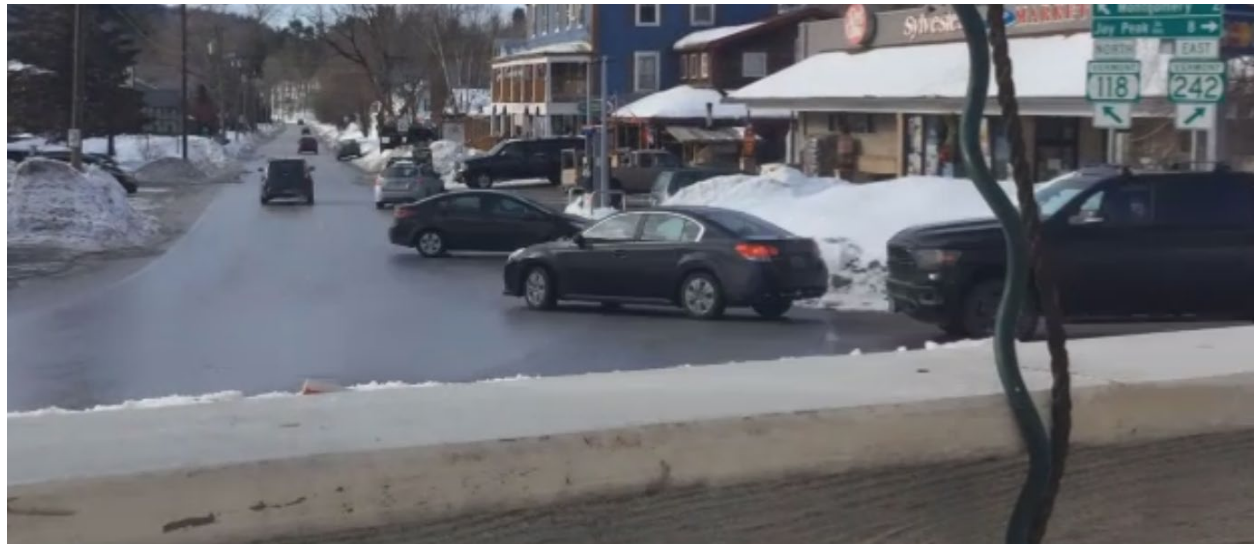
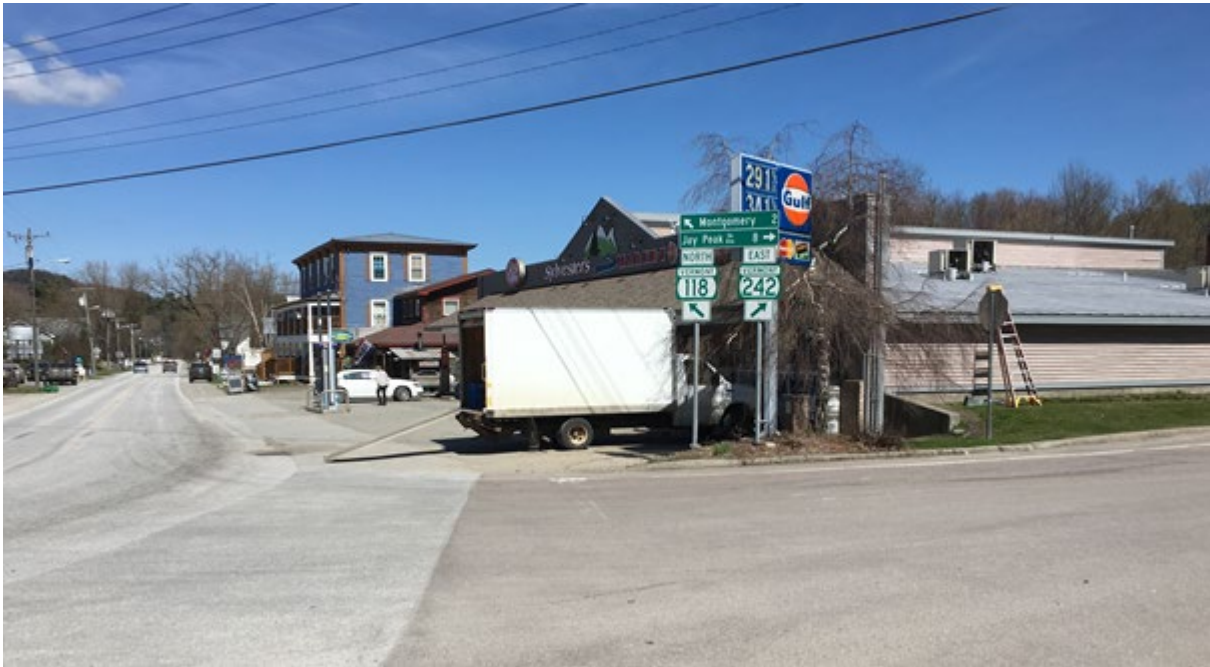
Concern 3: Obstructions caused by Delivery Vehicles or Snowbanks on the Sylvester's Market Property Create a Potential Safety Conditions

The snowbank on Sylvester's Market Property could prevent a motorist on VT 242 who wants to continue straight on VT 118 from seeing oncoming southbound traffic. Similarly, it could also prevent a motorist who is making a right turn from VT 242 from seeing a vehicle that is entering VT 118 from the Sylvester's Market parking area. Such a situation is illustrated in the next two pictures. The first picture shows a VT 242 vehicle that is making a right turn as a vehicle is backing out of the Sylvester's Market. The second picture shows the VT 242 vehicle applying the breaks to let the backing vehicle complete its maneuver.

Delivery vehicles could create a similar situation. The third picture in this series illustrate this.

- Make the owner of the Sylvester's Market aware of this safety concern (District 8 suggested that they could bring the snowbank issue to the attention of the owner via a letter).

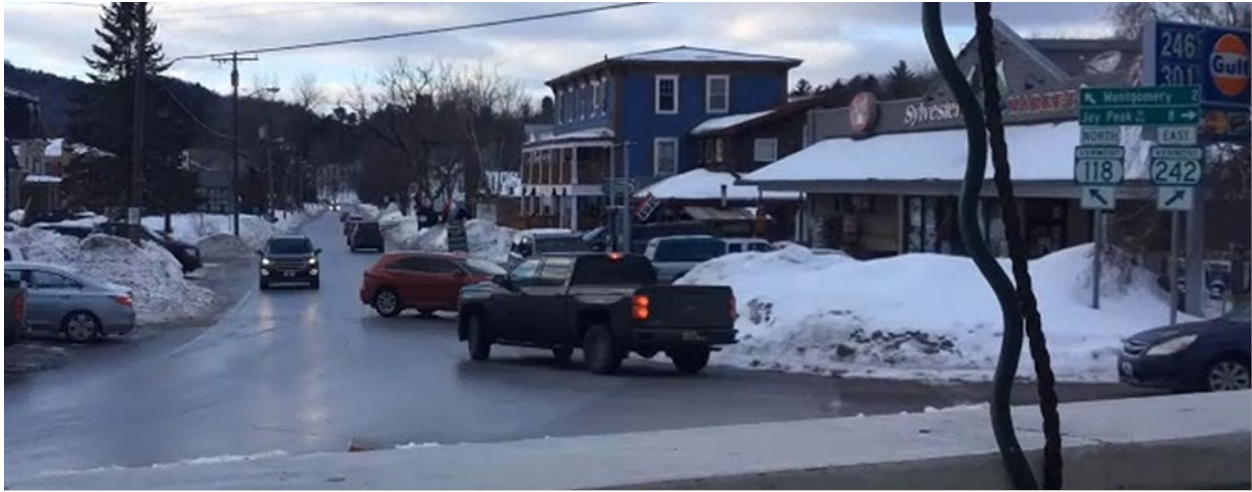
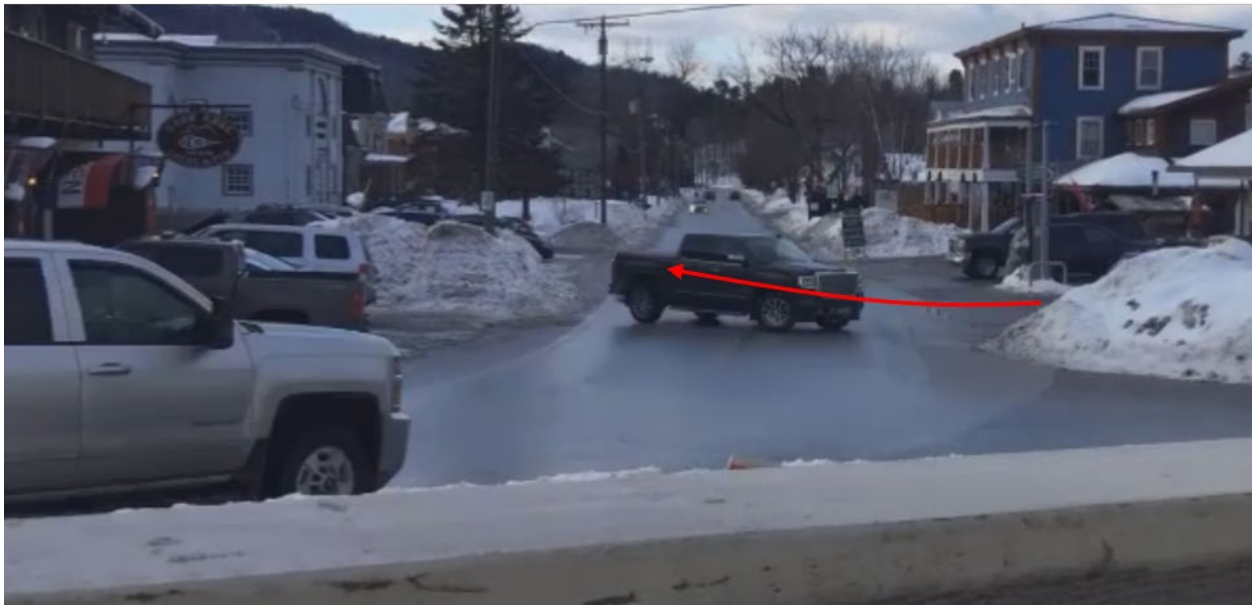
Concern 4: Conflict point on the north approach created by entering vehicles leaving the Snowshoe Lodge & Pub and the Sylvester's Market as well as by other vehicles slowing down to enter these businesses

The two pictures below exemplify this issue.

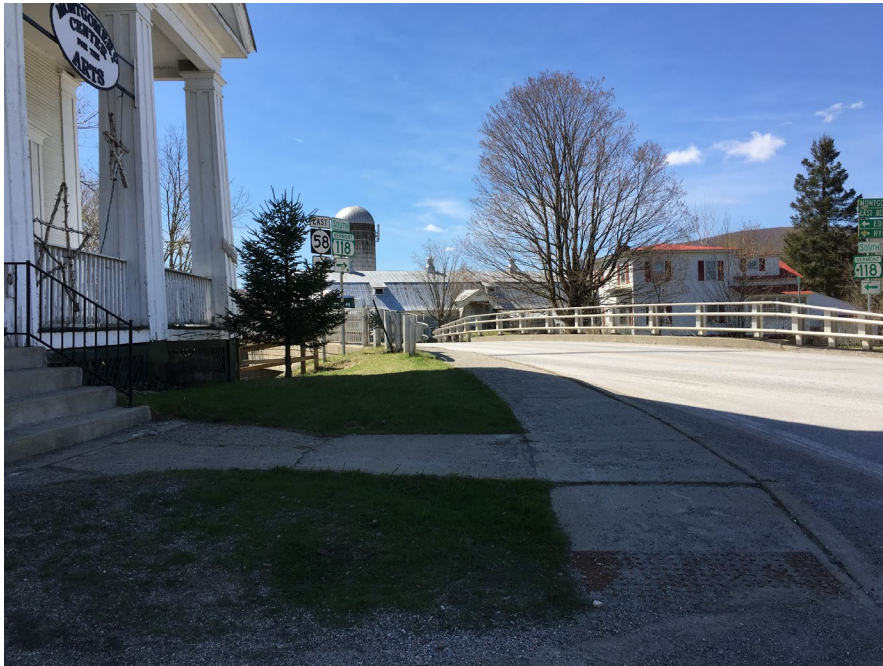
Concern 6: Obstruction to the Left caused by the Bridge Railing for a Vehicle that is Coming out of the MCA driveway

As shown in the picture below, the bridge railing reduces the visibility of the traffic coming out of the bridge for a motorist that is waiting to enter the intersection from the MCA driveway.

The suggested improvements for this issue are a repeat of previous countermeasures that were mentioned previously. These improvements aim at reducing the speed of the approaching vehicles on VT 118 or stopping the vehicles.

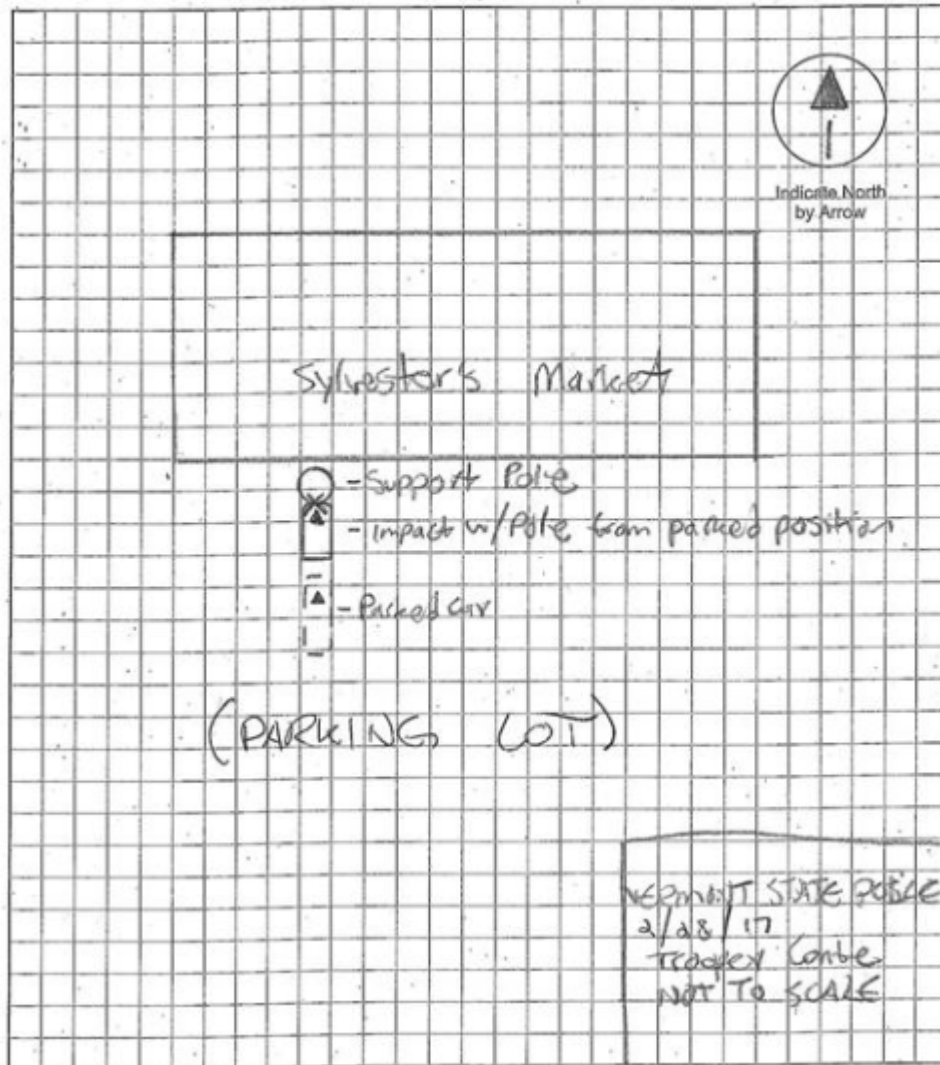
17A200994 (in a parking lot, 20 Main Street)1

On February 26th, 2017 at 1154 hours at 20 Main Street in the town of Montgomery. This address is also known as Sylvester's Market. The complainant stated that at approximately 0930 hours in the morning, a vehicle in the parking lot in front of the store drove over the curb and struck a support beam of the building.
