Office of Highway Safety

Road Safety Audit Review

Town:	Swanton	Date Reviewed:	September 7 2016
Route:	VT 207	Mile points:	VT 207 MM 1.57-1.87

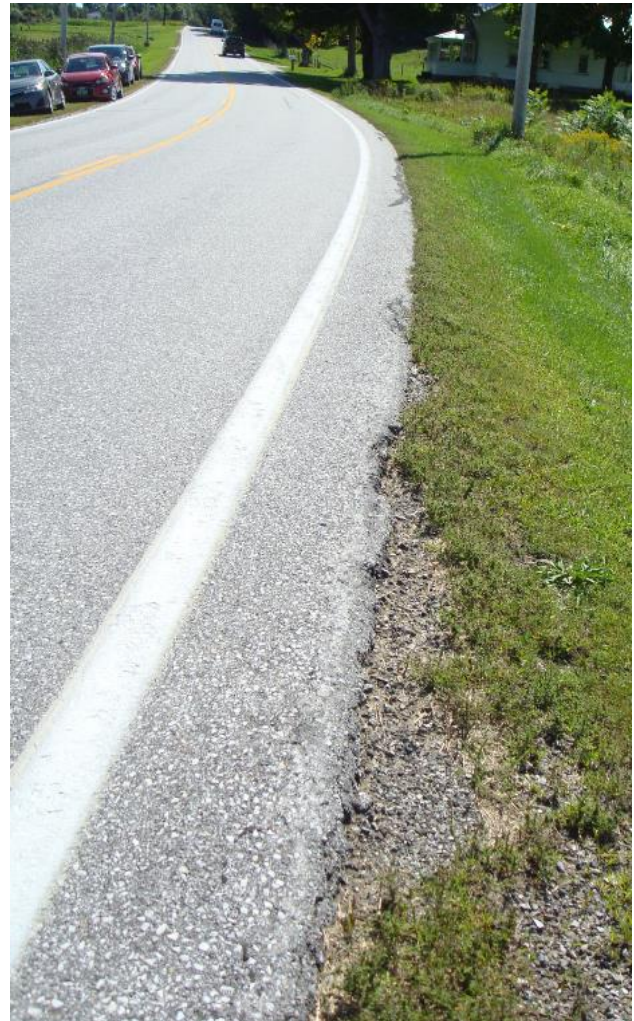
This section of VT 207 is a two-lane road with an eleven-foot lane and a narrow two-foot shoulder in each direction.

The specific section is bounded between mile points 1.57 and 1.87. Within this section, there is a four-degree horizontal curve from mile point 1.69 to mile point 1.79. This is a curve to the right when traveling north on VT 207.

According to GIS data from the VTrans Mapping Unit, still when traveling north, there is a six percent vertical downgrade from mile point 1.61 to mile point 1.73 as well as a positive upgrade from mile point 1.895 to 1.946.

The pavement surface of this section of VT 207 is rated as fair. The year the road was last paved was in 2004 (VTransparency, December 2016).

Pavement edge drop off and pavement edge crumbling were observed on the outside of the curve.

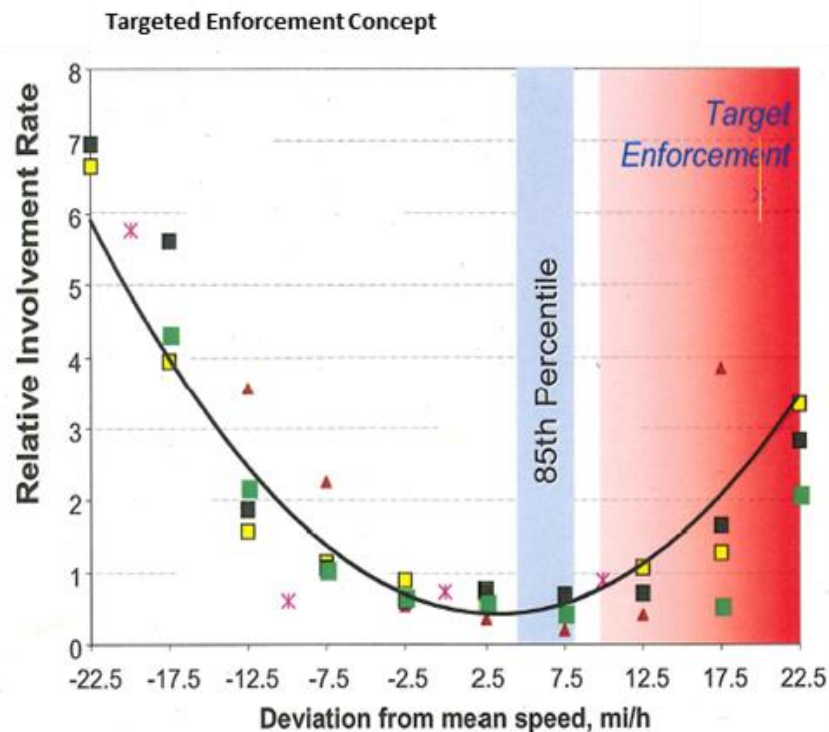
The graph below from NHSTA shows that the crash involvement rate increases as traveling speeds deviate from the 85th percentile speed. This means that targeting motorists who are traveling above the 85th percentile speed will apprehend motorists who are more likely to cause a crash. Crash involvement starts to increase more drastically 5 mph above the 85th percentile speed or around the 90th percentile speed.

Consider targeting, for the first month, drivers who are in the top five percent of speeders (in this case, over 59 mph) and later on targeting motorists who are traveling at or above the 90th percentile speed (55 mph in this case) as per the following concept suggested by NHSTA:

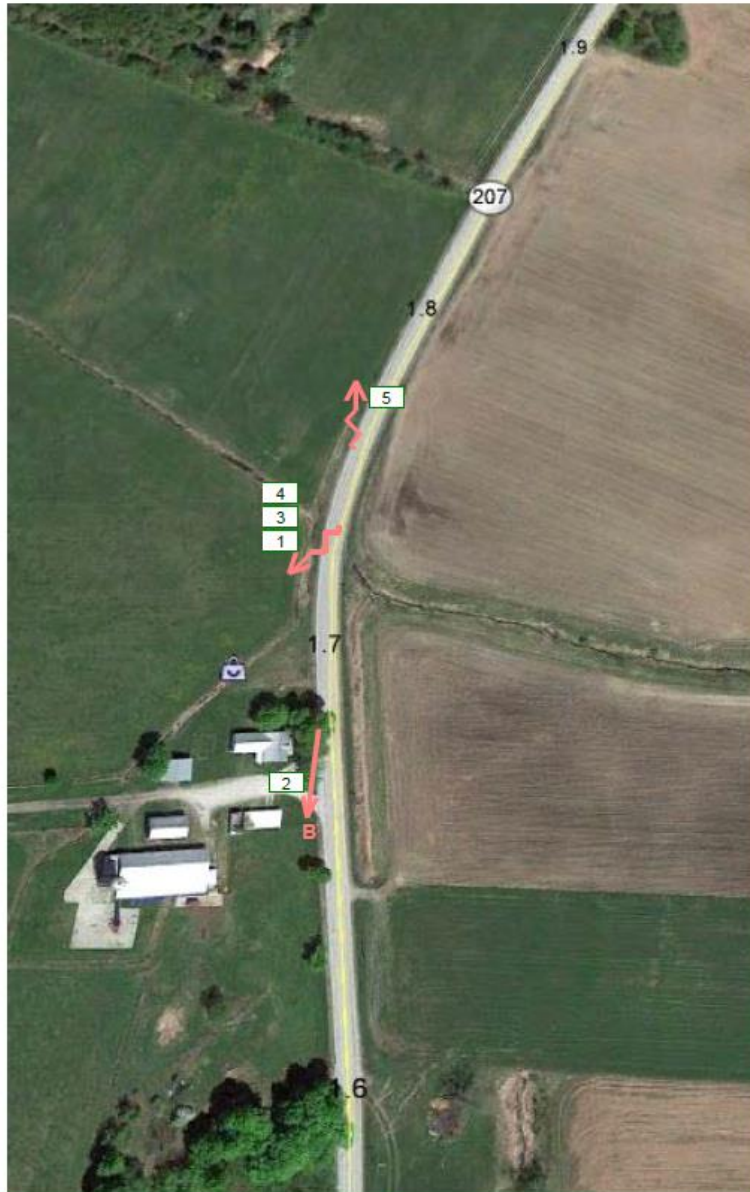
COLLISION DIAGRAM

The principal crash pattern at this location is a single vehicle that went off the road. This crash pattern represents five out of the six crashes within this section (83%). The majority of these run off the road crashes took place between the months of June and September (80%), under clear conditions. With the exception of one crash that took place in the evening, all of these run off the road crashes also happened in the afternoon between the hours of 2:30 pm and 5:30 pm and most happened when travel was in the southbound direction (60%, with one crash unknown).
