Road Safety Audit Review

VT 30, Newfane Village

September 22, 2020

Vermont Agency of Transportation
Operations & Safety Bureau

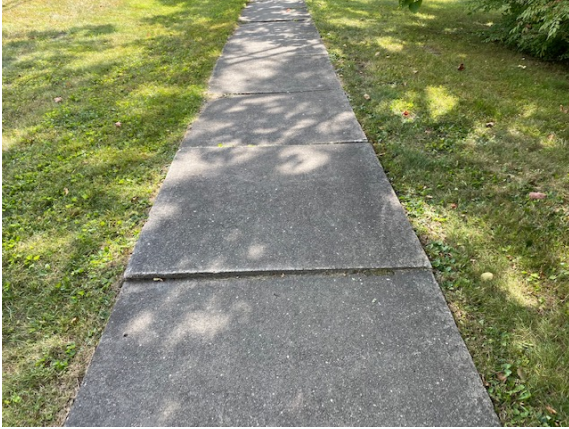
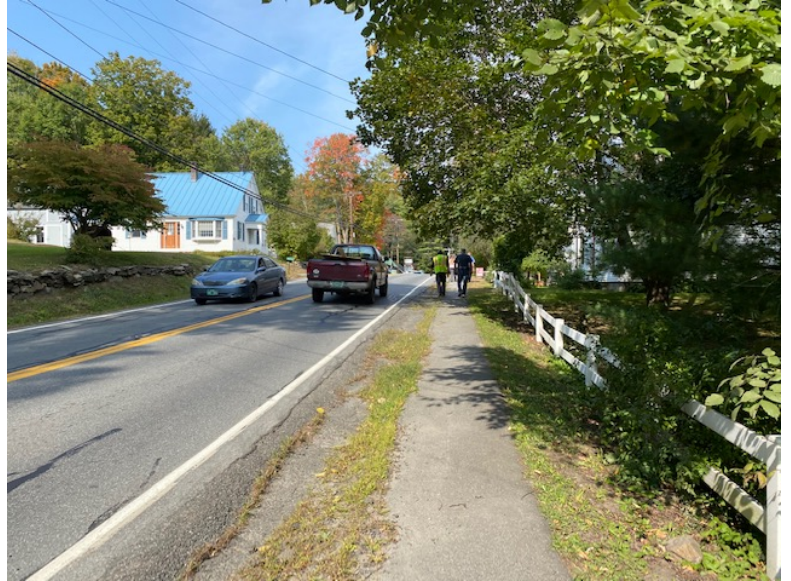
The past sidewalk study indicated that there were long stretches of sidewalk that needed to be reconstructed and new portions added. The current sidewalks are narrow, cracked and uneven. Some portions are prone to pounding.

Residents reported that, during the winter months when the snow was plowed along VT 30, the sidewalks were no longer visible or usable and pedestrians had to walk in the highway.

- Consider repairing the sections of sidewalks that are prone to ponding.

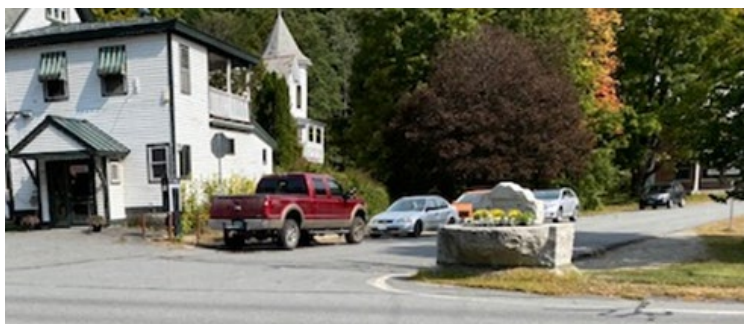
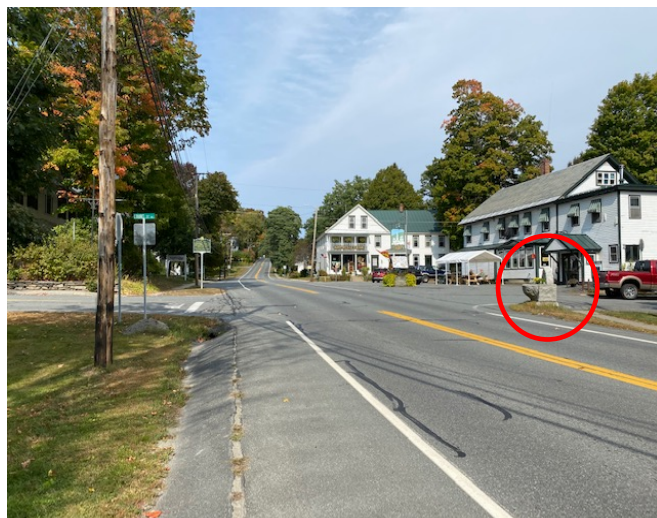
The monument on the southeast corner of Jail St (south of Newfane Market) is within the clear zone and is a hazard to motorists (as well as pedestrians as it is near the sidewalk). This monument was hit in one of the crashes reviewed for this road safety audit. One of the participants further mentioned that it seemed that the monument was hit at least once a year.

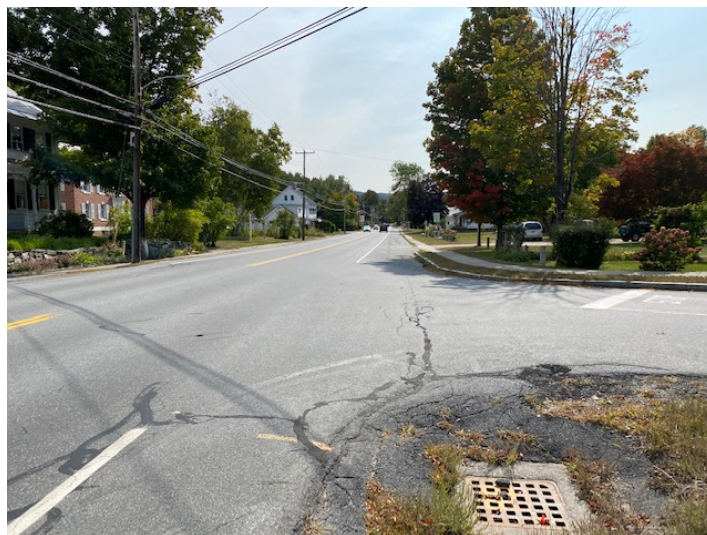
The drop inlet at the northwest corner of West St is significantly recessed. One of the participants commented that it had caused incidents with bicyclists in the past.

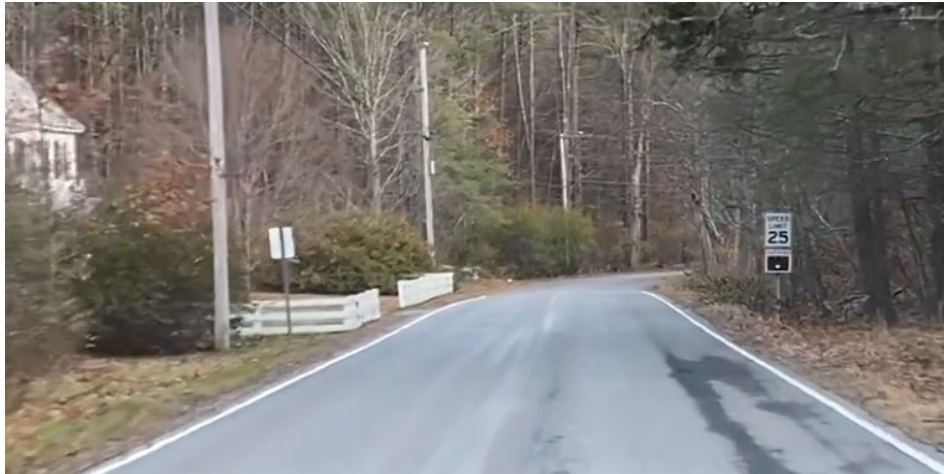
The first 25 mph speed limit sign is near house #32 at the beginning of the 25 mph speed zone. There is a speed feedback radar sign below this 25 mph speed limit sign.

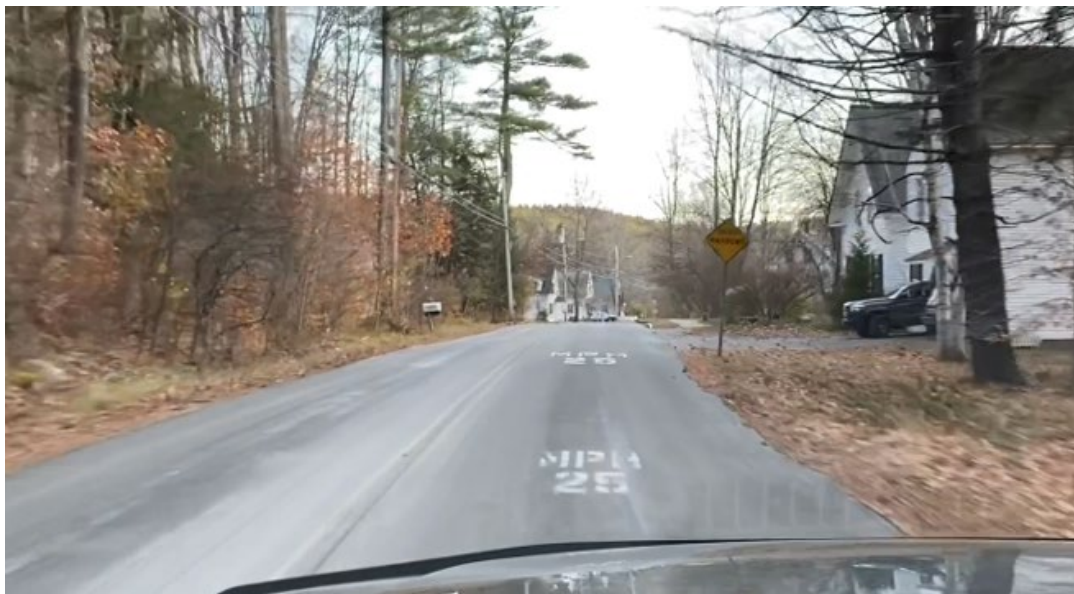
Continuing east towards VT 30, there is a warning sign with the words “SLOW STRICKLY ENFORCED”, followed by another warning sign with the words “ ROAD NARROWS”. At this location (just before house #9), there are also two sets of white 25 mph word pavement markings.

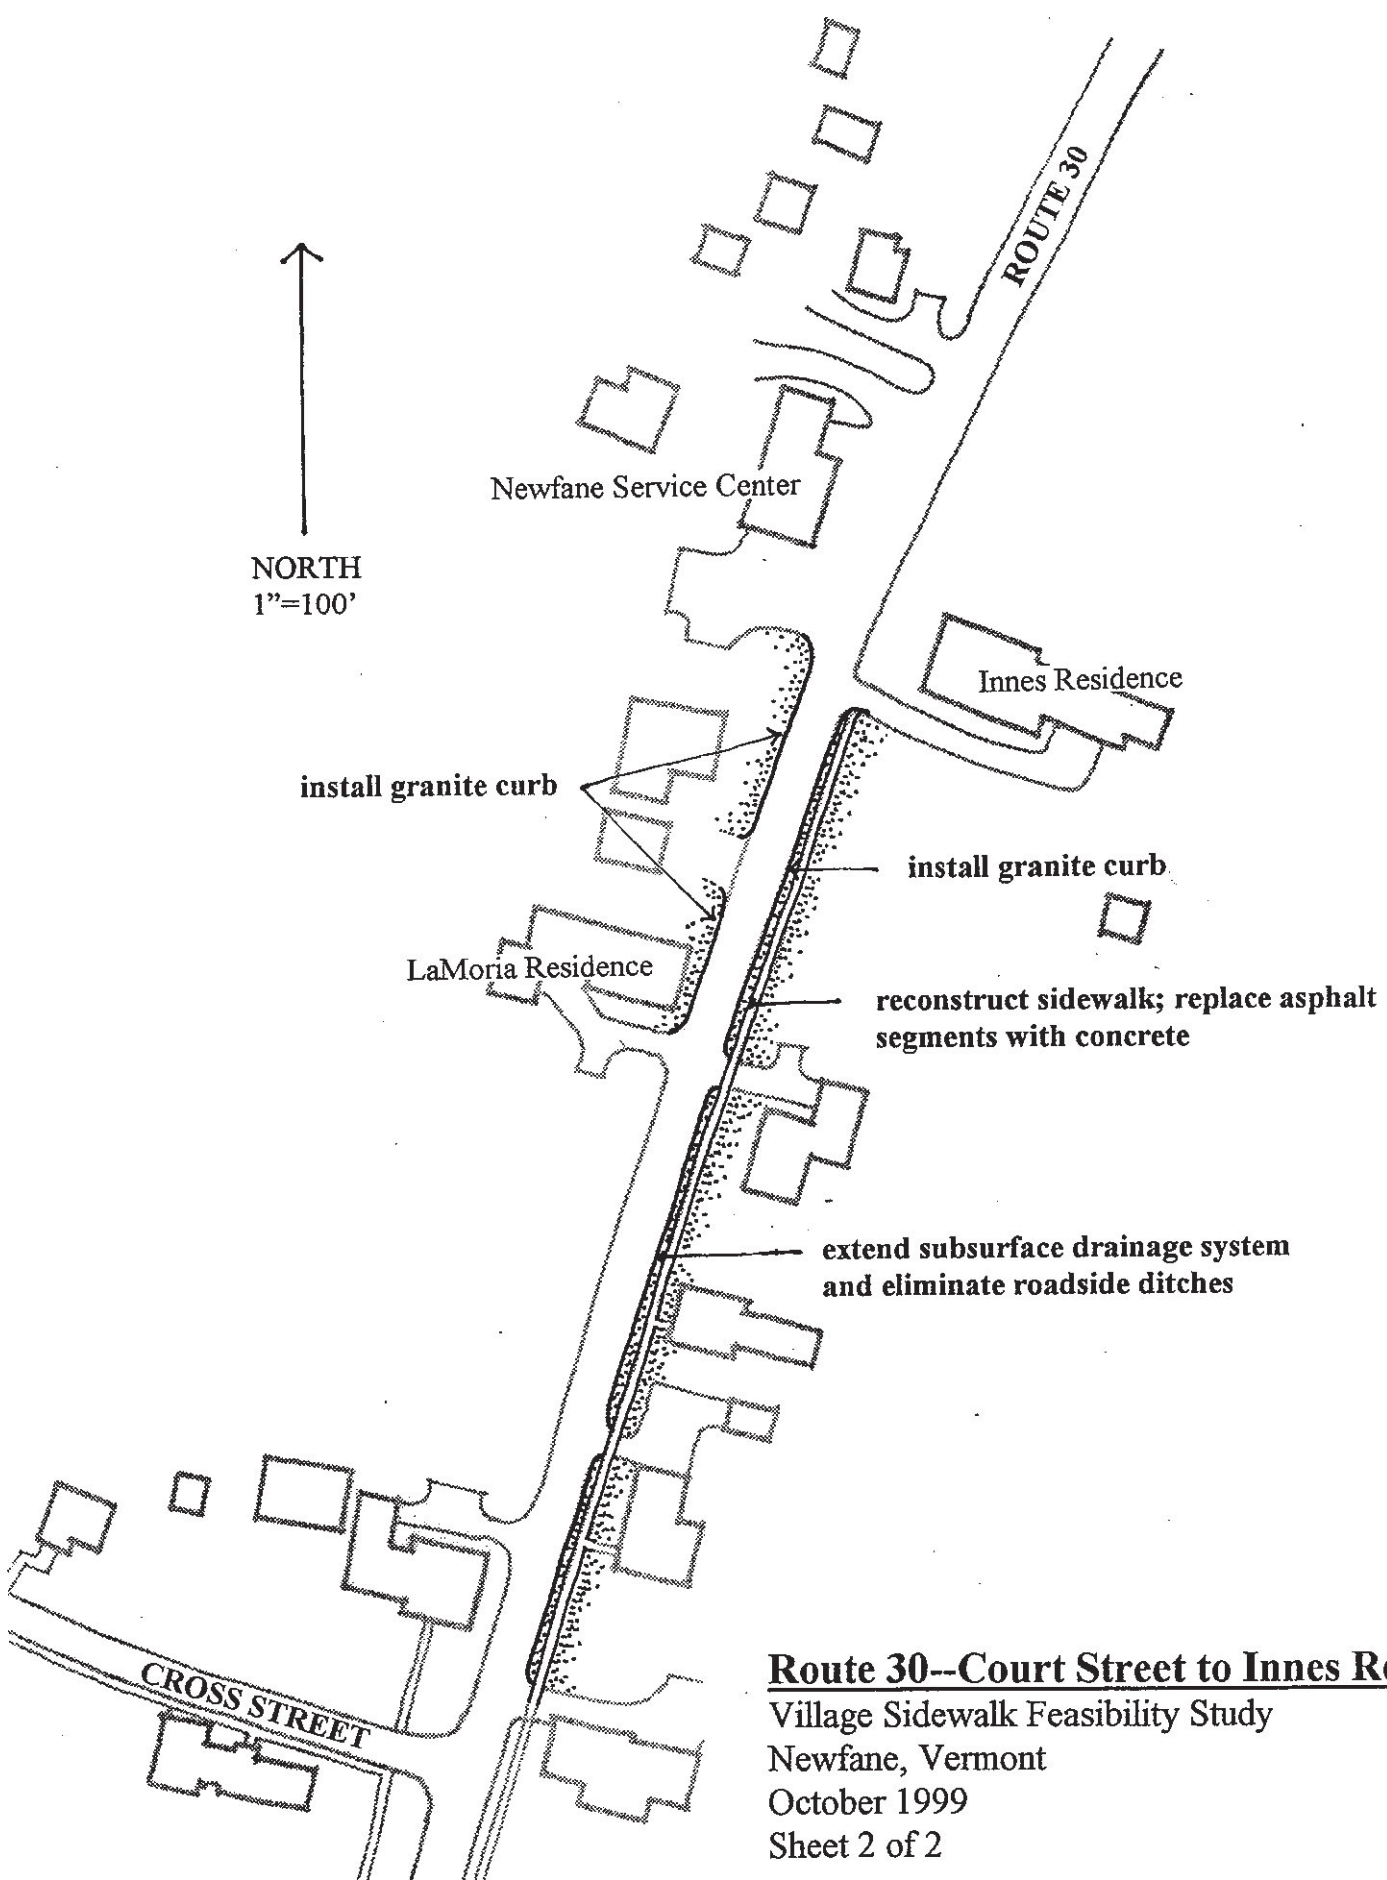
Route 30--Court Street to Innes Residence
Village Sidewalk Feasibility Study
Newfane, Vermont
October 1999
Sheet 2 of 2

- The sidewalk on the east side of Route 30 from Cemetery Hill Road to the northern edge of the village varies widely in both condition and material.
- An enclosed drainage system is in place on much of Route 30 between Cemetery Hill Road and Cross Street. However, from Cross Street southward approximately 200 feet, stormwater runoff from the street drains onto the sidewalk rather than into the drainage system.

- An excessively depressed catch basin on the east side of Route 30 in the vicinity of Cross Street poses a safety hazard for vehicles and pedestrians.

- Portions of the original concrete sidewalk on the east side have been repaved with asphalt. However, where original concrete panels were left in place rather than removed, the sidewalk continues to show signs of cracking and heaving.

- Reconstruct the sidewalk on the east side of Route 30 from a point approximately 200 feet north of Cemetery Hill Road to the end of the existing village system; replace all asphalt segments with concrete.

reconstruct sidewalk; replace asphalt segments with concrete

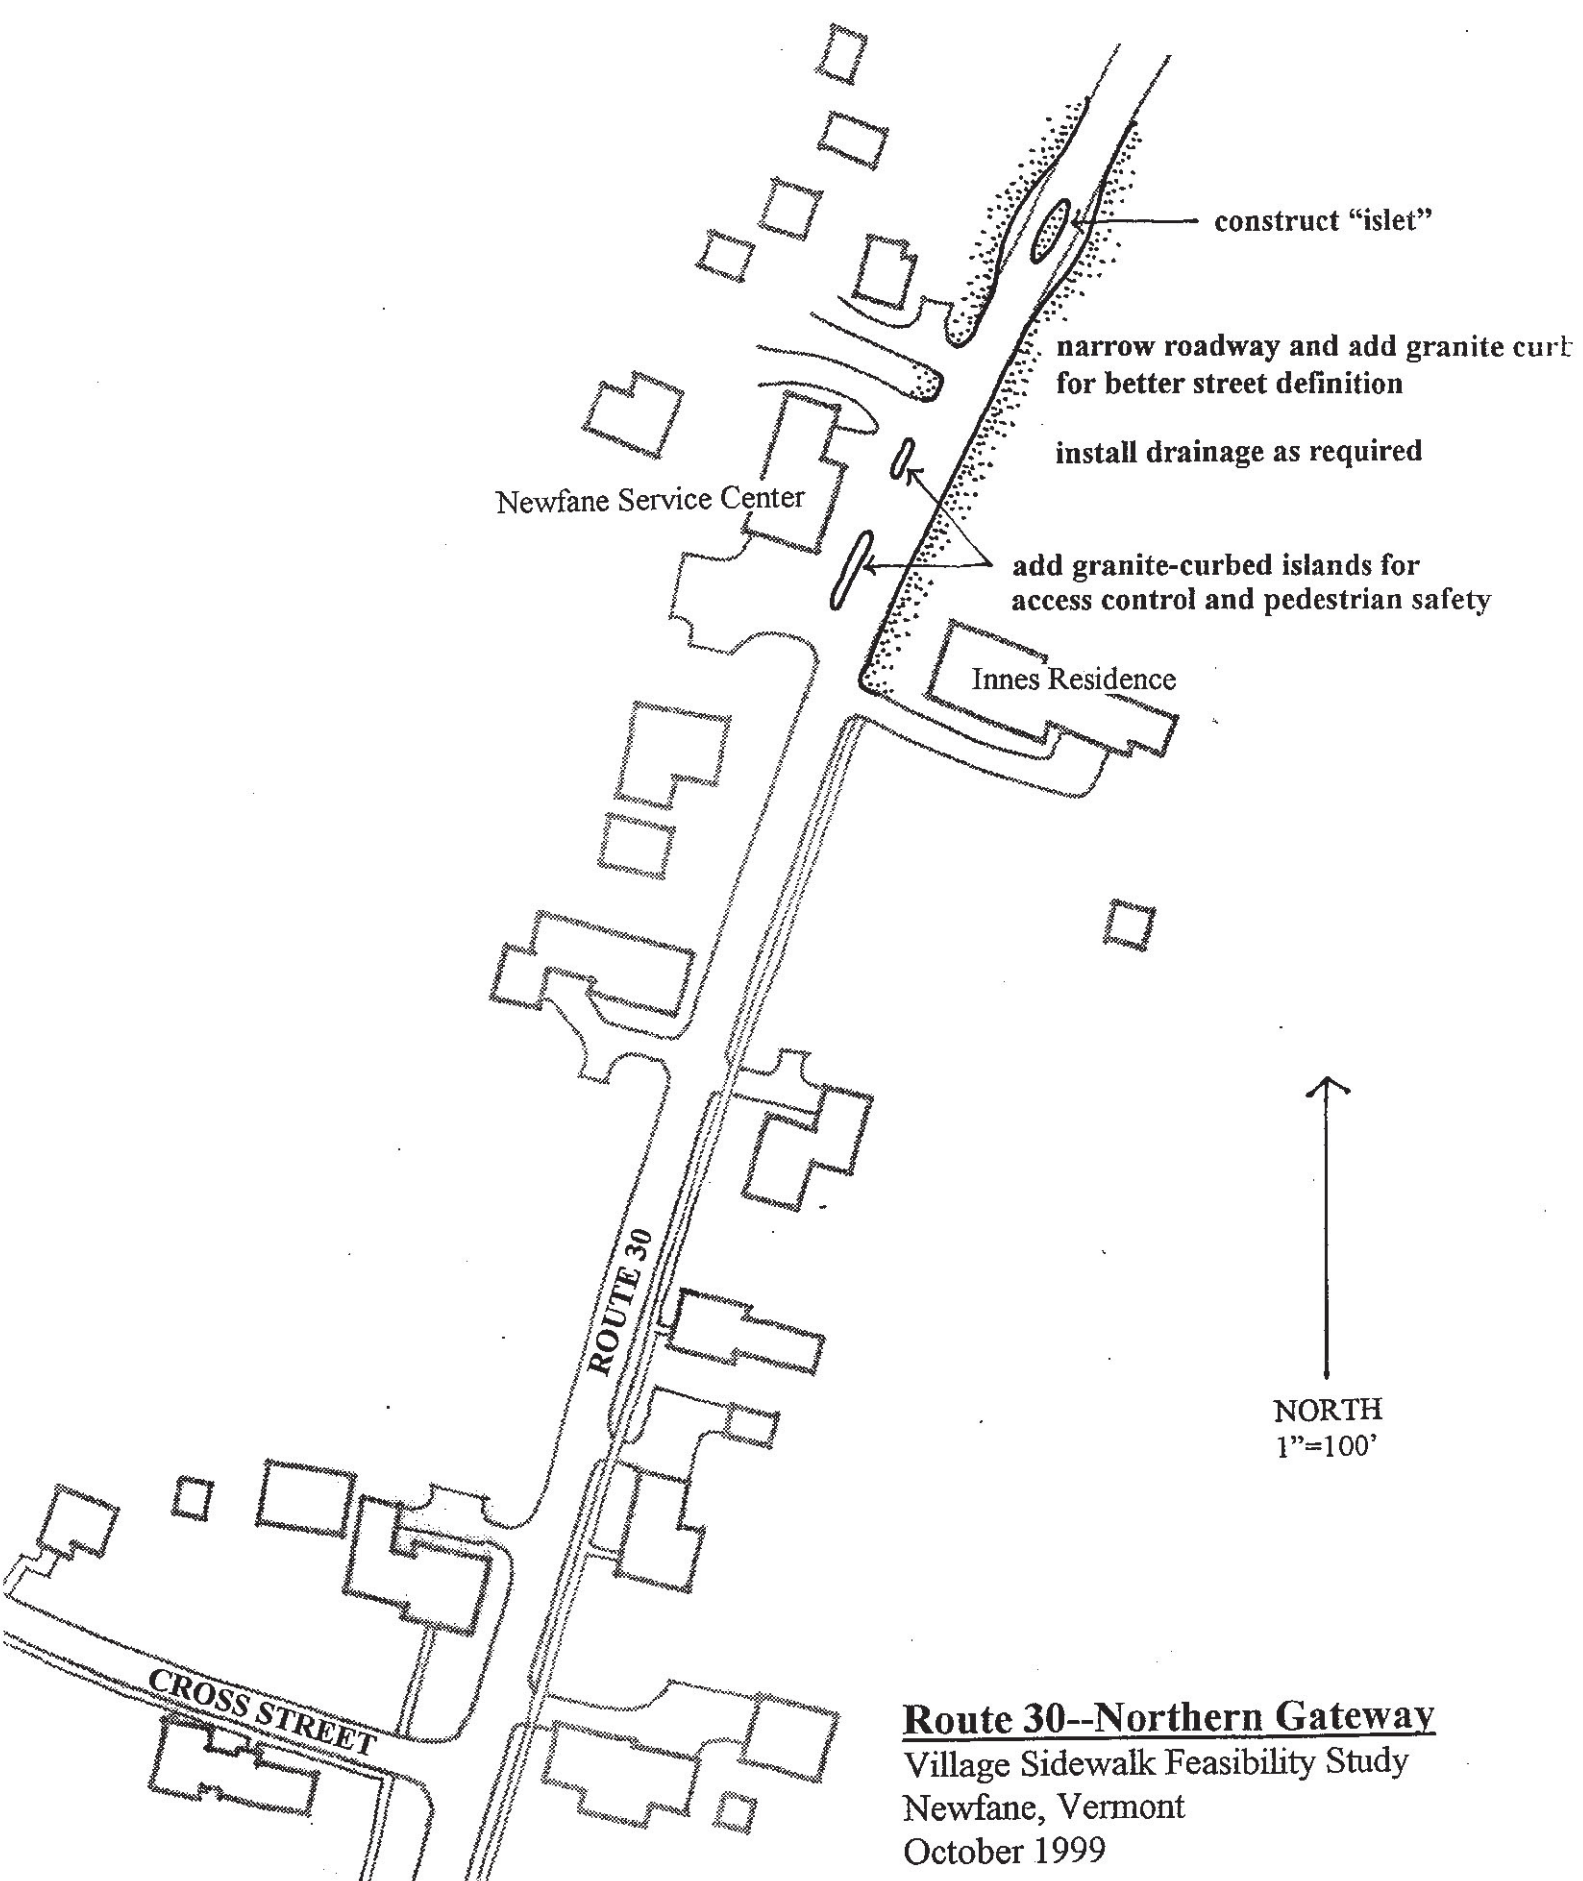
Due to questionable sight distances along the crest of the hill at the northern edge of the village, no “islet” was initially proposed at this location. However, village residents felt that it was equally important to slow travel speeds of southbound vehicles entering the village. At the request of village residents, an “islet” was reconsidered. An acceptable location with adequate sight distances in each direction was found several hundred feet north of the village limits.

- Construct “islet” (small curbed median island) or other similar traffic-calming device to serve as the primary “gateway” feature and slow traffic as it enters the more densely developed area of the village.
- Narrow roadway and add granite curb for better “street” definition.
- Add granite-curbed islands along Newfane Service Center frontage to better control access and reduce pedestrian hazard posed by excessively long curb cut.
- Install additional drainage as may be required by curb installation.

construct "islet"

narrow roadway and add granite curb for better street definition
