Road Safety Audit Review

Town:	Poultney	Date Reviewed:	<u>September 28, 2016</u>
Route:	VT 30	Mile points:	VT 30 MM 6.627-6.927

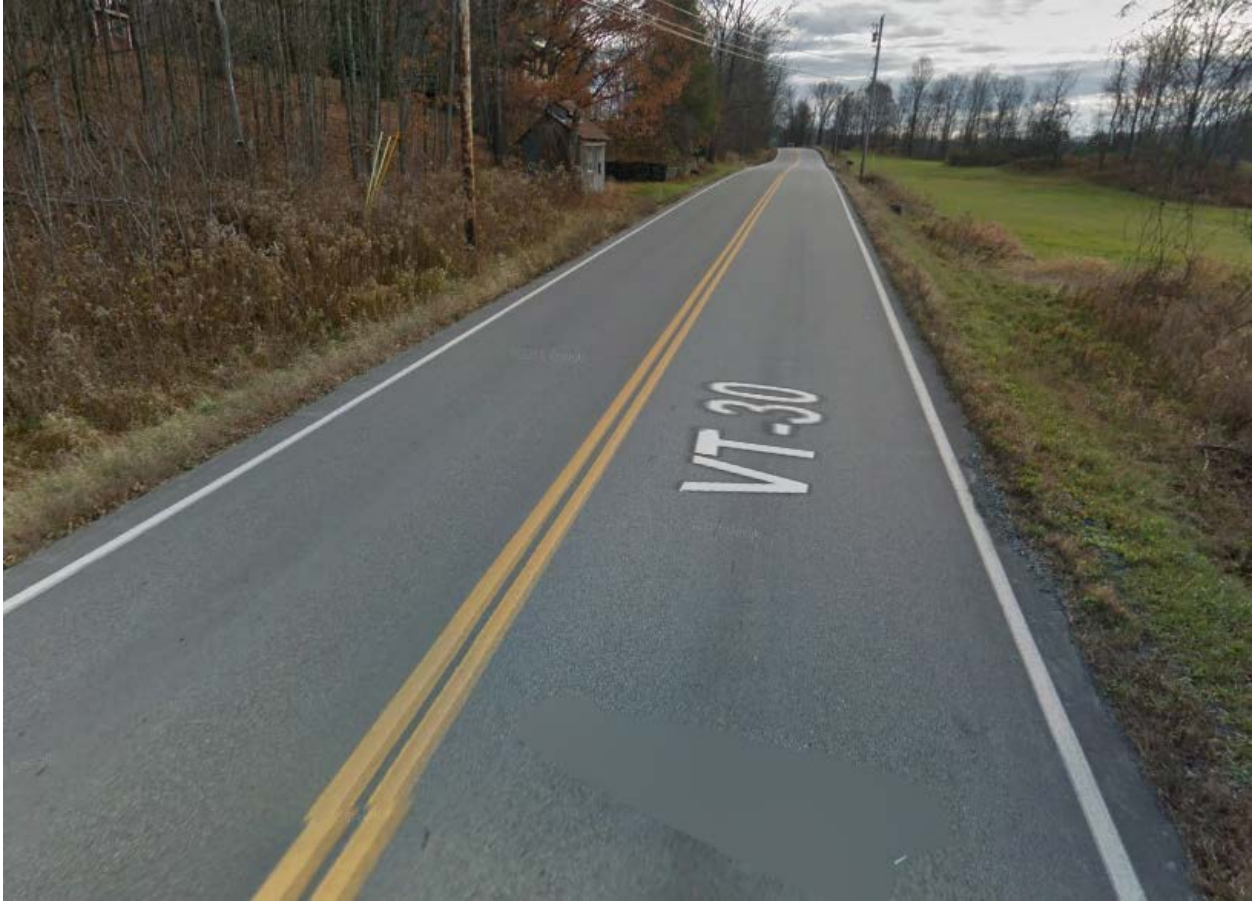
Concern: Lack of Adequate Shoulders

The shoulders on VT 30 are very narrow.

Consideration should be given for widening the shoulders on the entire length of VT 30.
