Road Safety Audit Review

Town:	Milton	Date Reviewed:	October 19, 2016
Route:	Westford Rd & Main St (mm 0.63) Main St and Railroad St (mm 0.47)	Mile points:	0.47 to 0.69

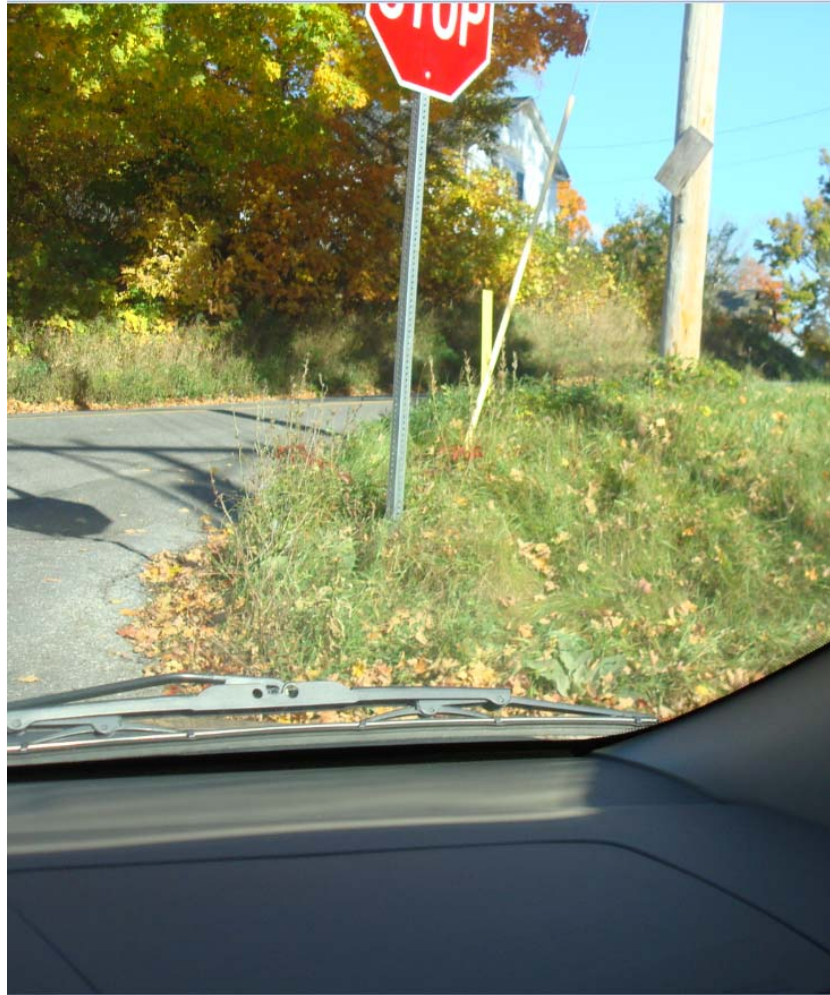
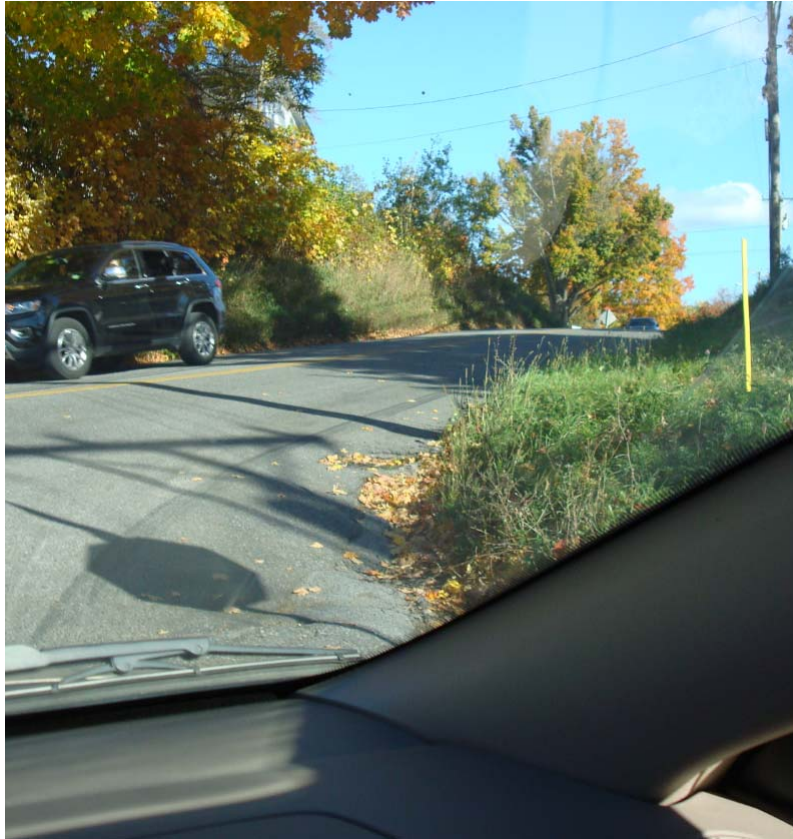
Concern: Poor Sight Distance and Corner Sight Distance at the Railroad Street Intersection

Left turning vehicles that are stopped on the Railroad Street approach cannot see Main Street traffic that is approaching from the right due to the vertical crest and the embankment. As per the AASHTO Green Book, the required corner sight distance for a vehicle making a left turn is 335 feet (for a cross speed of 30 mph). In its 2016 memorandum, CCRPC estimated the available corner sight distance to be 200 feet while the Town's 2015 Pedestrian Scoping study estimated that same available distance to be about 250 feet. This issue is illustrated in the next two figures. The first picture shows the view when a vehicle is stopped at the stop sign. The second picture shows the view after creeping forward into the road.

Prohibit Left Turns from Railroad Street: The Town could consider prohibiting left turns from Railroad Street by installing the appropriate regulatory sign and enacting ordinance to this effect. However, without enforcement, it is unlikely that this measure would be efficient.

Upgrade Intersection Warning Sign: Replace the Dangerous Intersection sign with a conventional side road warning sign. Supplement this sign with a Railroad Street plaque.

Dynamic Warning System: Install a dynamic warning system in conjunction with the westbound intersection sign that will activate a flashing beacon or LEDs around a supplemented plaque to warn Main Street westbound traffic that a vehicle is stopped on Main Street and about to turn left or that a vehicle on Railroad Street is about to turn left onto Main Street. See the diagram at the end of this report for a general layout.

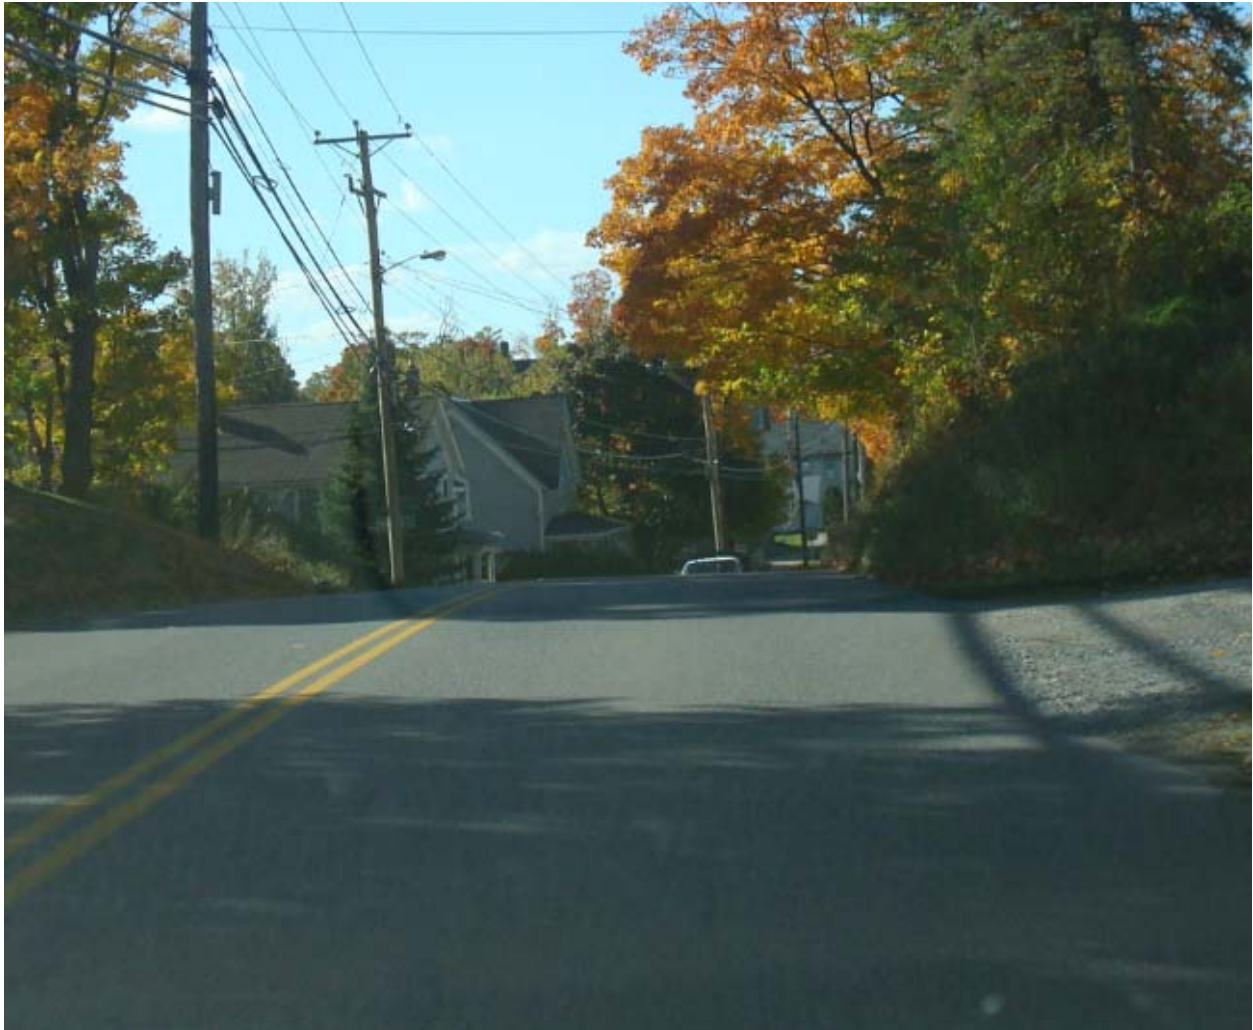
Westbound traffic on Main Street have a limited view of traffic turning left onto Railroad Street or turning left from Rail Road Street due to the vertical crest on Main Street. The available sight distance was measured by VTrans to be approximately 186 feet. As per the AASHTO Green Book, the required stopping sight distance for a 30 mph speed on a 9% downgrade is 227 feet. The picture below shows what a driver sees as he/she approaches the intersection.

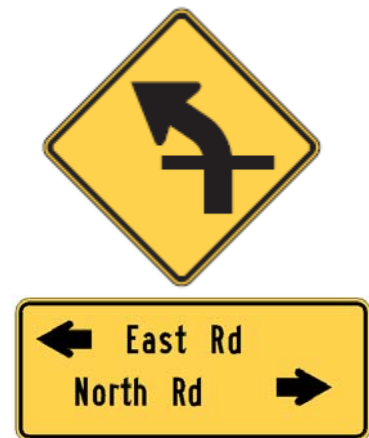
Concern: Lack of Delineation at Curve to the Left when Traveling towards the North Road Intersection from Westford Road

While the safe speed around the curve was determined to be around 40 mph or below, given that there is a vertical curve prior to this curve and the intersection, it is likely that speeds approaching the curve are higher.

Nighttime visibility of the curve could potentially be a concern.

Install 6" x 8" delineators spaced about 50 feet apart around the curve.

Install a horizontal curve sign with two side roads displayed on it (MUTCD Code W1-10a, Left) along with a street name plaque below it (MUTCD code W16-8aP).
