Road Safety Audit Review

Town:	Highgate	Date Reviewed:	January 19 2016
Route:	VT 78 @ Machia Road	Mile points:	VT 78: 6.76

The location of this RSAR is the intersection of VT 78 and Machia Road in Highgate.

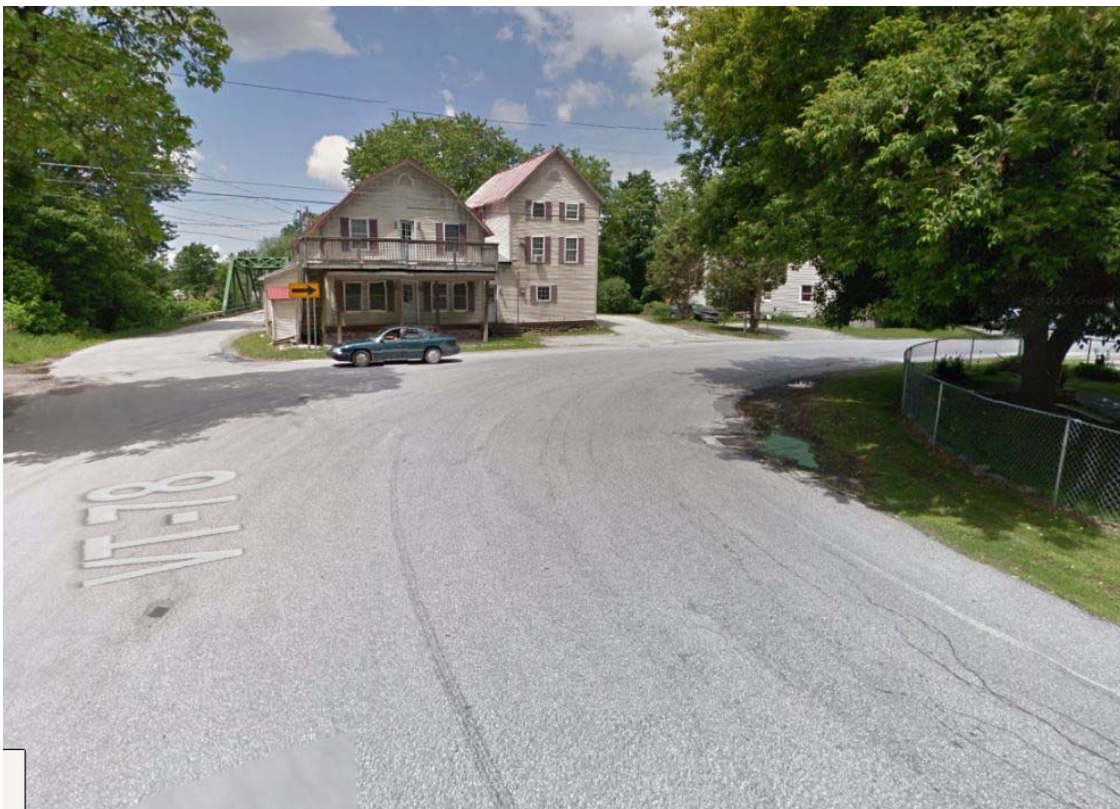
Concern: Sight Distance Issue When Making a Left Turn onto Machia Road

Westbound motorists who are continuing onto Machia Road and making a left turn have limited sight distance to the eastbound traffic on VT 78 that is coming from the right. This is due to the horizontal curve and the large trees on the property on the inside of the curve. It was determined that approximately 125 feet of sight distance was available compared to the

minimum 200 feet suggested by AASHTO for a travel speed of 30 mph. Note that this measurement was taken during winter and that the large tree did not contribute significantly to reducing the sight distance.

Ensure that the yellow centerline markings that define the intersection and specifically the opening through which motorists should enter Machia Road are visible. By properly stopping and entering the intersection at the centerline opening, motorists would be able to see oncoming eastbound VT 78 traffic better.

Relocate Machia Road on a new alignment that would go through the property at 6756 VT 78 as considered by project BO 1448(43). This would force motorists to make a left turn at about a 90 degree instead of shooting straight. The available sight distance for making the left turn onto Machia Road on a new alignment would be approximately 230-240 feet.

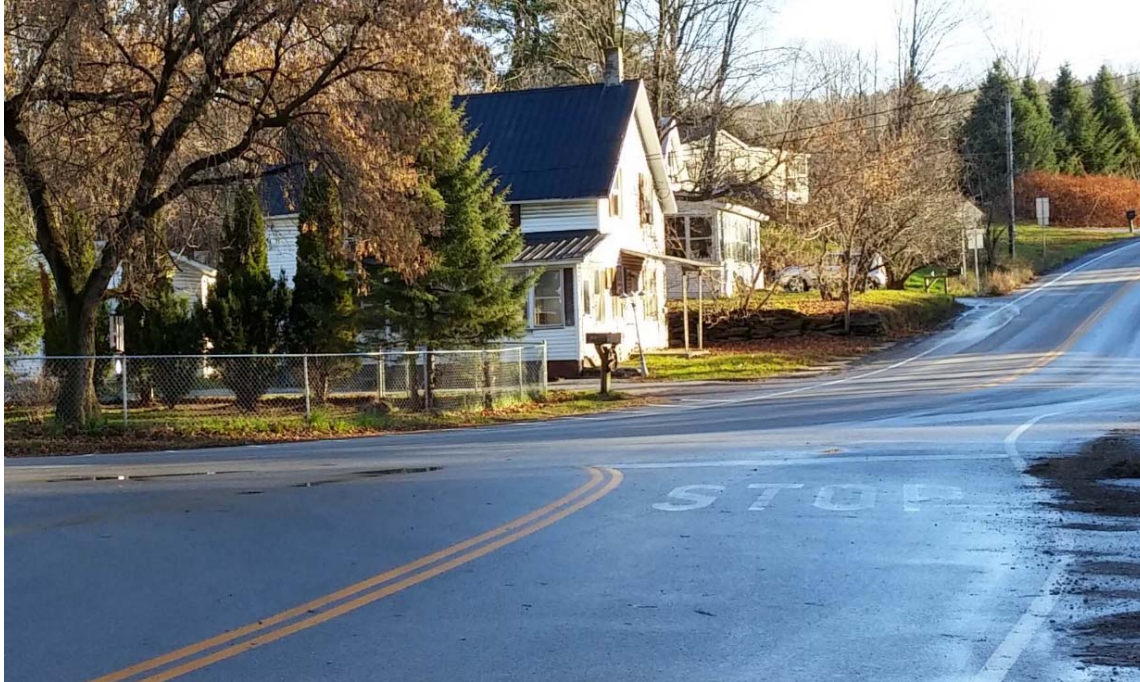
Concern: Issue with Water Pooling at the Intersection.

Water has been reported to be pooling at the intersection from different sources. In general, from water shading off driveways but specifically from a spring on a property on the north side of VT 78 (on the hill side approach to the intersection). During the freezing months, water turns into ice and creates slippery conditions at the horizontal curve.

Could VTrans Structures investigate the issue with the spring and consider alternative improvements as part of project BO 1448(43)?

If the water pooling issue cannot be physically resolved, to reduce the incidences of motorists leaving the road when the road surface is icy, could a dynamic ice warning system using advance signs that would have some form of flashing mechanism with the message ICING MAY OCCUR WHEN FLASHING be considered as of part project BO 1448(43)? *Detection of icy conditions would be achieved with a non-intrusive road surface sensor capable of detecting ice on the road surface. The system could have the capabilities of being monitored remotely by the district using a web-based application.*
