Office of Highway Safety

Road Safety Audit Review

Town:	Bennington	Date Reviewed:	September 17, 2015
Route:	VT 7a @ Houghton Lane	Mile points:	VT 7a: 1.71

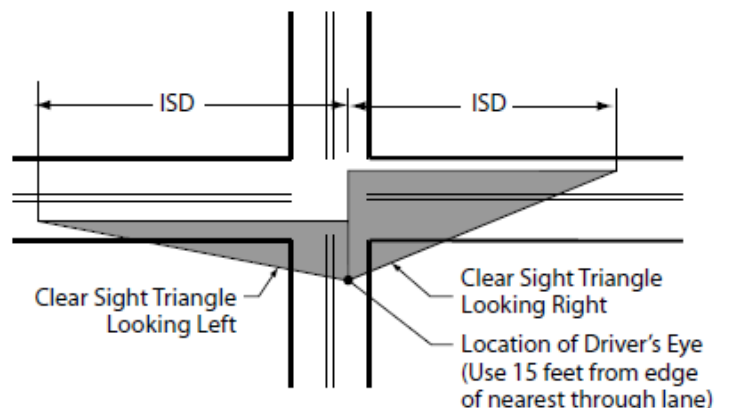
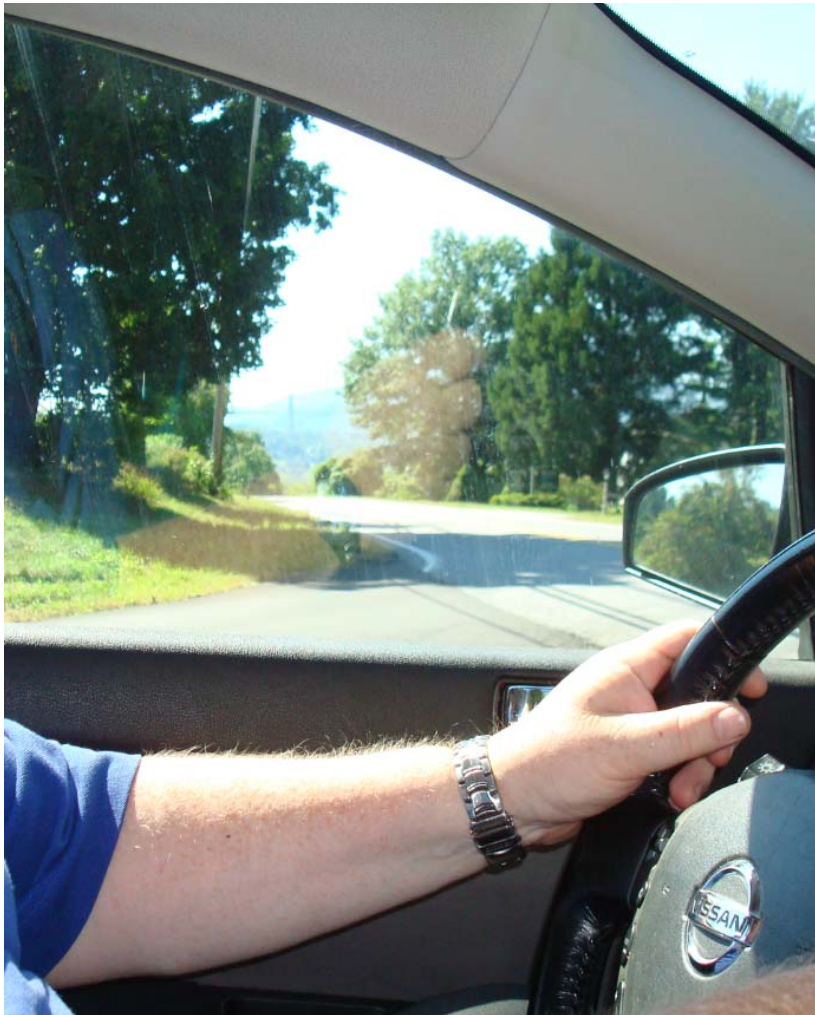
Concern: Corner Sight Distance Issue, Southeast Quadrant

The corner sight distance (ISD) when stopped on Houghton Lane and looking to the left (or south), towards VT 7a is inadequate (*it was measured at 388 feet, which is below AASHTO's guidance of 555 feet for the actual*

50 mph posted speed limit and below the value suggested for the 85th percentile speed of 49 mph). The embankment, a utility pole, a mail box and possibly the vertical crest south of the intersection contribute to this issue. Tall grass during the summer months was also reported as a contributing factor.

Mow twice a year in this area. District and Town to work together and coordinate.

Evaluate what gain in corner sight distance could be achieved by cutting back the bank on the east side. Evaluate what additional gain could be obtained by lowering the road.

Relocate the utility pole.

Install a dynamic warning system (like the one at Rice lane and VT 67a) that would warn traffic on VT 7a that a vehicle is stopped on Houghton Lane (as well as on Rice Lane as well).

Alternatively, install the system so that a vehicle on Houghton Lane is informed that a northbound vehicle on VT 7a is approaching the intersection.

Add an advisory plaque to the northbound advance warning intersection assembly that would match the speed for the corresponding available corner sight distance.

Reduce the speed limit on VT 7a to 45 mph (5 mph below the recorded 85th percentile speed).

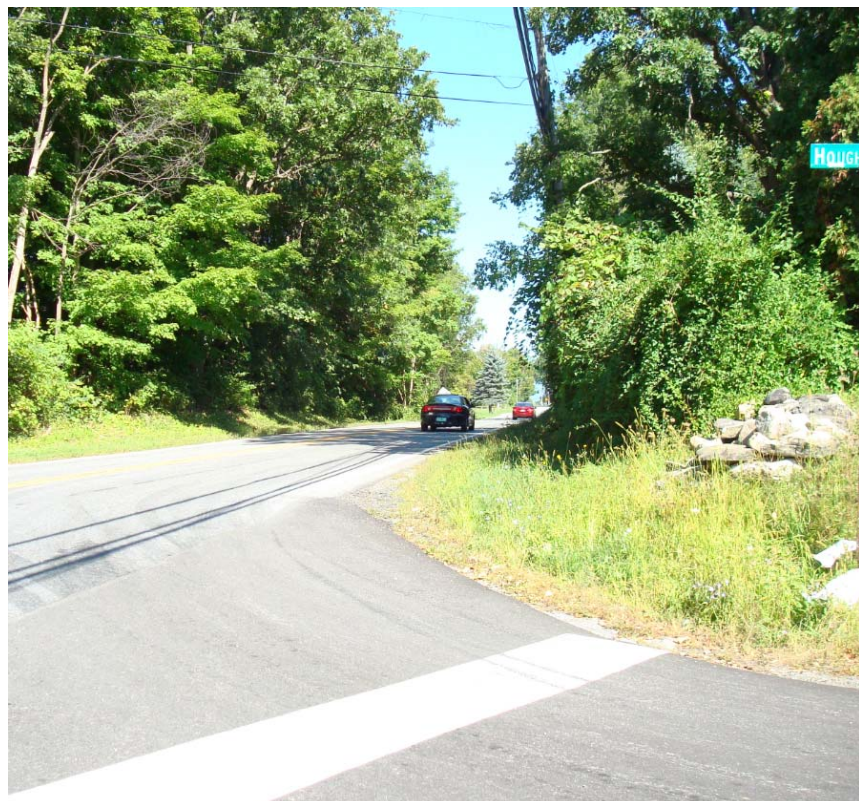
Concern: Corner Sight Distance Issue, Northeast Quadrant

The corner sight distance (ISD) when stopped on Houghton Lane and looking to the right (or north), towards VT 7a is inadequate (*it was measured at 403 feet, which is below AASHTO's guidance of 555 feet for the actual 50 mph posted speed limit and below the value suggested for the 85th percentile speed of 49 mph*).

The embankment, and a utility pole, contribute to this issue. Tall grass could potentially be an issue here as well.

Evaluate what gain in corner sight distance could be achieved by cutting back the bank on the east side, north of the intersection.

Relocate the utility pole.

Mow twice a year in this area. District and Town to work together and coordinate.

Add an advisory plaque to the northbound advance warning intersection assembly that would match the speed for the corresponding available corner sight distance.

Reduce the speed limit on VT 7a to 45 mph (5 mph below the recorded 85th percentile speed).

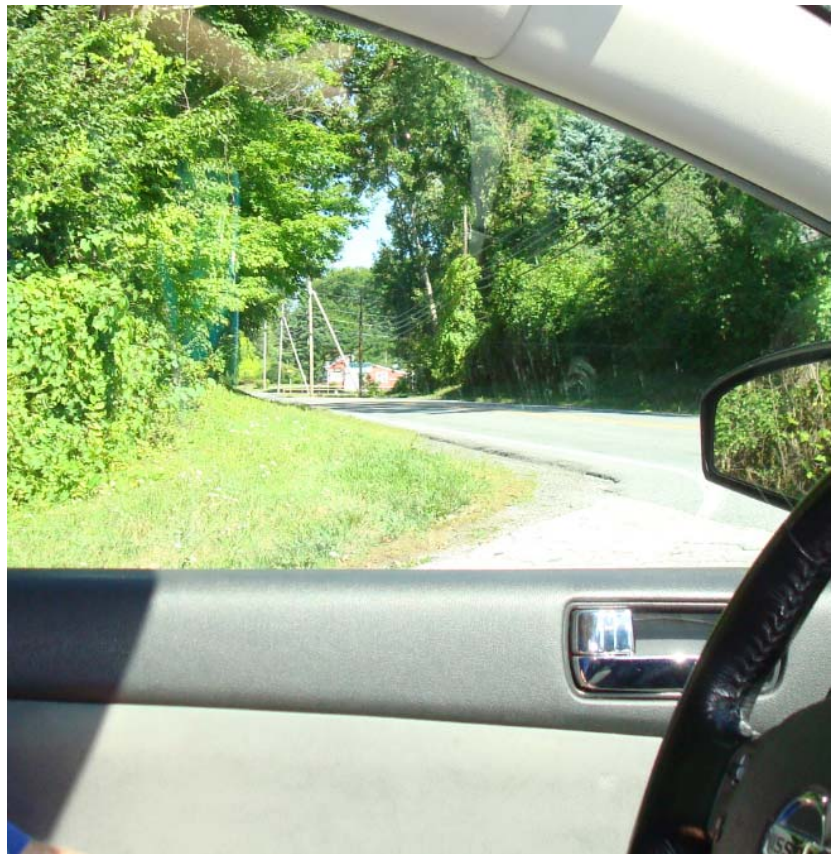
Concern: Corner Sight Distance Issue, Northwest Quadrant

The corner sight distance (ISD) when stopped on Rice Lane and looking to the left (or north), towards VT 7a is inadequate (*it was measured at 407 feet, which is below AASHTO's guidance of 555 feet for the actual 50 mph posted speed limit and below the value suggested for the 85th percentile speed of 49 mph*).

The embankment, and tall grass during the summer months could reduce the corner sight distance.

Evaluate what gain in corner sight distance could be achieved by cutting back the bank on the west side, north of the intersection.

Mow twice a year in this area. District and Town to work together and coordinate.

Assess if removing brush and tree limbs permanently would improve visibility.

Reduce the speed limit to 45 mph (5 mph below the recorded 85th percentile speed).

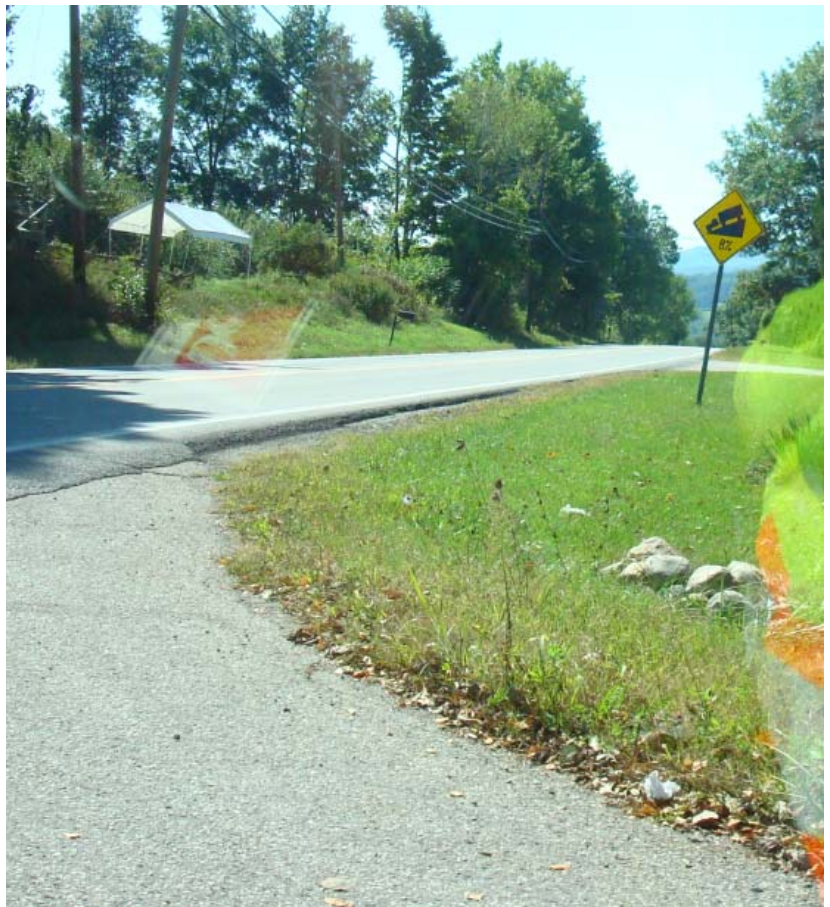
Concern: Potential Corner Sight Distance Issue, Southwest Quadrant)

The corner sight distance (ISD) when stopped on Rice Lane and looking to the left (or north), towards VT 7a is limited (*it was measured at 538 feet, which is somewhat below AASHTO's guidance of 555 feet for the actual 50 mph posted speed limit and below the value suggested for the 85th percentile speed of 49 mph*). The vertical crest south of the intersection contributes to this *issue*.

Tall grass during the summer month could be also a contributing factor.

Mow twice a year in this area. District and Town to work together and coordinate.

Evaluate what gain in corner sight distance could be achieved by lowering the road.

Reduce the speed limit to 45 mph (5 mph below the recorded 85th percentile speed).
