# Road Safety Audit Review

VT 15 and East Hill Rd, Wolcott

September 23, 2020

Vermont Agency of Transportation  
Operations & Safety Bureau

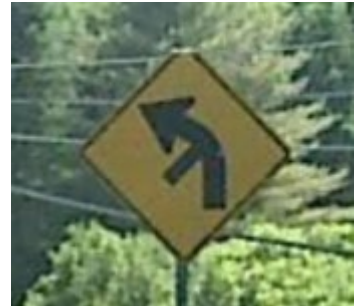
The curve is delineated with chevrons in both directions. A combination horizontal alignment/intersection sign (modified W1-10 with the intersecting road on the inside) is located in each direction in advance of the curve and of the intersection (at mile point 4.565 EB and at mile point 4.745 WB). The signs are 30" x 30" in size and of type IV sheeting. The chevrons have type IX sheeting according to the signs inventory.

- Consider upsizing the two modified W1-10 curve signs from 30" x 30" to 36" x 36"

Making this change will bring the signs to standard. The MUTCD indicates that the minimum size for the combination horizontal alignment/intersection sign series on a conventional road is 36" x 36".

- Consider using type IX sheeting

According to the signs inventory, the existing sheeting is type IV. The chevrons within the curve have type IX sheeting.

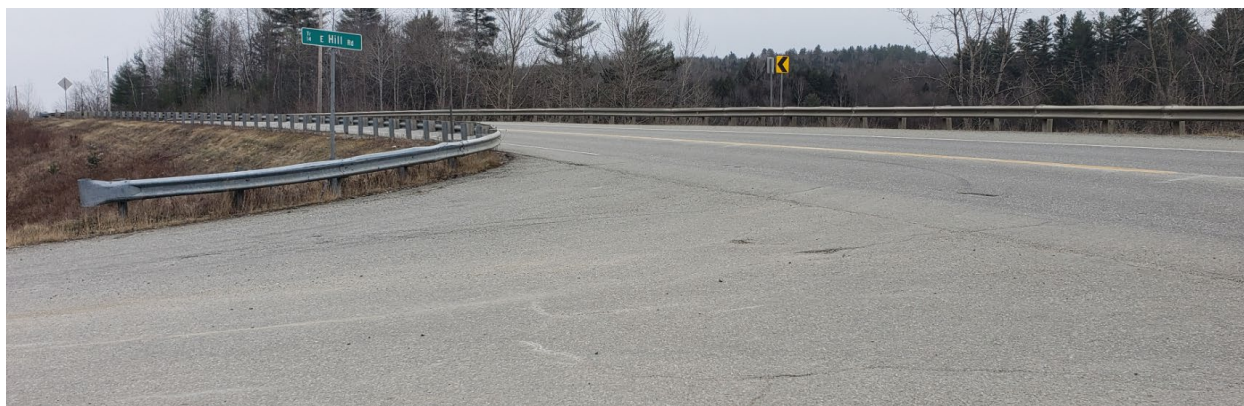
The corner sight distance to the left (looking east) is poor due to the crest and the horizontal curve. The available corner sight distance is estimated at about 250 – 330 ft.

The East Hill Rd approach is uphill towards VT 15. This makes a vehicle that is on East Hill Rd lower and hinders the ability of a motorist to see to the left.

- Consider raising the grade on the East Hill Rd approach to help improve the line of sight to the left

During the road safety audit, the Town expressed willingness to make this improvement the next time East Hill Rd is paved. The Town did inquire during the audit if VTrans would be able to provide technical assistance. The District is a very good technical resource should the Town have questions. The Town will have to get any required permits and submit their engineers plan with a T19 S1111 permit application to work in the state right-of-way.

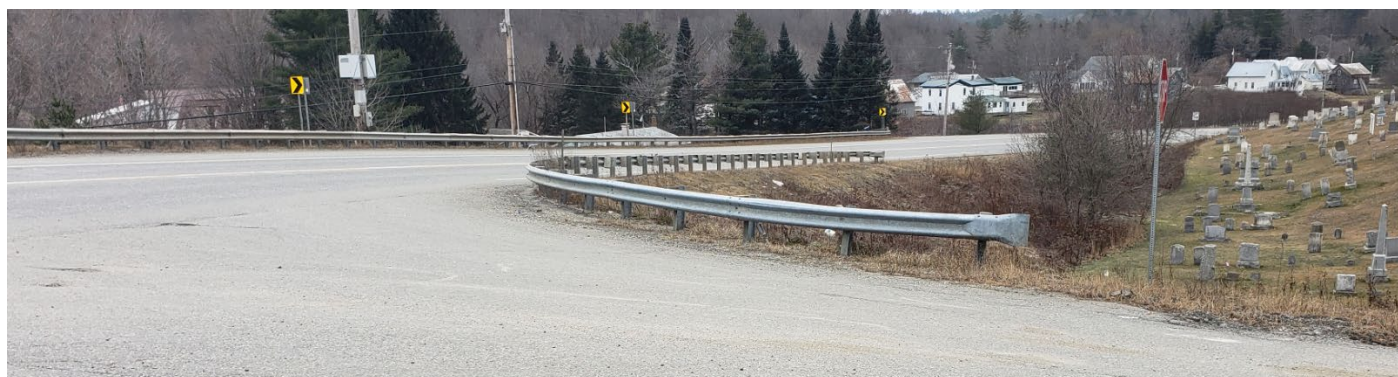
The corner sight distance to the right (looking west) is reduced due to the trees. The available corner sight distance is estimated at about 370 - 410 ft.

- Consider removing the trees on the north side of VT 15 by the cemetery.

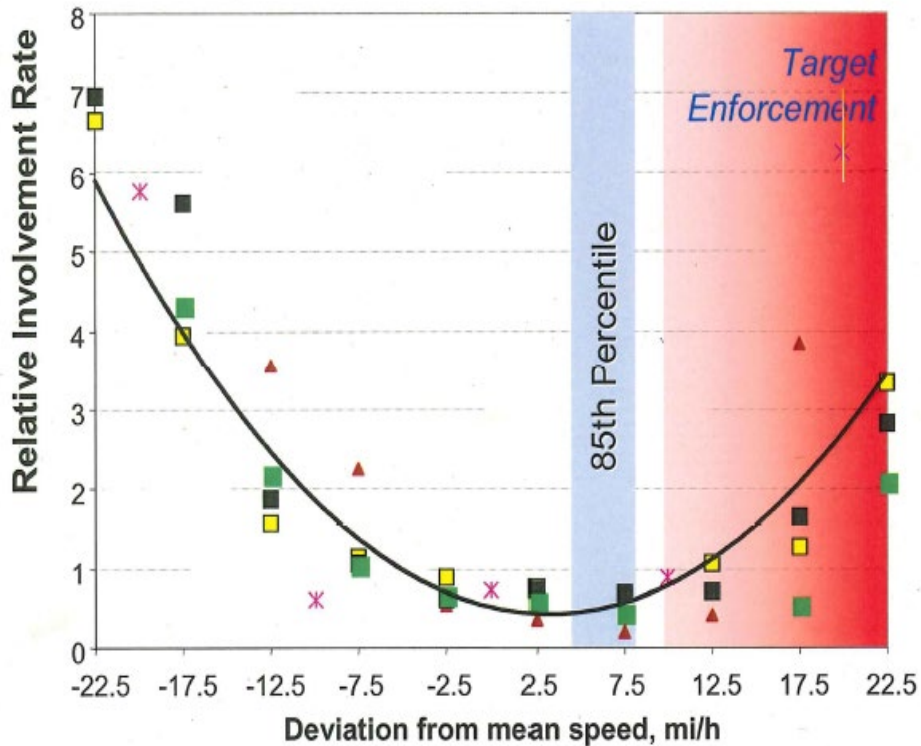
## Targeted Enforcement Concept

In doing this, consider the following concept suggested by the National Highway Traffic Safety Administration (NHTSA). As shown in the next graph, the crash involvement rate increases as traveling speeds deviate from the 85<sup>th</sup> percentile speed. This means that targeting motorists that are traveling above the 85<sup>th</sup> percentile speed will apprehend motorists that are more likely to cause a crash. Crash involvement starts to increase more drastically 5 mph above the 85<sup>th</sup> percentile speed or around the 90<sup>th</sup> percentile speed.

Applying this concept to this section of VT 15 means that the focus should be put on vehicles that are traveling at or above 54 mph (5 mph above the 85<sup>th</sup> percentile).

- Consider conducting recurring speed limit enforcement campaigns for the high-risk drivers (as per the discussion below, target drivers at or above 54 mph).

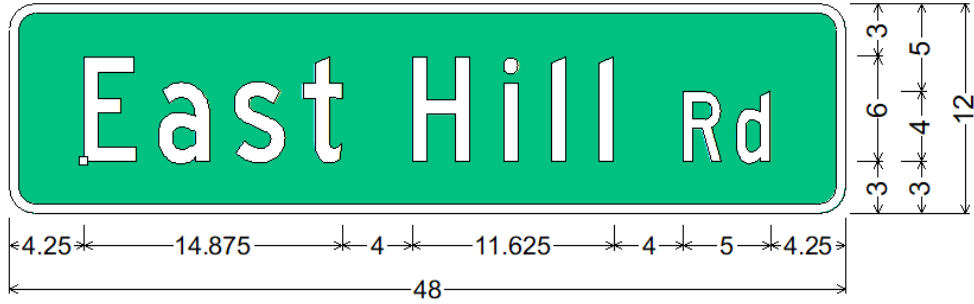
It was reported that the Town received complaints from residents that the intersection was difficult to see at night or when the weather was poor.

Residents use the guardrail as a guide to turn into East Hill Rd at night. Because many of the reflectors on the guardrail have fallen off, making turns into East Hill Rd when it is dark or when it is hard to see the intersection has been reported to be more difficult.

- Consider inspecting the guardrail sections (District & LCPC) and replacing (District) the reflectors inside the guardrail as needed.
- Consider (VTrans Traffic Ops) installing delineators along the guardrail to supplement the guardrail reflectors.
- Consider (Town) refreshing the white edgeline markings around the two radii on the East Hill Rd approach.
- Consider (Town) installing an updated East Hill Rd street name sign (D3-1) per MUTCD standards.

The new sign would be bigger (48" x 12" as shown on the detail below) and more visible. The sign should be installed on two posts.

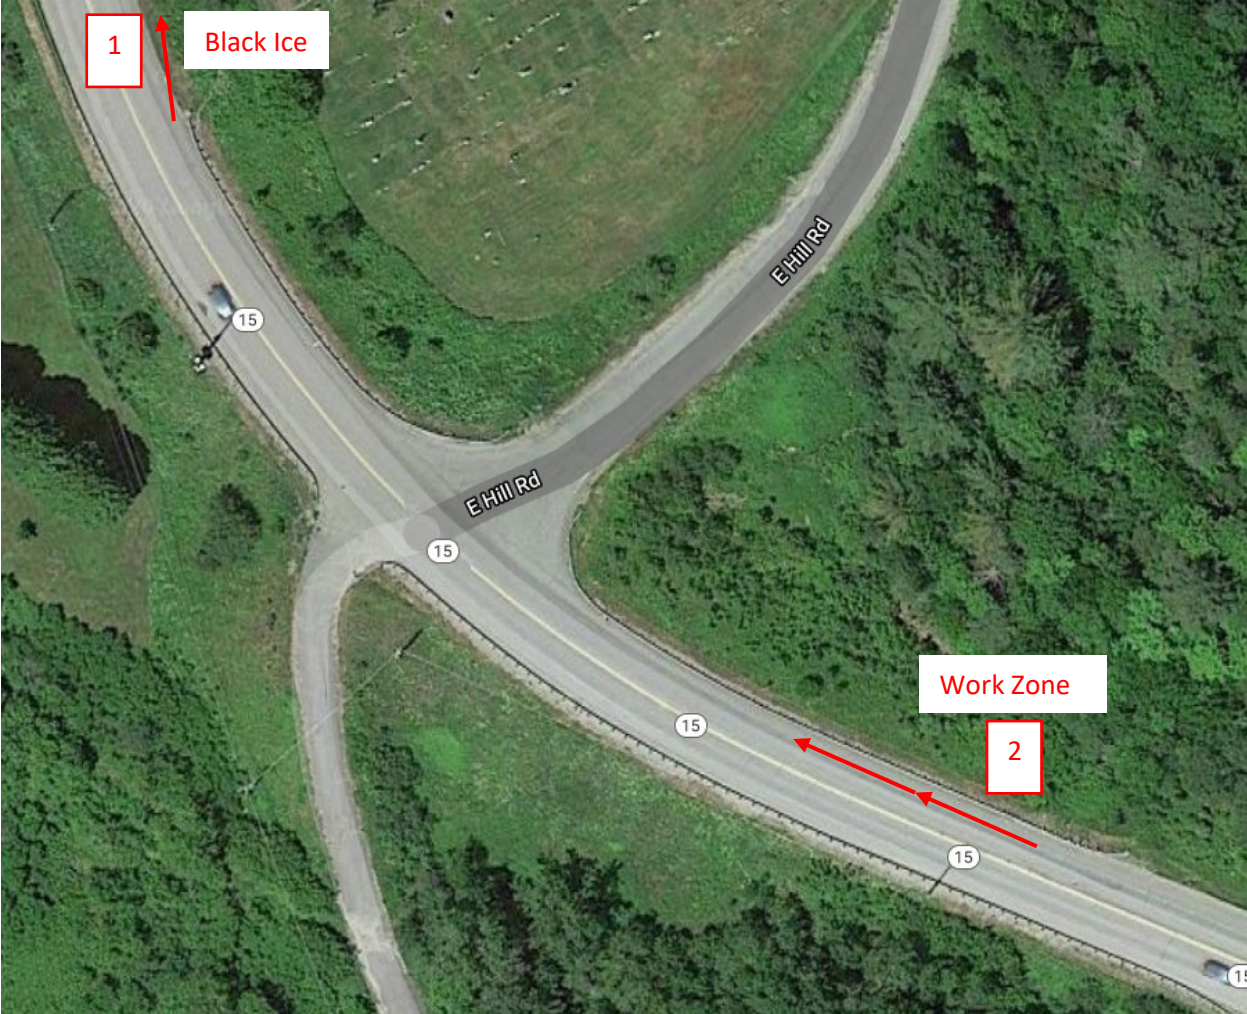
## Crash Data 2015-2019

Crash #	Incident #	Date	Time	Weather	Contributing Circumstances	Collision Type	# Injuries	# Fatalities	Narrative
1	16LC005207	11/23/16	3:00	Sleet- Hail (Freezing Rain or Drizzle)	Driving too fast for conditions	Single Vehicle Crash	1	0	Investigation reveals that op 1 was traveling west on VT 15 when he lost control of his vehicle and could not navigate the turn. At the time of the crash the roads were slick and covered with black ice. The vehicle was down the embankment off of the west bound travel lane just west of the intersection of East Hill Rd.
2	19LC003748	08/05/19	16:12	Clear	Followed too closely- Inattention- No improper driving	Rear End	1	0	Operator #1 was WB and came over the hill and was slowing for the traffic in the construction zone. He came to a stop in the line of traffic and then the vehicles in front of him started to move. He started to move and looked down for a second and when he looked up the vehicle in front of him has stopped and he swerved to miss it and just hit the back drivers side bumper of the vehicle.
