# Office of Highway Safety

## Road Safety Audit Review

<b>Town:</b>	Berkshire	<b>Date Reviewed:</b>	September 11, 2015
<b>Route:</b>	VT 118, Richford Rd and Water Tower Rd	<b>Mile points:</b>	S0302: 2.65 S0307: 4.10

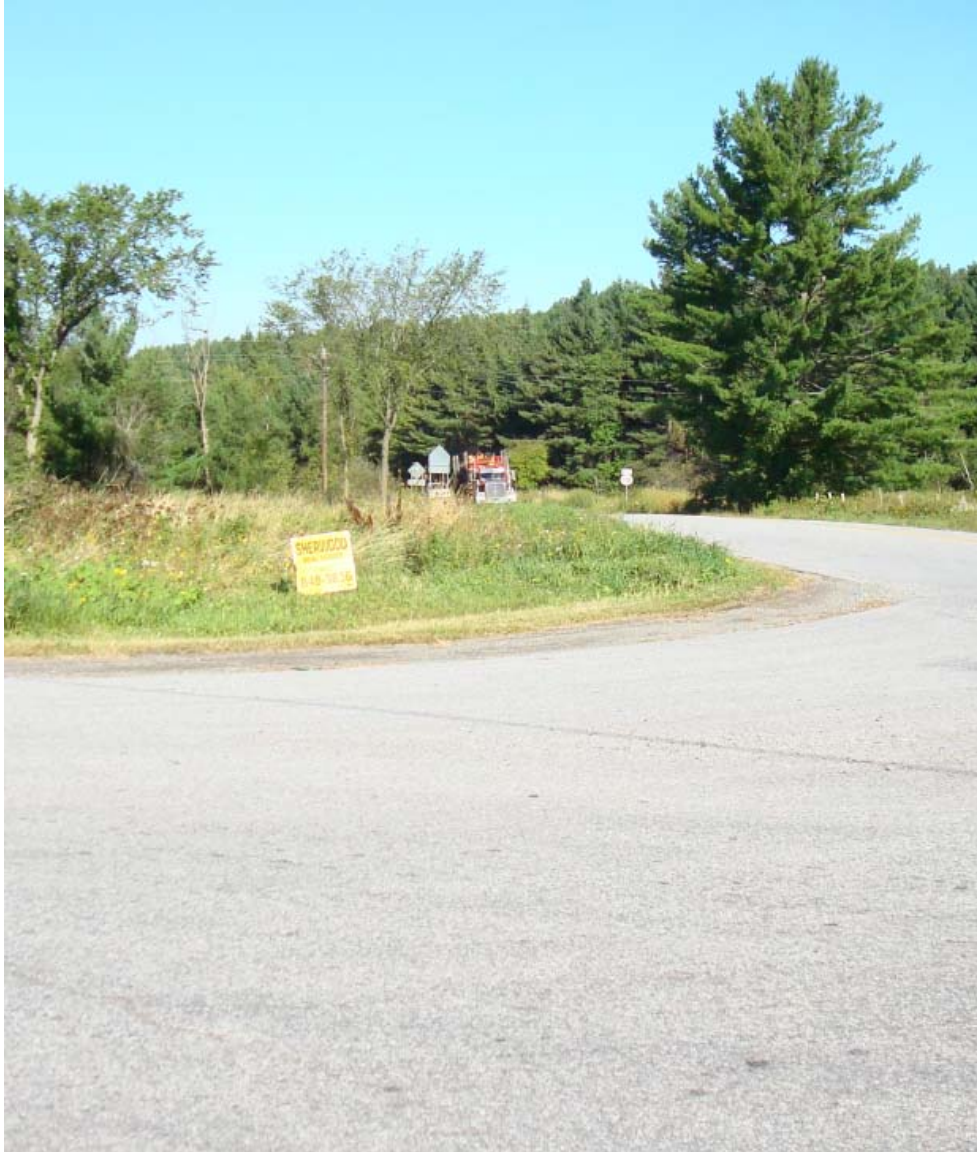
Concern: Corner Sight Distance Issue, Northwest Quadrant

The corner sight distance when stopped on Water Tower Road and looking to the left (north) is poor (*measured at 384 feet, which is below the required 555 feet value for the 50 mph posted speed limit*). The presence of brush/trees contributes to this issue.

Safety Enhancements:

Ensure that the stop bar is located four feet from the edge of the road to maximize corner sight distance and that it is visible and refreshed on a yearly basis as needed (see the detail below).

Provide a clear sight triangle by removing any obstructions that are located inside the boundaries of the triangle.

Add an advisory plaque to the northbound advance warning intersection assembly that would match the speed for the corresponding available corner sight distance (35 mph plaque).

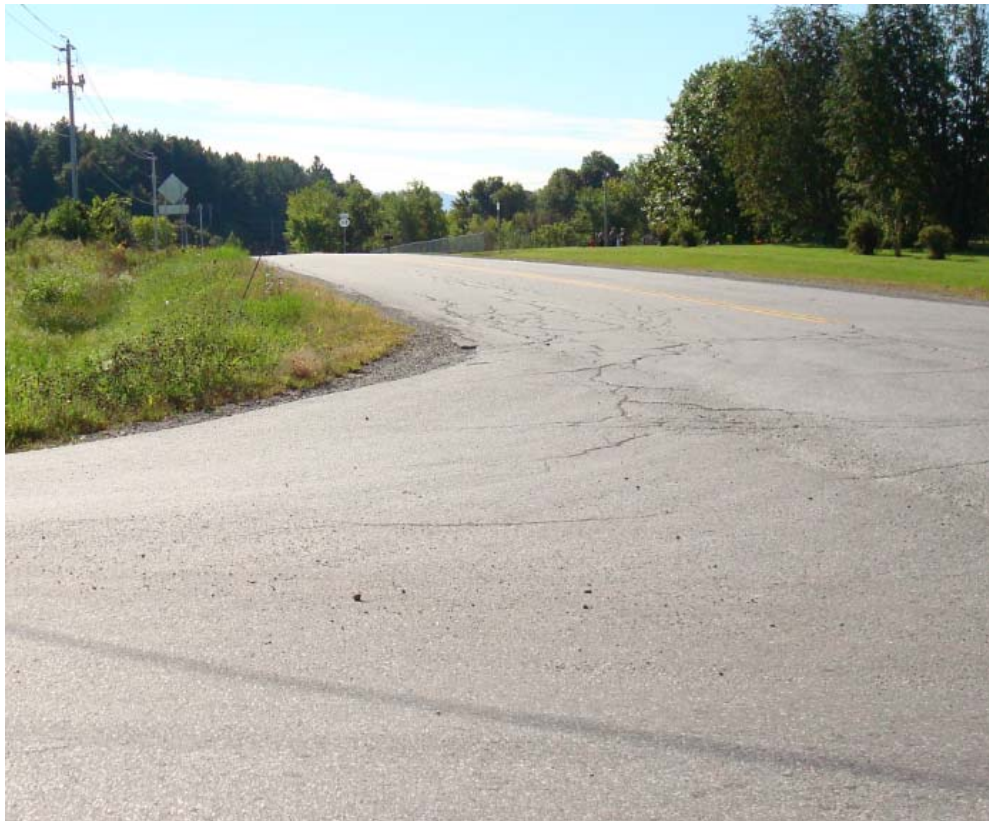
Concern: Corner Sight Distance Issue, southeast Quadrant

The corner sight distance when stopped on Richford Road and looking to the left (south) is poor (*measured at 440 feet, which is below the required 555 feet value for the 50 mph posted speed limit*). The crest of the road on VT 118 contributes to this issue.

Ensure that the stop bar is located four feet from the edge of the road to maximize corner sight distance and that it is visible and refreshed on a yearly basis as needed (see previous layout diagram).

Add an advisory plaque to the northbound advance warning intersection assembly that would match the speed for the corresponding available corner sight distance (40 mph plaque).

Evaluate what gain in corner sight distance could be achieved by lowering the road.

Evaluate if a roundabout or a mini roundabout could be constructed at this intersection.
