Office of Highway Safety

Road Safety Audit Review

Town:	Barre City	Date Reviewed:	September 3, 2015
Route:	Prospect St and Berlin St Intersection	Mile points:	Prospect: 0.539, Berlin: 0.000

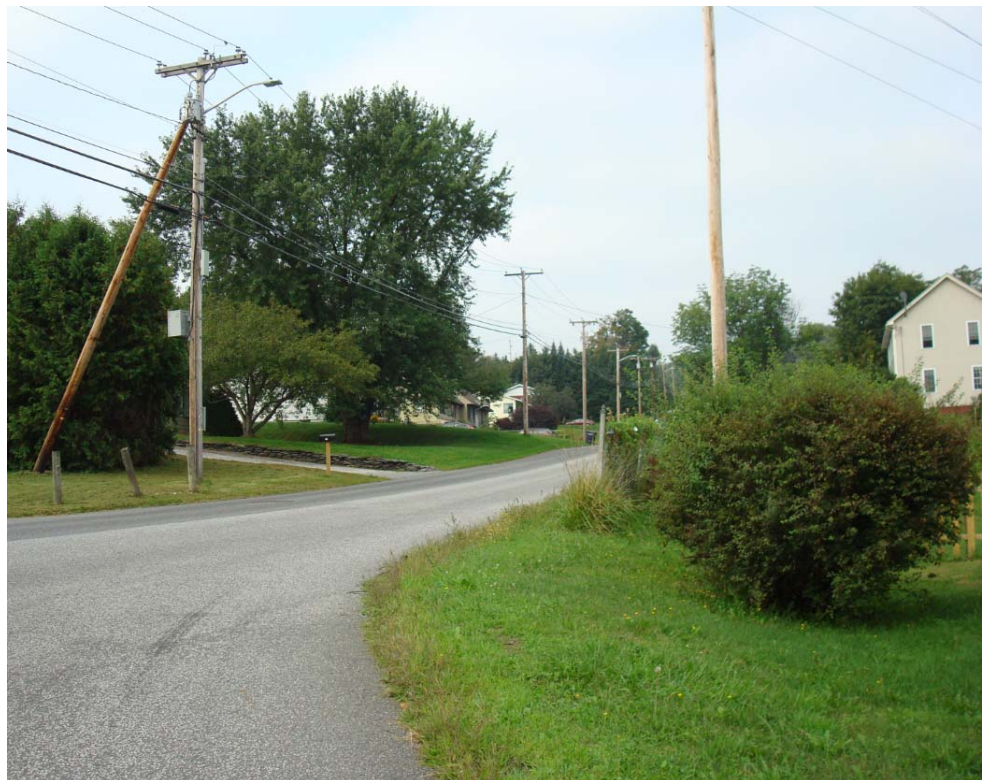
Concern: Corner Sight Distance Issue, Northwest Quadrant

The corner sight distance when stopped on Berlin Street and looking to the right (west) is impeded by the presence of a fence covered with leaves and of a bush.

Ensure that the stop bar is located four feet from the edge of the road to maximize corner sight distance and that it is visible and refreshed on a yearly basis as needed.

Provide a clear sight triangle by removing any obstructions that are located inside the boundaries of the triangle.

Note, Intersection Sight Distance (ISD) for 25 mph is 280 ft, for 30 mph, 335 feet and 390 ft for 35 mph as per AAHSTO.

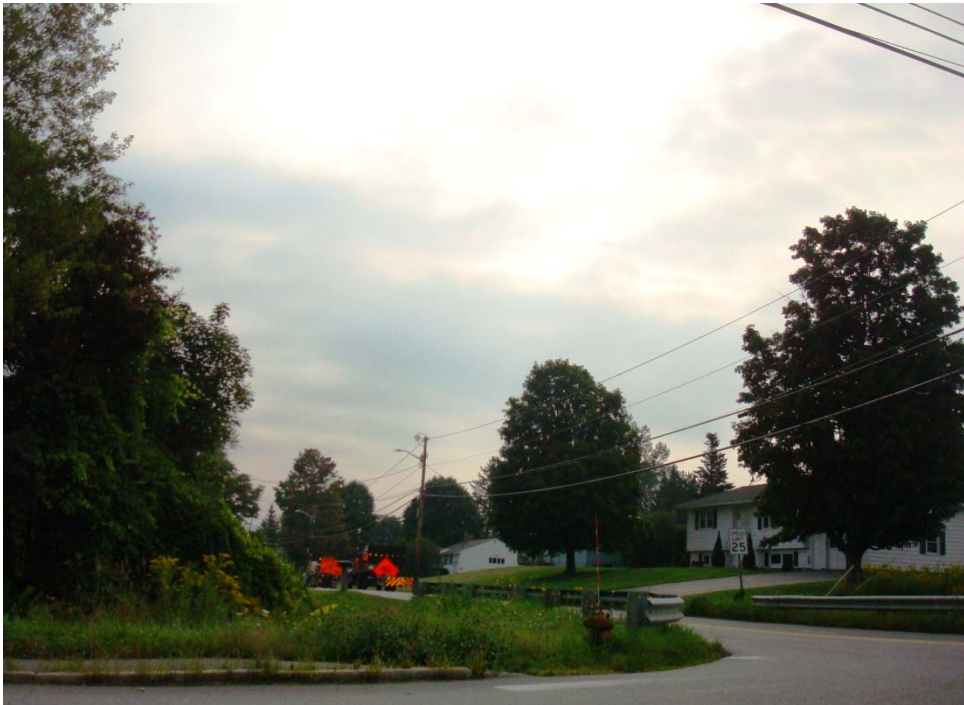
Concern: Corner Sight Distance Issue, Northeast Quadrant

The corner sight distance when stopped on Berlin Street and looking to the left (east) is impeded by the presence of trees and brush.

Provide a clear sight triangle (as explained previously) by removing any obstructions that are located inside the boundaries of the triangle.

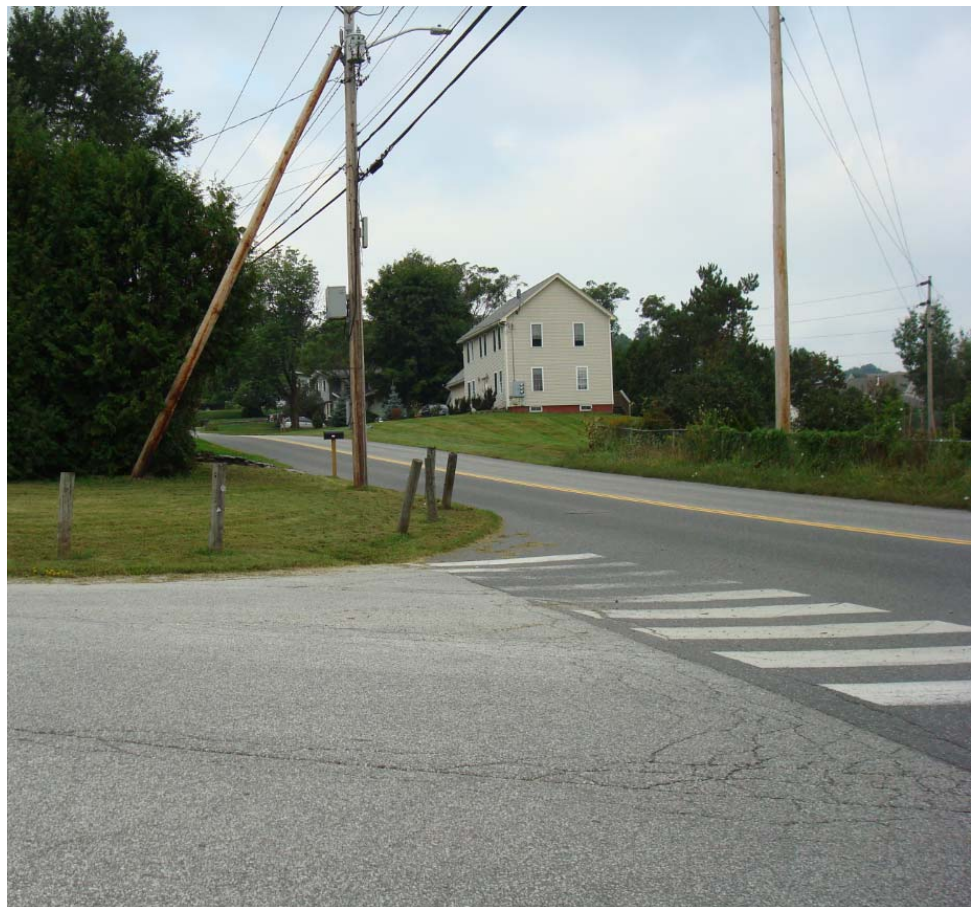
Concern: Corner Sight Distance Issue, Southwest Quadrant

The corner sight distance when stopped on Westwood Parkway and looking to the left (west) is possibly impeded by the presence of brush.

Ensure that the stop bar is located four feet from the edge of the road to maximize corner sight distance and that it is visible and refreshed on a yearly basis as needed (see previous layout diagram).

Provide a clear sight triangle (as explained previously) by removing any obstructions that are located inside the boundaries of the triangle.

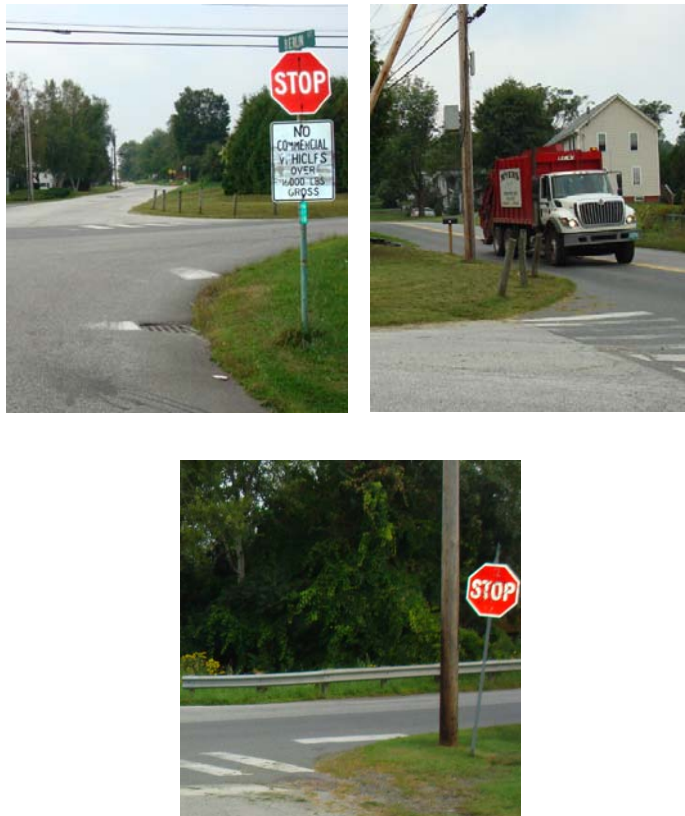
Concern: Issue with Crosswalks that Corner Sight Distance Issue, Southwest Quadrant

With the exception of one terminal, the painted crosswalks at this intersection do not connect to a safe landing.

As per VTrans guidance, it is an unsafe practice to install crosswalks in the absence of sidewalks unless adequate shoulders exist for use by pedestrians¹.

Remove the crosswalks.
