Town:	Saint Johnsbury	Date Reviewed:	Sept 18, 2018
Route:	US 2 and VT 18 Intersection	Mile points:	VT 18 MM 0.18-0.26 (Int 0.26), US 2 MM 6.47-6.63 (Int 6.55)

RSAR Process

The location of this RSAR is the intersection of US 2 and VT 18 in Saint Johnsbury and its approaches.

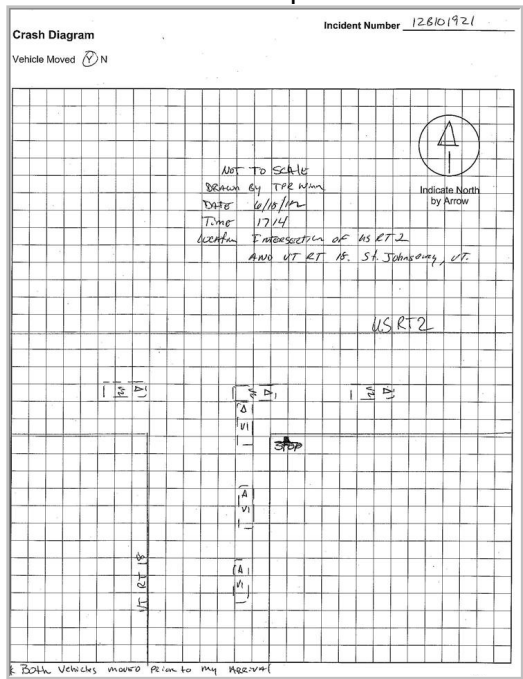
12B101921 1

Two vehicle crash on US Rt. 2, near the intersection of VT. Rt. 18. There were no reported injuries.

Conclusion: The primary cause of this crash is Operator 1 failed to stop at a posted stop sign. A contributing factor to this crash was driver inattention.

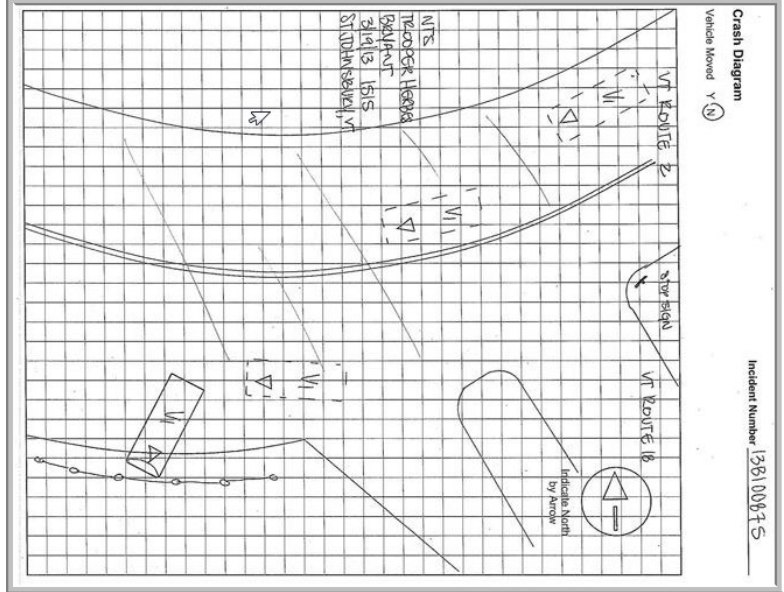
13B100875 2

Single motor vehicle accident on US Route 2 near the intersection of Vermont Route 18. The speed limit in this section is 50 mph. The roadway was snow covered.

CONCLUSION: Officer's conclusion is that the cause of this accident was due to a violation of Title 23 VSA 1031, driving to the right. A contributing factor was the snow on the roadway.

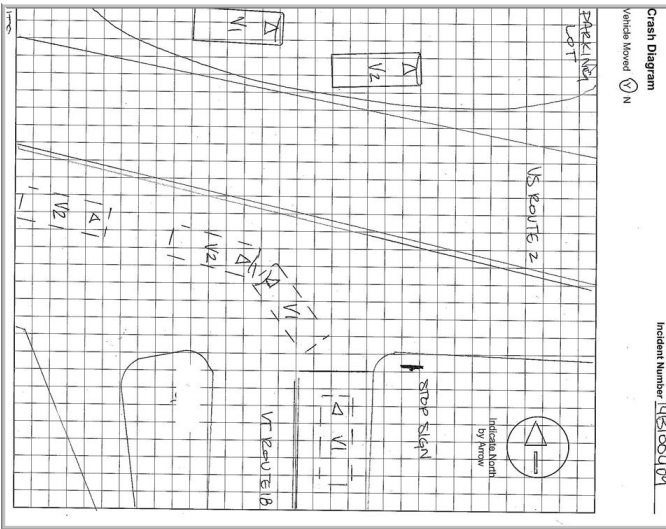
14B100409 3

Crash involving a collision of two motor vehicles in transport. US Route 2 is a blacktop covered surface road and the roadway was snow covered.

CONCLUSION: The cause of this accident was due to the inattention of Operator 1. A contributing factor was due to a violation of Title 23 VSA 1047, vehicle turning left.

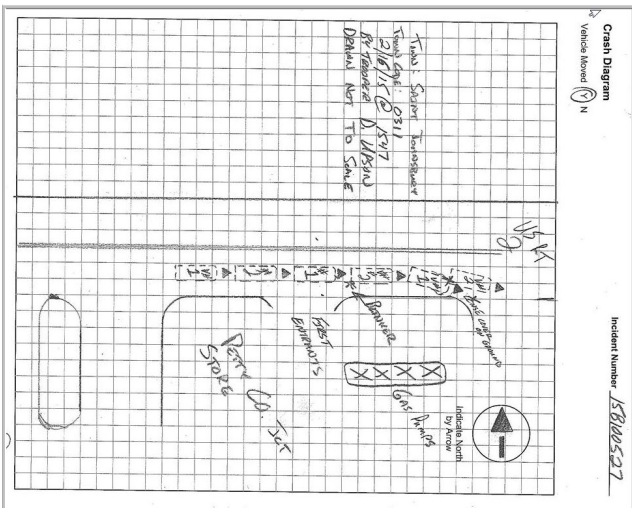
15B100527 4

Two vehicle crash near 12 US Route 2 in Saint Johnsbury. The roadway at the location of the crash is straight. The surface of the road is asphalt and at the time of the crash was clear. The weather at the time of the crash was clear and cold.

Conclusions: Op 1 failed to observe Vehicle #2 turn signal and change of speed which caused a rear end collision. A contributing factor was the afternoon sun casting a significant glare on vehicle #2's rear turn signal lens.

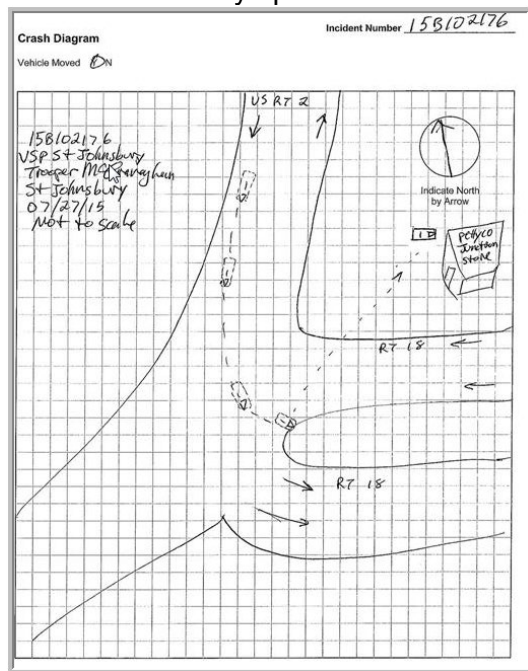
15B102176 5

Single vehicle (motorcycle) crash occurred at the intersection of RT 2 and RT 18 in the town of St Johnsbury. There was very minimal damage to the motorcycle (scraped peg) and no property damage.

Conclusion: In my opinion the cause of the crash was the Operator inexperience with the motorcycle.

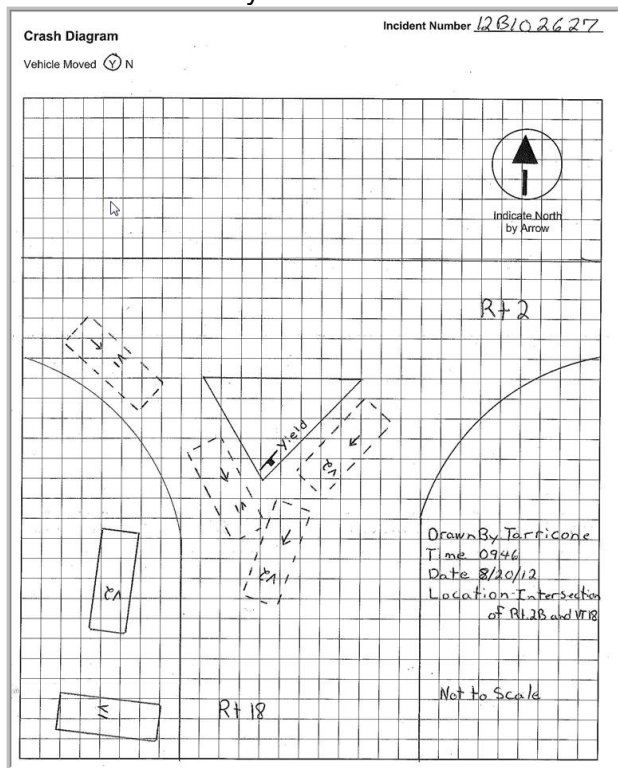
12B102627 7

Two vehicle crash resulting in damage at the intersection of Rt. 2 and VT 18 in St Johnsbury VT.

Conclusion: The primary cause of the crash was Op 1's failure to yield at the yield sign. Op 1 was issued a ticket for failure to yield.

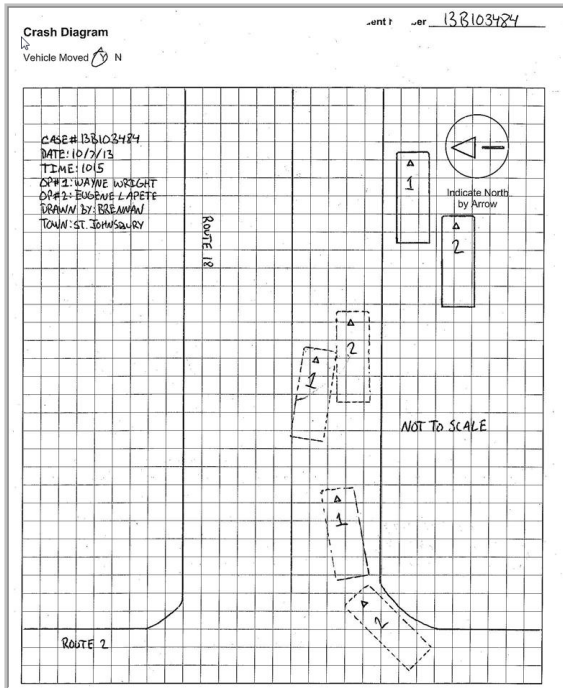
13B103484 8

Two vehicle crash on Route 18 in the town of St. Johnsbury. The roadway was dry. The posted speed limit on Route 18 in this area is 50 mph. It was cloudy outside and the temperature was approximately 50 degrees.

Conclusion: The primary cause of the crash was the Op 1 failing to maintain his proper lane. This is a violation of Title 23 Vermont Statutes Annotated 1038(a).

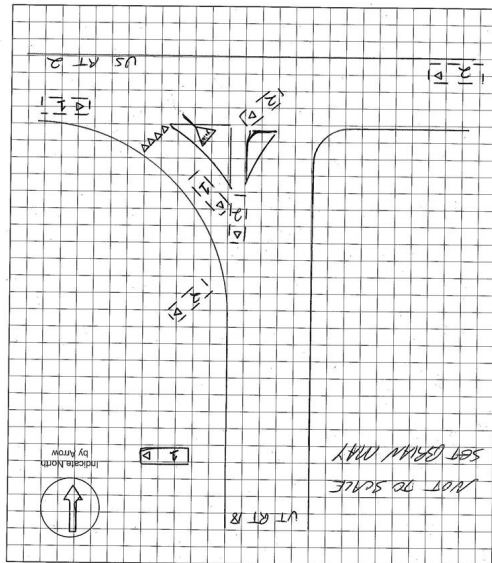
13B104475 9

Two-vehicle crash that occurred at the intersection of VT Route 18 and US Route 2 in the Town of St. Johnsbury. The roadway was wet and partially covered with snow and slush.

CONCLUSION: The cause of this crash was Op 1 failing to yield to Veh 2 in violation of 23VSA1048(c).

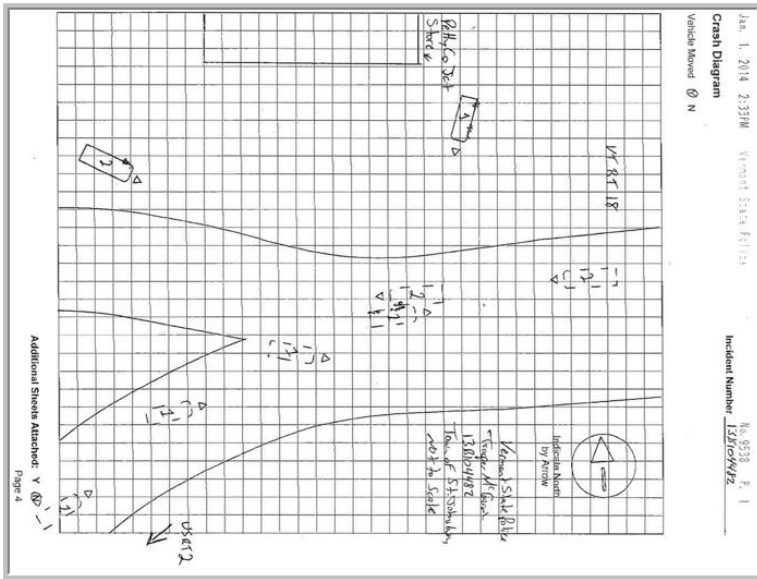
13B104482 10

Two vehicle crash occurred on VT RT. 18 in the Town of St. Johnsbury, VT. No injuries were reported.

The primary cause of this crash is Operator 1 was traveling too fast for road conditions. A contributing factor is the roadway was icy at the time.

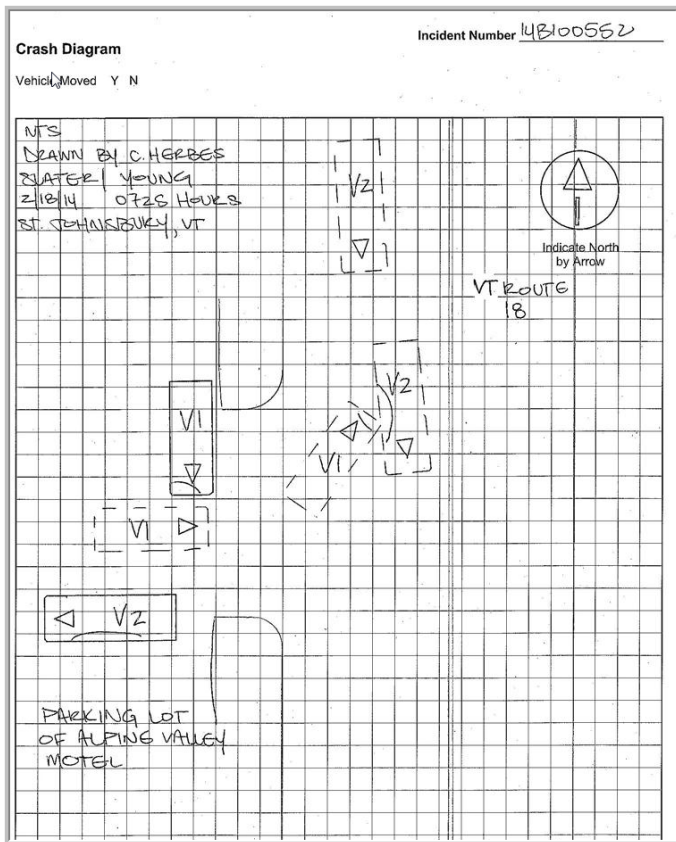
14B100552 11

Two motor vehicles in transport. On VT Route 18 near the intersection of US Route 2. The roadway was dry.

CONCLUSION: Officer concluded that the cause of this accident is due to the inattention of Operator 1. A contributing factor was a violation of Title 23 VSA 1049, vehicle entering from a private road.

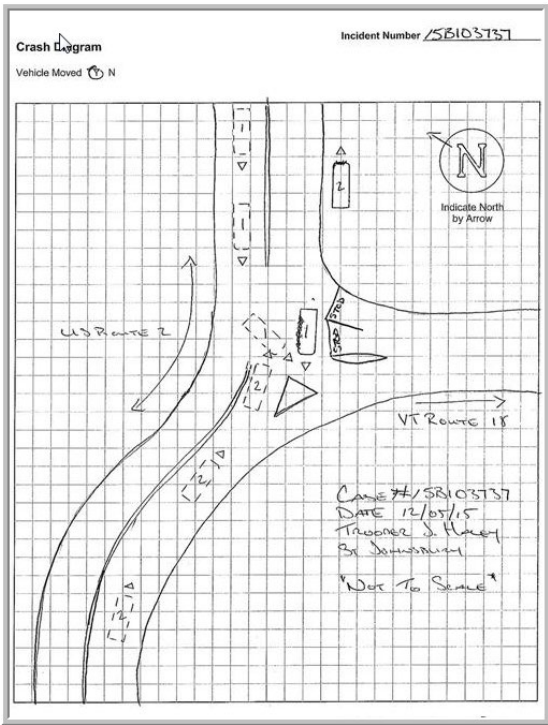
15B103737 12

Two-vehicle crash on US Route 2 at the intersection of VT Route 18 in the Town of St. Johnsbury, VT. Both operators advised they were wearing their seat belts and were not injured.

CONCLUSION: Based on the statement of both operators and the observations made, Officer's opinion that this collision occurred as a result of Operator #1 failing to yield turning left, a violation of Title 23, VSA 1047. Op 1 was issued a written warning for failure to yield left turn, which is a violation of Title 23 VSA 1047.

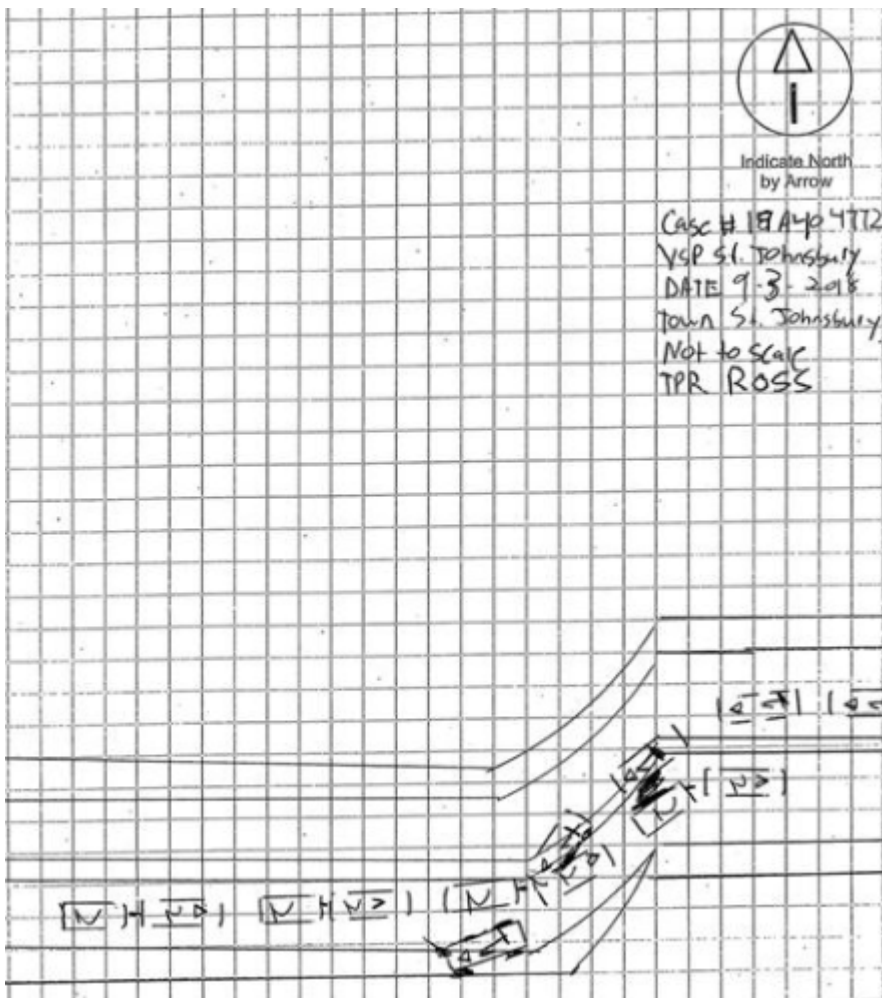
18A404772 18

On 9/3/2018, at approximately 2016 hours, a single vehicle crashed into the guardrail on the south side of U.S route 2. Op 1 had hit another vehicle before crashing into the guardrail.

Upon investigation, officer observed vehicle 1 to be at a position of uncontrolled rest against the guardrail on the south side of U.S route 2. Vehicle 1 was facing east in the westbound lane of travel.
