Office of Highway Safety

Road Safety Audit Review

Town:	St George	Date Reviewed:	November 2, 2016
Route:	VT 116 and VT 2a intersection	Mile points:	VT 116 MM 0.27-0.37 VT 2a MM 0.00 – 0.04

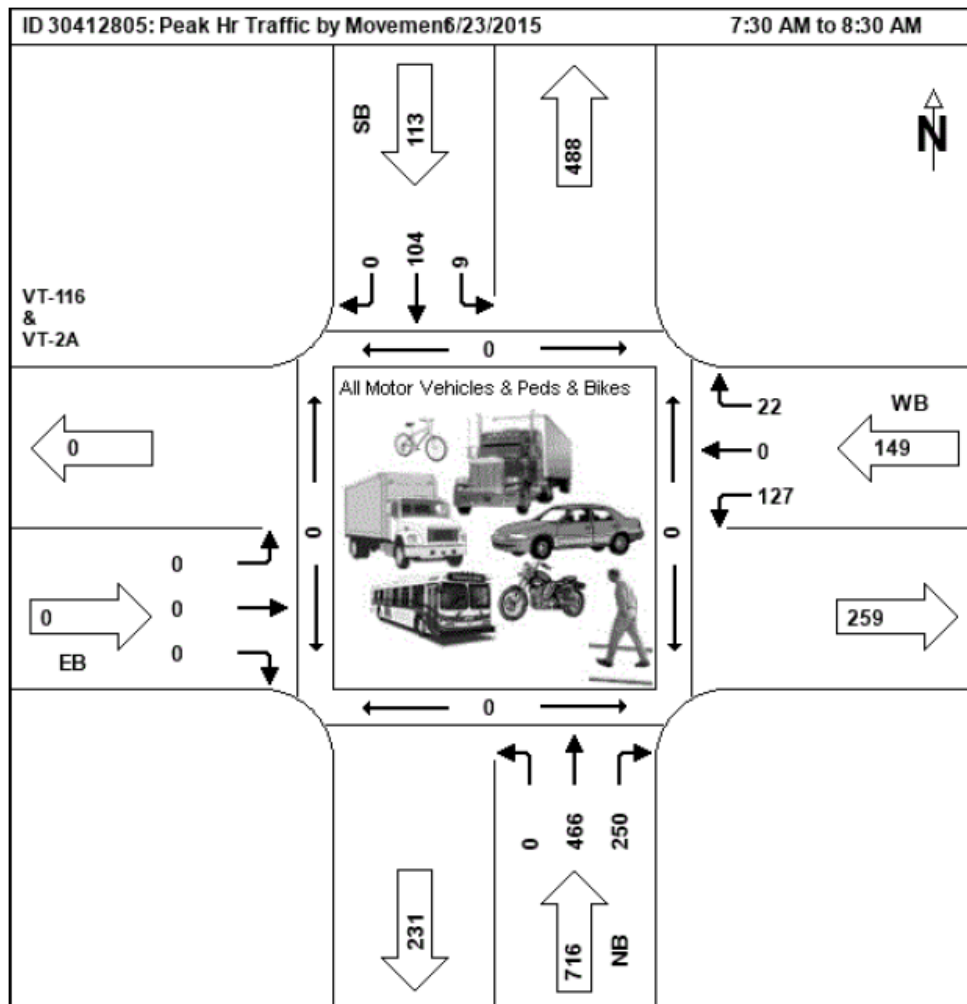
These two charts show that the main movements are the same in either peak hour period but that the movements have slightly different proportions.

During the morning peak hour, ninety-two percent of the traffic that is traveling south on VT 116 is continuing south. Northbound, sixty-five percent of the traffic is continuing north while thirty-five percent is turning right onto VT 2a. From VT 2A, eighty-five percent of the traffic is making a left turn while fifteen percent is making a right turn.

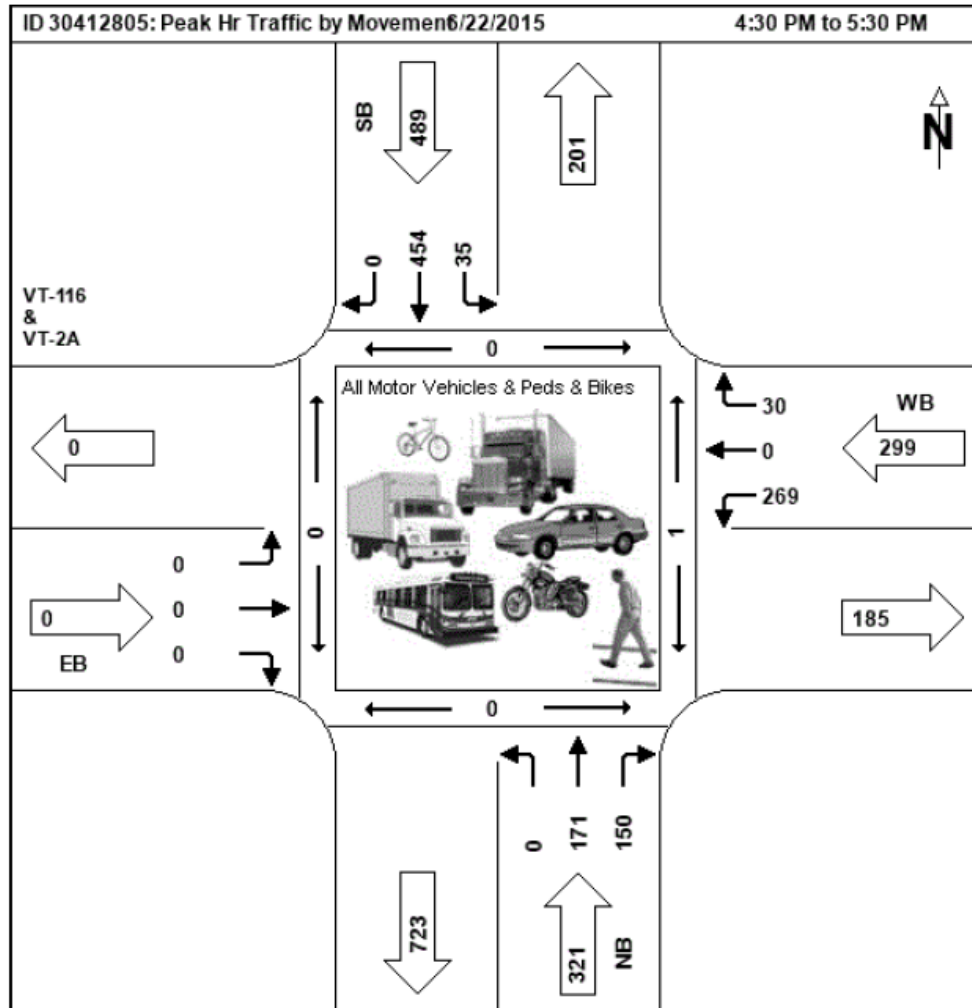
During the afternoon peak hour, ninety-two percent of the southbound traffic on VT 116 is continuing south past the intersection, while ninety-percent of the motorists on VT 2a are making a left turn onto VT 116. From the south approach, fifty-three percent of the traffic is continuing straight while forty-seven percent is turning right onto VT 2a.

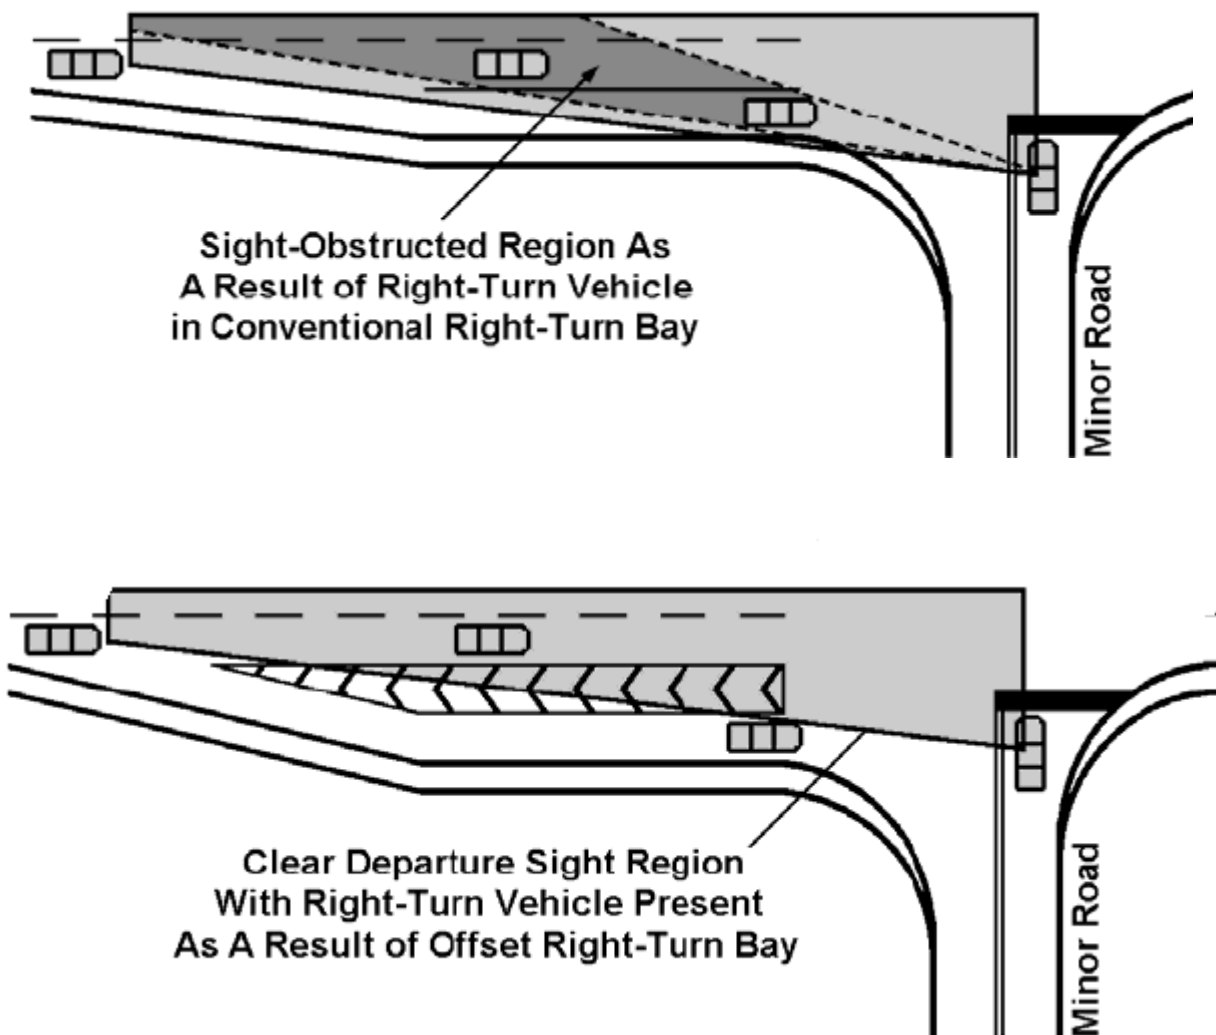
Concern: Limited Sight Distance of On-Coming Traffic due to Vehicles in the Right Turn Lane.

Vehicles that are traveling northbound on VT 116 in the right turn lane are blocking the view of northbound through traffic for motorists on VT 2a that are making a left turn onto VT 116 southbound.

Convert the existing right turn lane to an offset right turn lane.

An offset right turn lane is a right turn lane that is constructed outside of the intersection sight distance triangle for minor road traffic. This concept is illustrated in the figure¹ below. The top intersection shows a conventional right turn lane and how the right turning car prevents the motorist on the minor road to see the through vehicle on the main road. The second intersection shows an offset right turn lane and how its design provides the motorist on the minor road a clear view of the oncoming through vehicle.

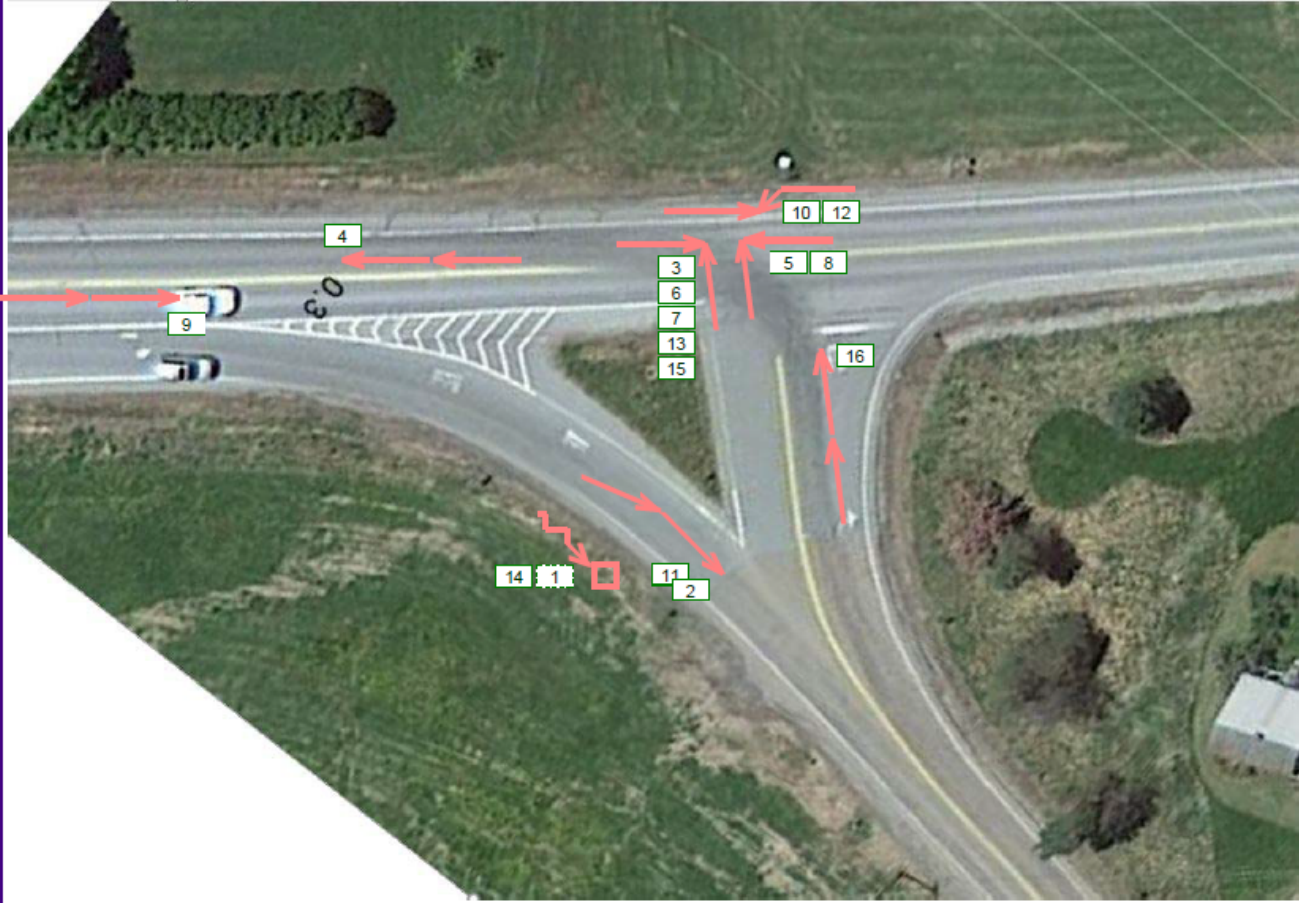
COLLISION DIAGRAM

The principal crash pattern at this intersection is a right angle crash. This crash pattern represents forty-four percent of the crashes at this intersection (7 out of 16 crashes). Of these seven right angle crashes, seventy-one percent involved a vehicle that is traveling northbound on VT 116 and a vehicle that is making a left turn south onto VT 116.

The second crash pattern of importance at this intersection is rear-end crashes. There is not a specific approach where these rear-end crashes are happening (4 out of 16 crashes or 27%).
