# Office of Highway Safety

## Road Safety Audit Review

<b>Town:</b>	Colchester	<b>Date Reviewed:</b>	July 13, 2015
<b>Route:</b>	US 2 at Exit 17 Ramp	<b>Mile points:</b>	US 2: 1.86-2.11

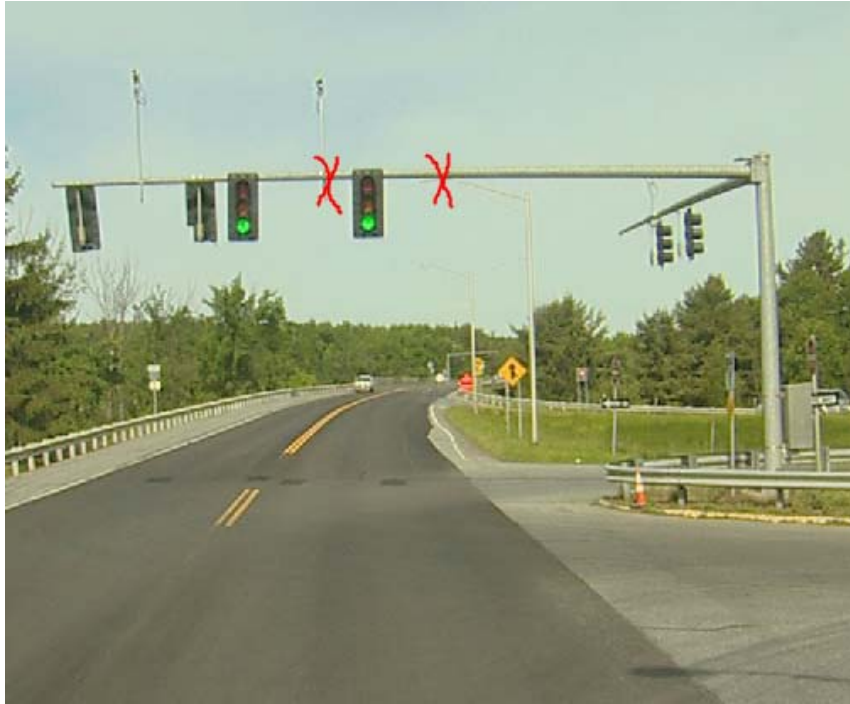
Concern: Issue with Right Angle Crashes at Southbound and Northbound Off Ramp

Right angle crashes between a vehicle coming off the southbound or the northbound ramps and a westbound vehicle on US 2 represent an important crash pattern. These crashes are caused by the US 2 vehicle running the red light. Being distracted or not aware of the signal indications is the reason that was cited the most by the drivers at fault in the crash reports. Intentionally running the red light was also cited but to a much lesser degree.

At the northbound ramp intersection, adjust the placement of the signal heads so that the two signal heads for westbound traffic are better centered over the through westbound lane (red Xs on the picture below).
