# Office of Highway Safety

## Road Safety Audit Review

<b>Town:</b>	Hartford	<b>Date Reviewed:</b>	October 5, 2016
<b>Route:</b>	US 5 US 4 South Intersection	<b>Mile points:</b>	US-5 MM 3.49-3.66 US-4 MM 9.29-9.35

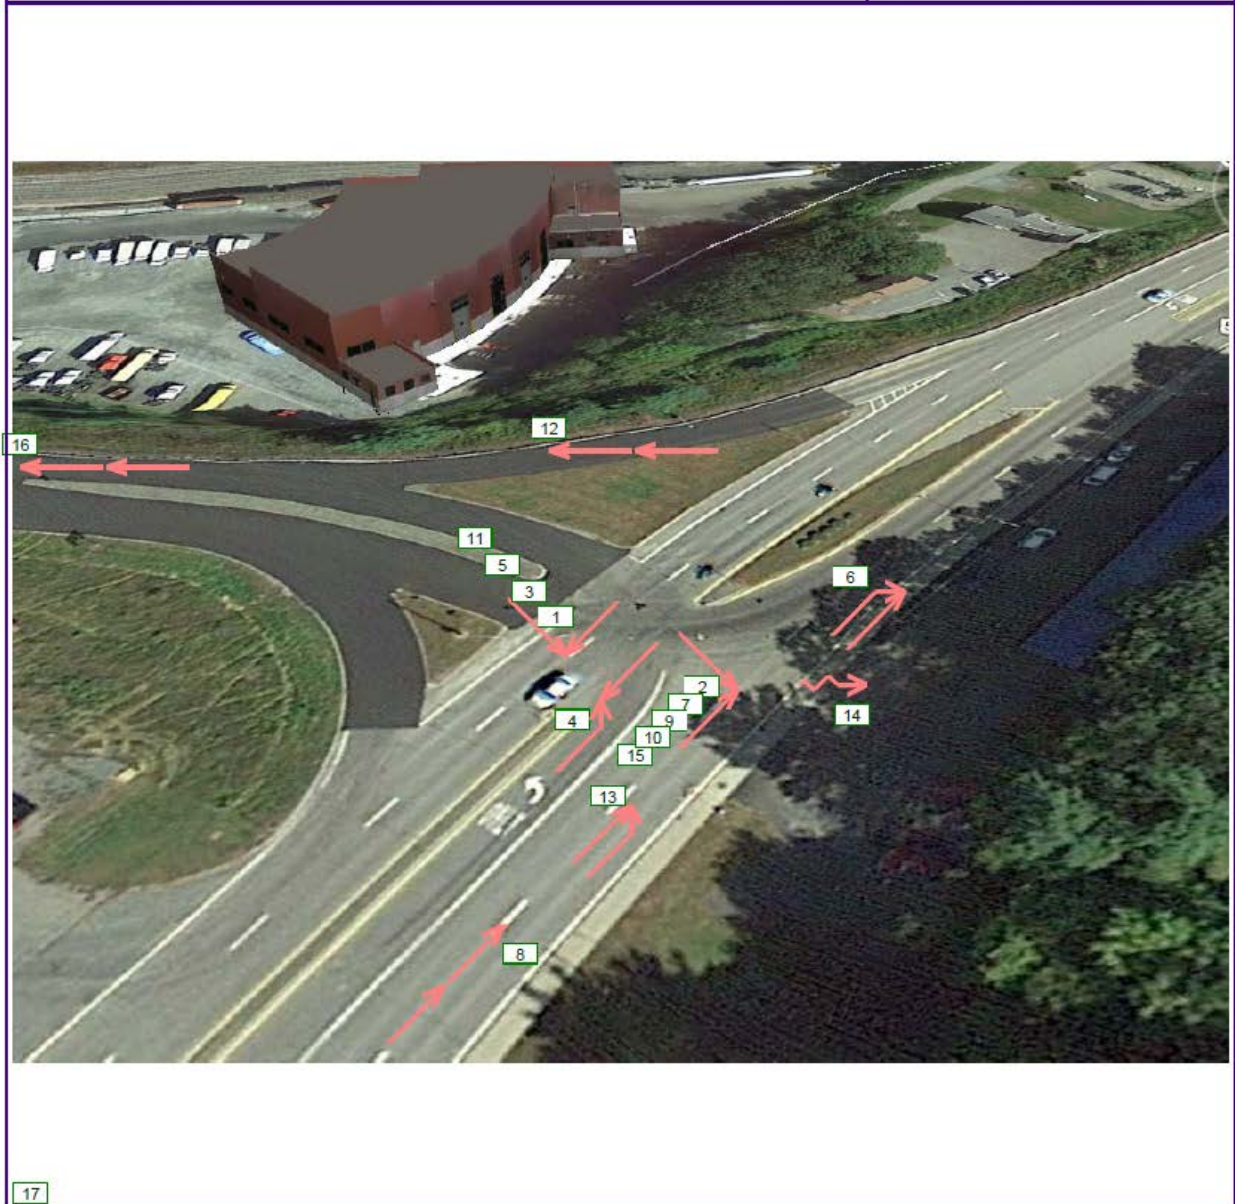
# COLLISION DIAGRAM

The crash history was reviewed at the intersection for the five-year period covering the years 2011 to 2015. A total of sixteen crashes occurred at this intersection during this period. Summary of crash narratives are provided at the end of this report along with a collision diagram.

Of these sixteen crashes, eleven of them were property damage only crashes (69%), two were non-incapacitating injury crashes (13%) and three were possible injury crashes (19%).

There is a clear crash pattern at this intersection. Left turn crashes off US 4 represents fifty-six percent of all the crashes at this intersection. For this crash pattern, sixty-six percent involved a US 4 vehicle that collided with a northbound US 5 vehicle and forty-four percent involved a US 4 vehicle and a US 5 southbound vehicle.
