Office of Highway Safety

Road Safety Audit Review

Town:	Charlotte	Date Reviewed:	July 13, 2015
Route:	US 7 at Ferry Road & Church Hill Road	Mile points:	US 7: 3.435

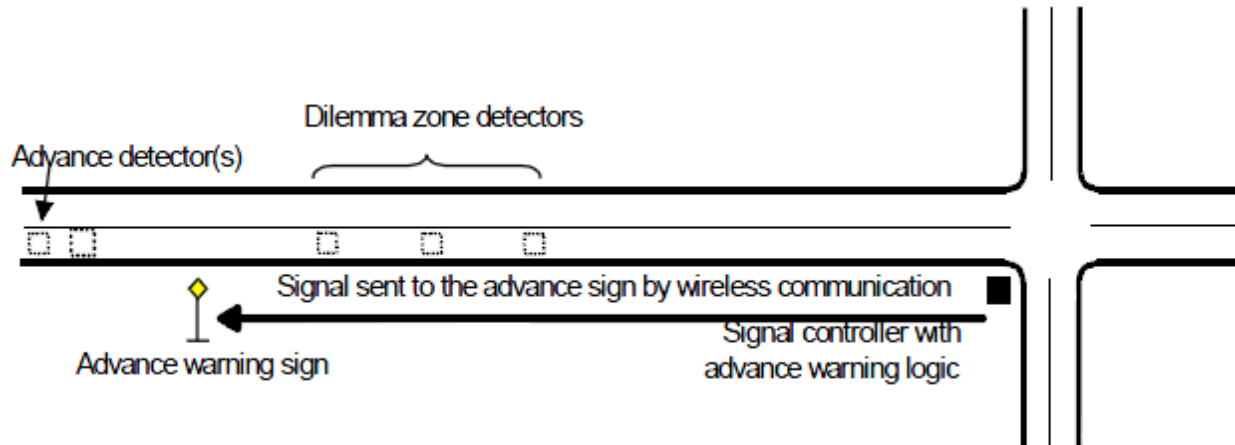
Concern: Northbound Red Light Running & Northbound Rear-End Crashes

The issue of red light running by a northbound vehicle was reported by the Town and observed in the field by the audit team during the site visit.

Northbound rear-end crashes are the principal crash pattern at this intersection.

Install a Be Prepared to Stop Sign and beacon (downstream from the Signal Ahead sign) that would warn motorists of the upcoming end of green phase (as illustrated below).

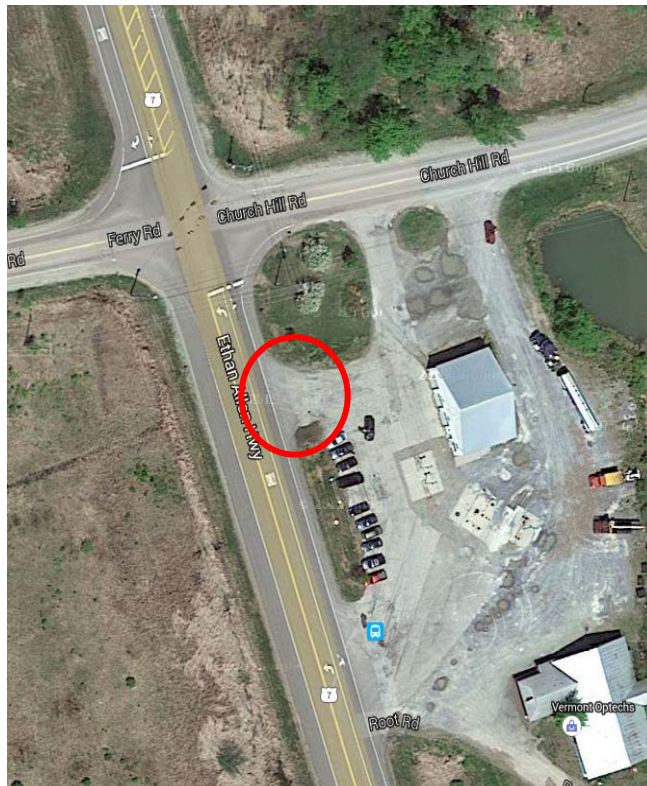
Concern: Potential Safety Issue with Access in Close Proximity to the Intersection

There are two accesses in close proximity to the intersection and that interfere with the US 7 south approach.

Eliminate the access on US 7 that is closer to the intersection.
