Office of Highway Safety

Road Safety Audit Review

Town:	Londonderry	Date Reviewed:	October 8, 2015
Route:	VT 100, Middletown Rd and Main St	Mile points:	Area of mm 2.99

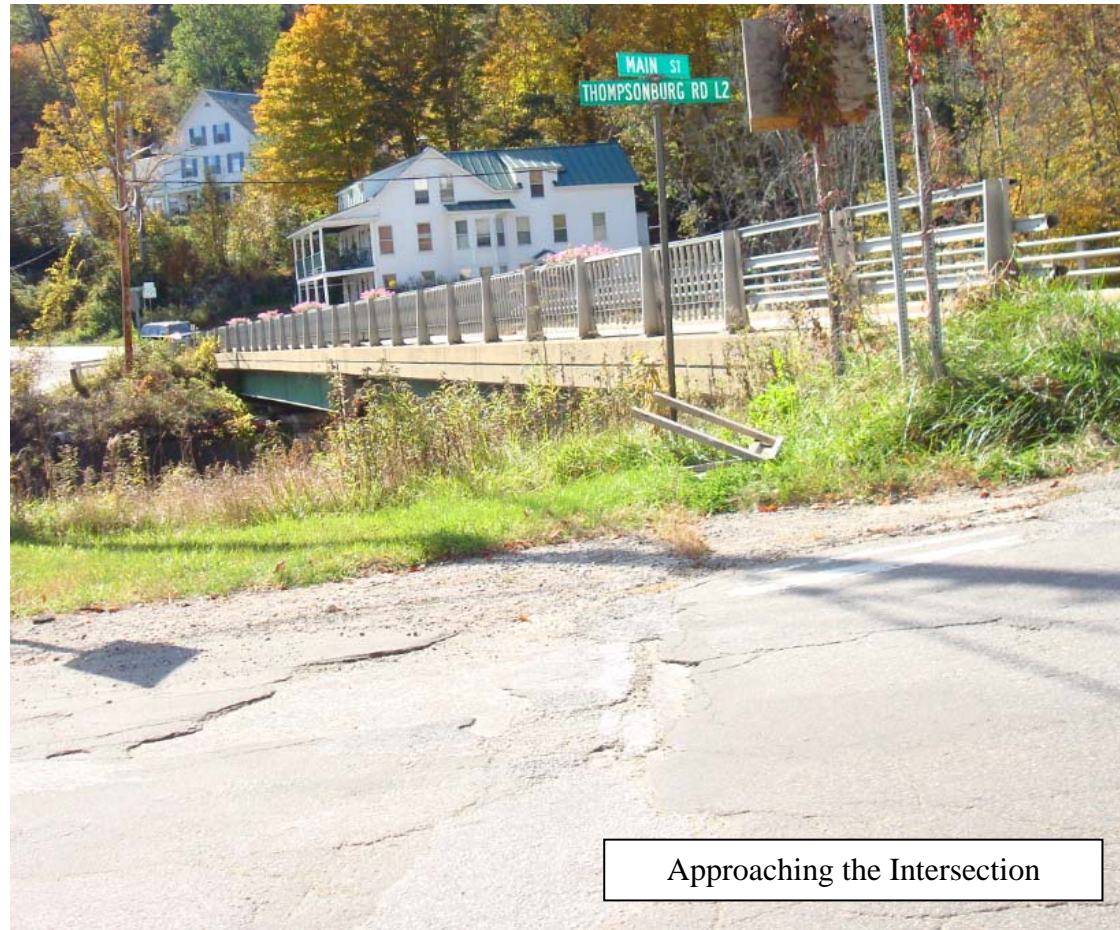
Approaching the Intersection

There is poor corner sight distance when stopped on the Main St approach and looking towards the VT 100 northbound approach (i.e., when looking to the left).

This poor condition is mainly caused by the presence of the bridge railing. Due to its design, it is very difficult to see oncoming traffic through it as one approaches the intersection.

It is questionable whether the presence of the flower boxes contributes to the limited visibility and if it is possible to see the top of a small car without them being there.

Brush in this quadrant including the vine that is growing up the sign posts is also somewhat distracting.

To improve the positioning of vehicles when they stop on the Main St approach so that visibility to oncoming traffic is improved, a stop bar and the "STOP" word markings should be installed (The proper location for a stop bar is typically four feet from the edge of the road). In addition, the yellow center line should be extended up to the stop bar.

Brush in this quadrant should be trimmed.

Should the flower boxes be removed (or lowered so the top is flush with the bridge rail)?

Evaluate the possibility of designing and installing a new railing that would be less compact.

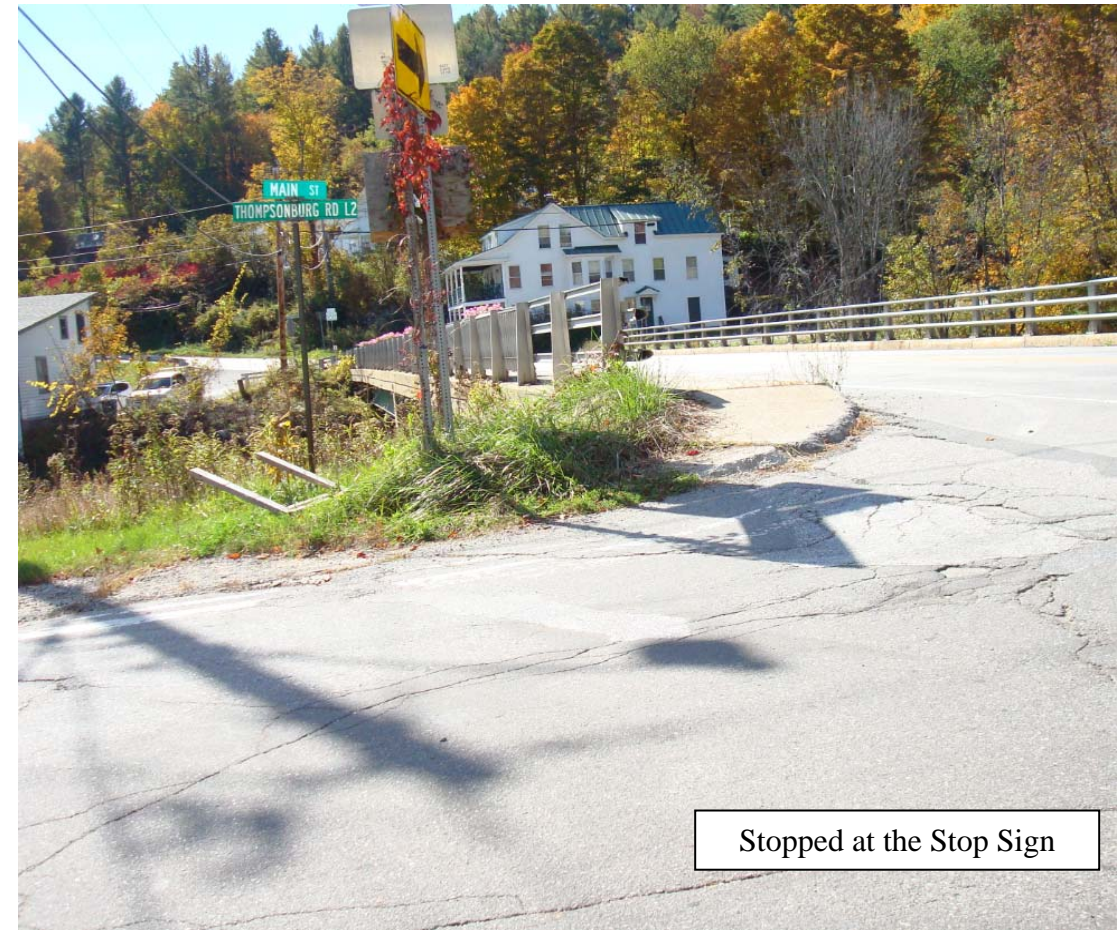
Stopped at the Stop Sign

It is also difficult to see oncoming traffic when stopped at the stop sign. It is only when the nose of the vehicle is in the road that an operator can start seeing traffic.

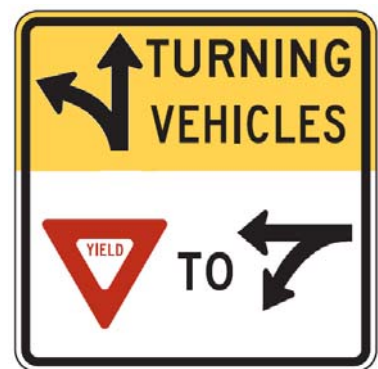
Some operators who are traveling southbound on VT 100 with the intention of continuing on Main Street are not yielding to traffic that is coming from VT 100 northbound (i.e., traffic that is coming from the right).

Yet, another alternative could be to create a sign with the similar concept than MUTCD sign R10-15. For example, a design such as the one shown at the right could be explored. This sign would also be installed following the modified turn sign.
