Office of Highway Safety
Road Safety Audit Review

Town:	Stowe	Date Reviewed:	October 27, 2016
Route:	VT 100 and Stagecoach Intersection	Mile points:	VT 100: 5.066 (5.02-5.12) Stagecoach: 0.00 -0.05

The location of this RSAR is the intersection of VT 100 and Stagecoach Road (MC0237) in Stowe.

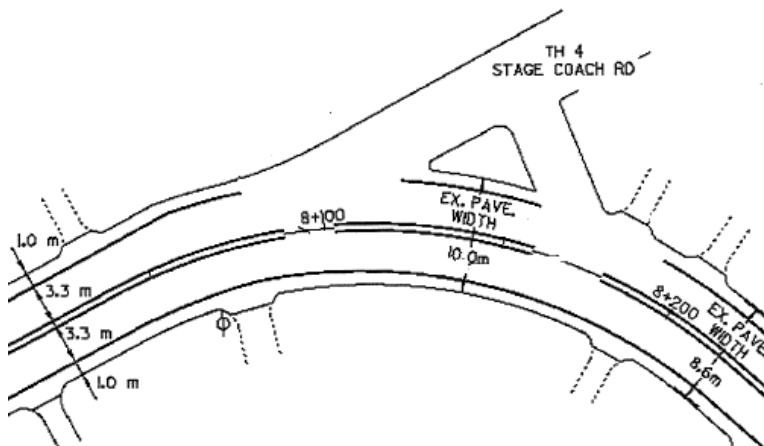
The northern branch of Stagecoach Road meets VT 100 at pretty much a 90-degree angle. It is mostly used by motorists who are turning left to travel north on VT 100 and by motorists who are making a right turn to travel north on Stagecoach Road.

The southern branch of Stagecoach Road intersects VT 100 at a 30-degree angle. It is used by those motorists who are traveling south on Stagecoach Road to continue south on VT 100 and by motorists who are traveling north on VT 100 and who are continuing north on Stagecoach Road.

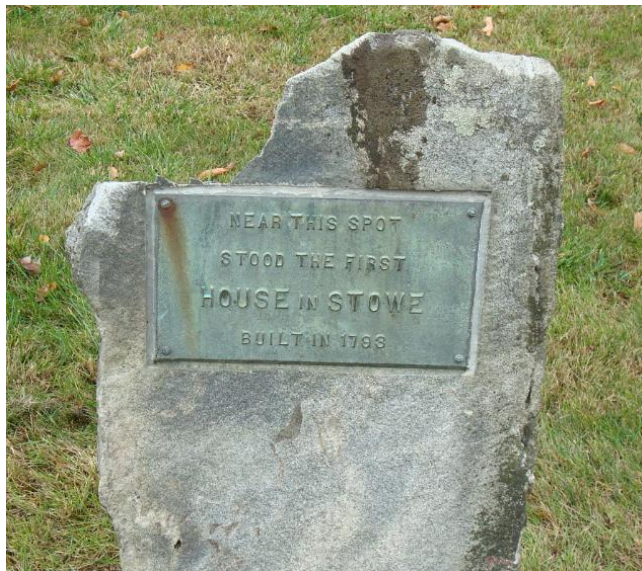
There is a historic marker within the grass island to indicate that the first house in Stowe was built near this spot (According to the Town, the marker is not at the exact location where the first house was built and this marker could be relocated within the area).

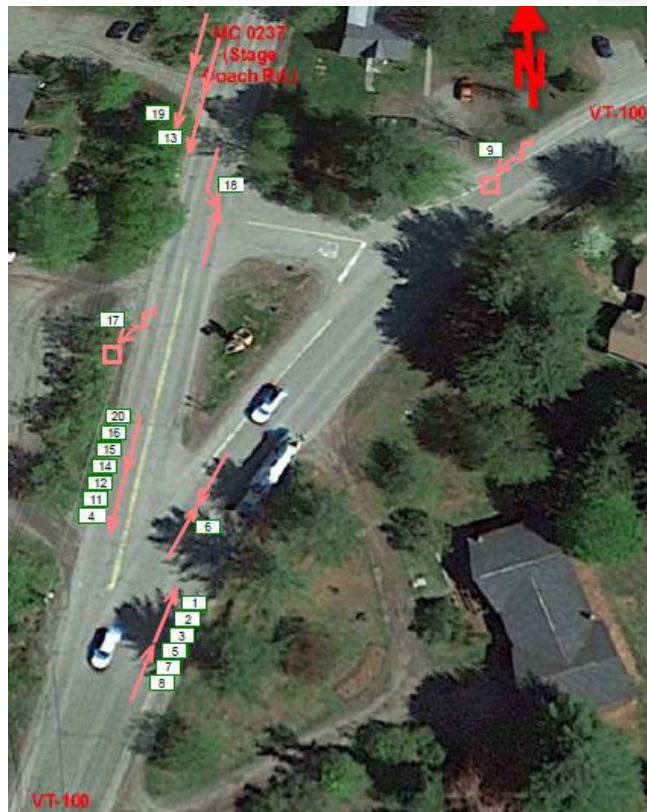
The first are southbound rear-end crashes on Stagecoach Road at the entry point with VT 100. This pattern represents 35% of all the crashes at this intersection. The typical way that these crashes happened was when the vehicle in front started to move but stopped again and the motorist behind did not realize that the vehicle in front had stopped and moved forward into the rear of the vehicle in front.

The second most important crash pattern consists of northbound rear-end crashes involving a vehicle waiting to turn left onto Stagecoach Road. This represent thirty percent of all the crashes at this

intersection. The major reason for these crashes was the motorists at fault having looked away and not being able to stop in time once they realized that the vehicle in front had stopped.
