Road Safety Audit Review

Town:	Arlington	Date Reviewed:	September 21, 2016
Route:	VT 313 Warm Brook Rd Intersection	Mile points:	VT 313: 7.19 Warm Brook: 0.00

The location of this RSAR is the intersection of VT 313 and Warm Brook Road (MC0171) in Arlington.

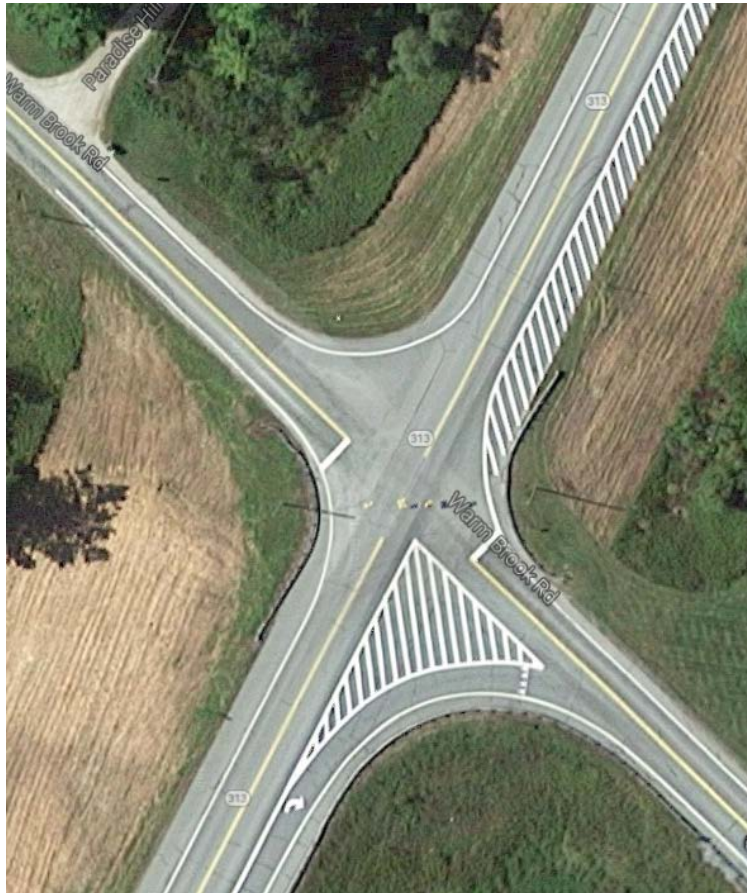
There are extensive crosshatched markings at the intersection and along the westbound north shoulder. This treatment was introduced around the year 2000.

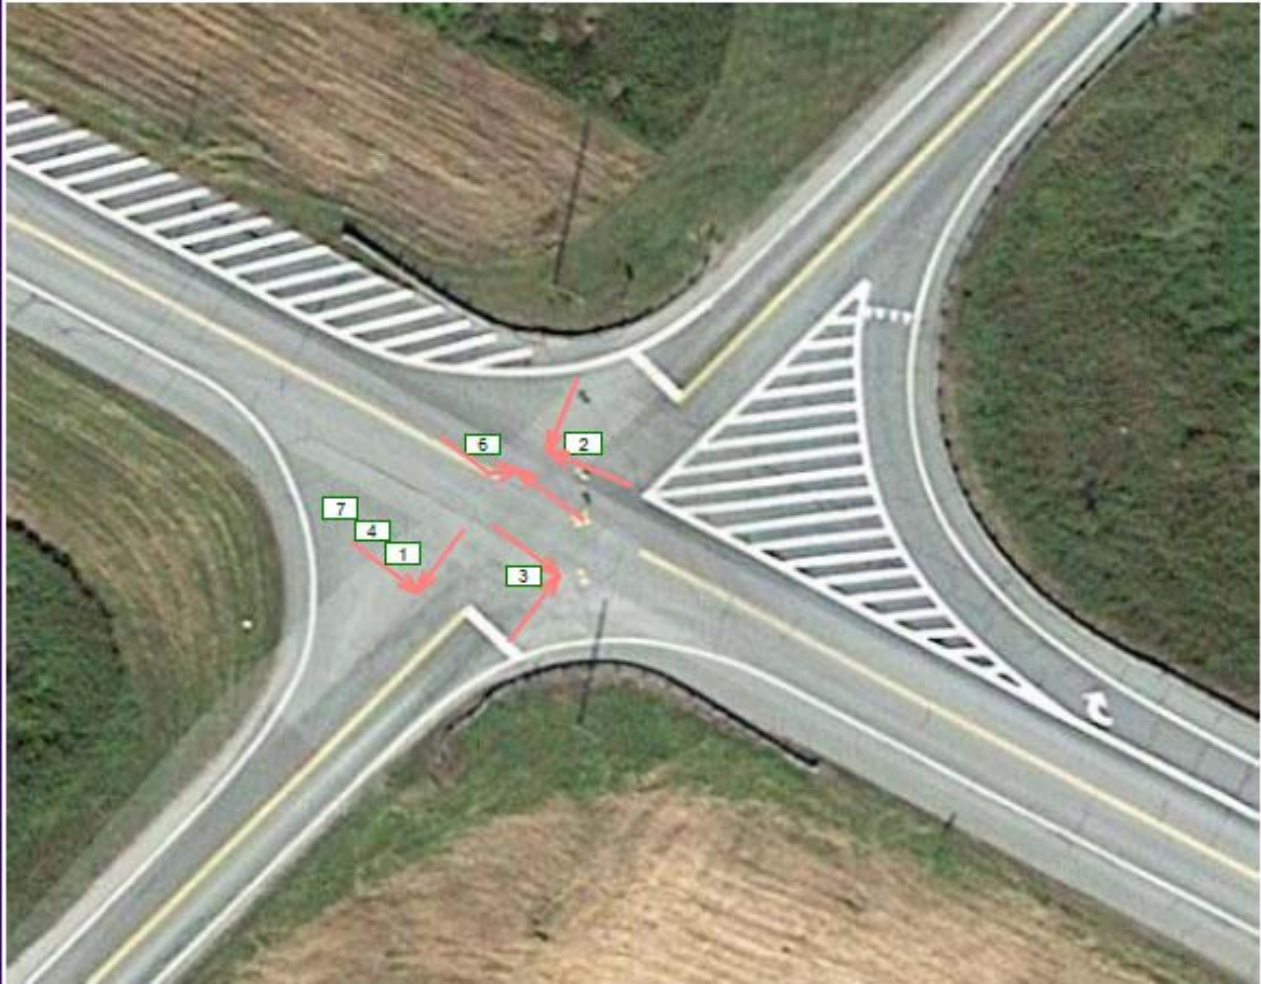
COLLISION DIAGRAM

Overall, the principal crash pattern at this intersection is a right angle crash (86%). The prominent right angle pattern is between a through southbound vehicle and a through eastbound vehicle (43%).

In general, a review of the crash narratives indicates that vehicles that were traveling on VT313 were able to see a stopped vehicle on Warm Brook Road but that the vehicles stopped on Warm Brook Road did not see any oncoming traffic until they pulled out into the intersection.
