Office of Highway Safety

Road Safety Audit Review

Town:	Alburgh	Date Reviewed:	November 2, 2015
Route:	US 2 and VT 78 Intersection	Mile points:	US 2: 6.23, VT 78: 0.0

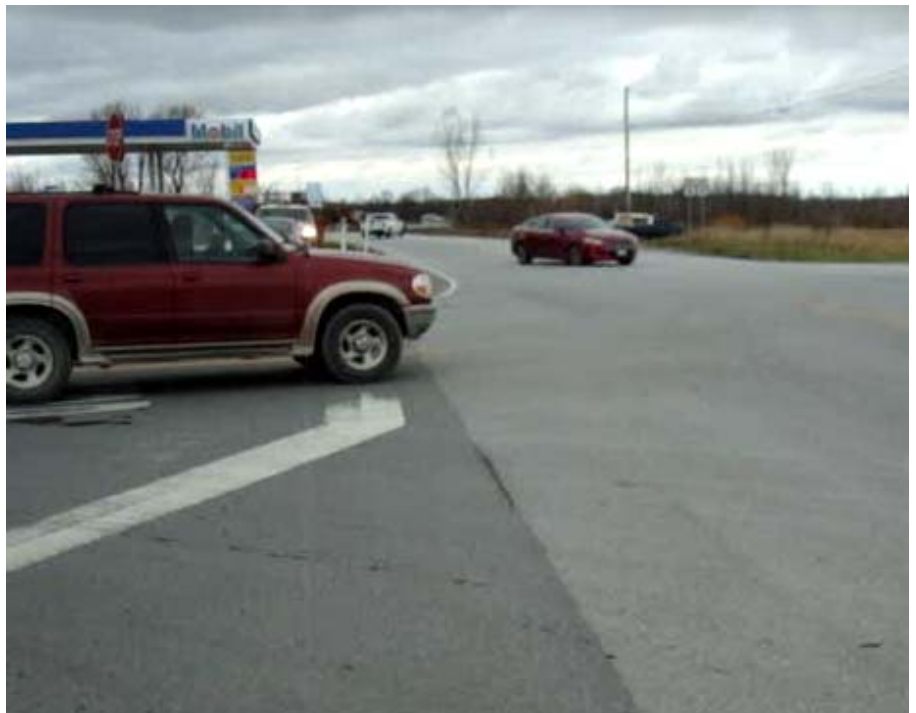
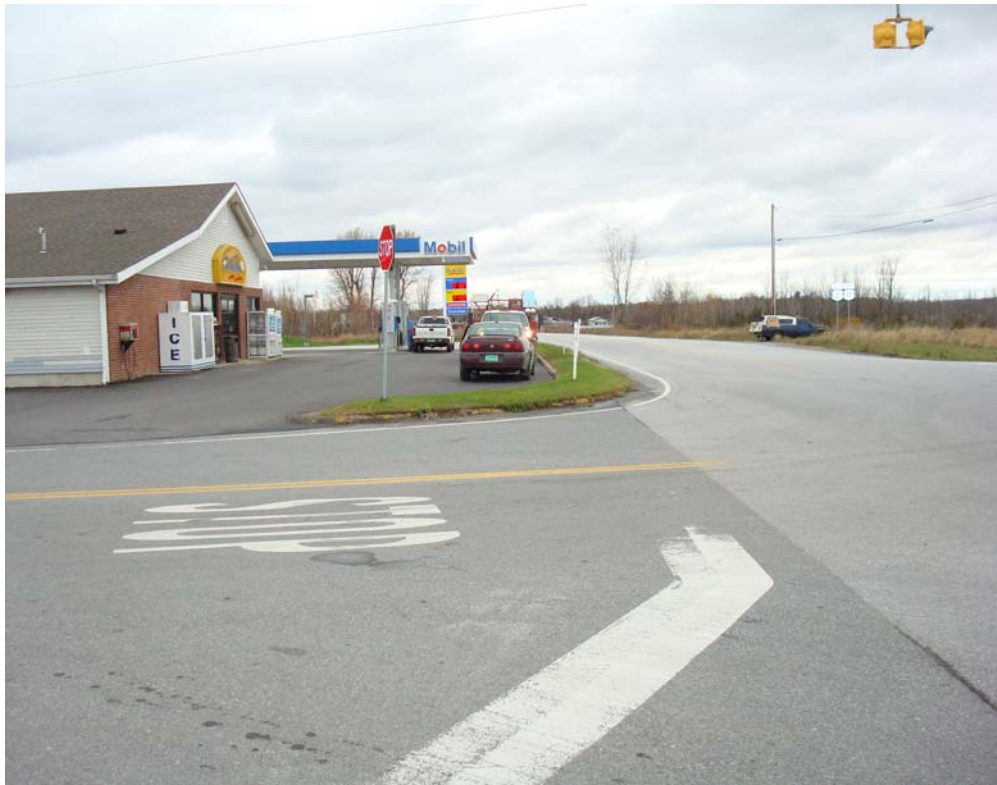
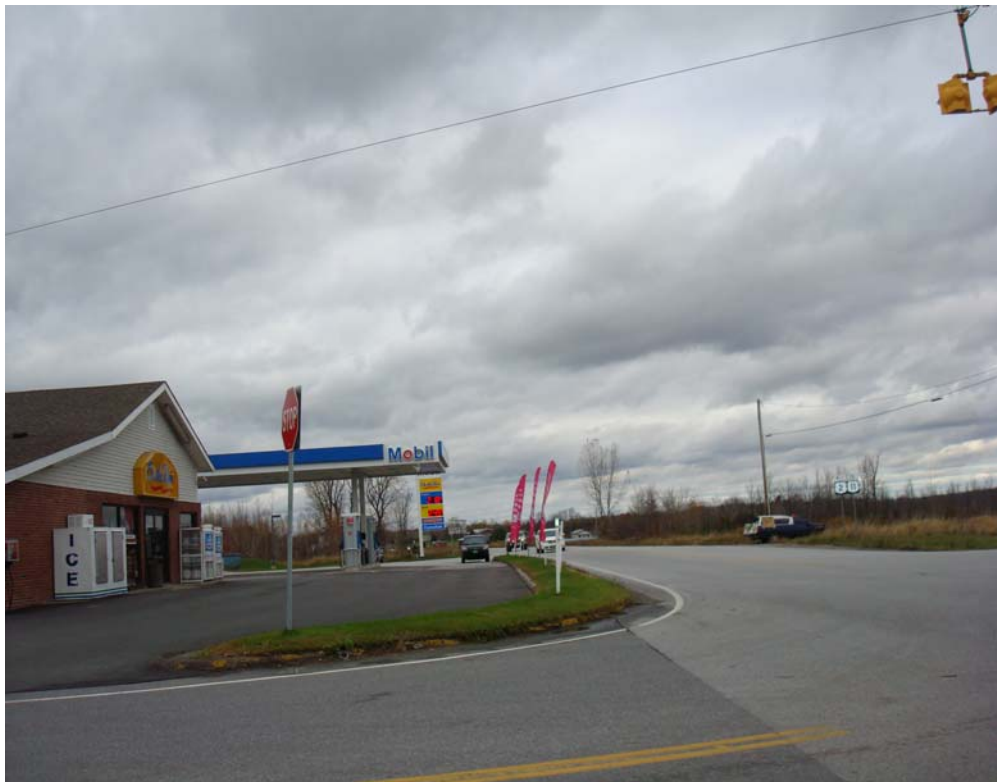
Concern: Corner Sight Distance Issue, Northwest Quadrant

The corner sight distance when stopped on Truck Route Road and looking north, towards US 2 (i.e., when looking to the left) is sometime poor. This is due when vehicles at the gas station are parked between the gas pumps and the raised island. Signage and banners inside of the grass island can also contribute to the visibility issue. These situations are illustrated in the next few pictures.

The district should enforce any signage obstruction located in the right-of-way and especially in the grass island.

Eliminate the possibility of parking vehicles in the sight triangle by enlarging the grass island.

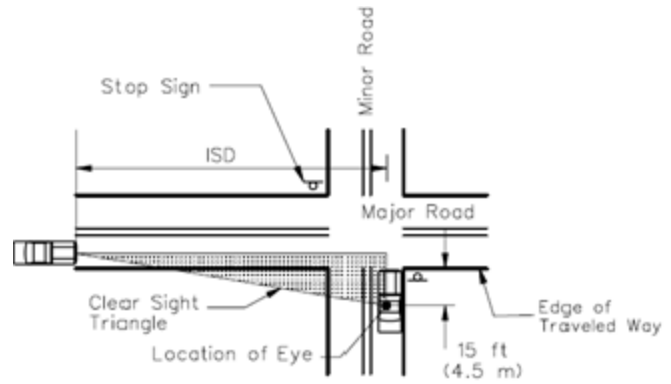
Clear Sight Triangle Concept
(for two-way stop)

Note, Intersection Sight Distance (ISD) on the diagram to the right, for 40 mph, is 445 feet as per AAHSTO.

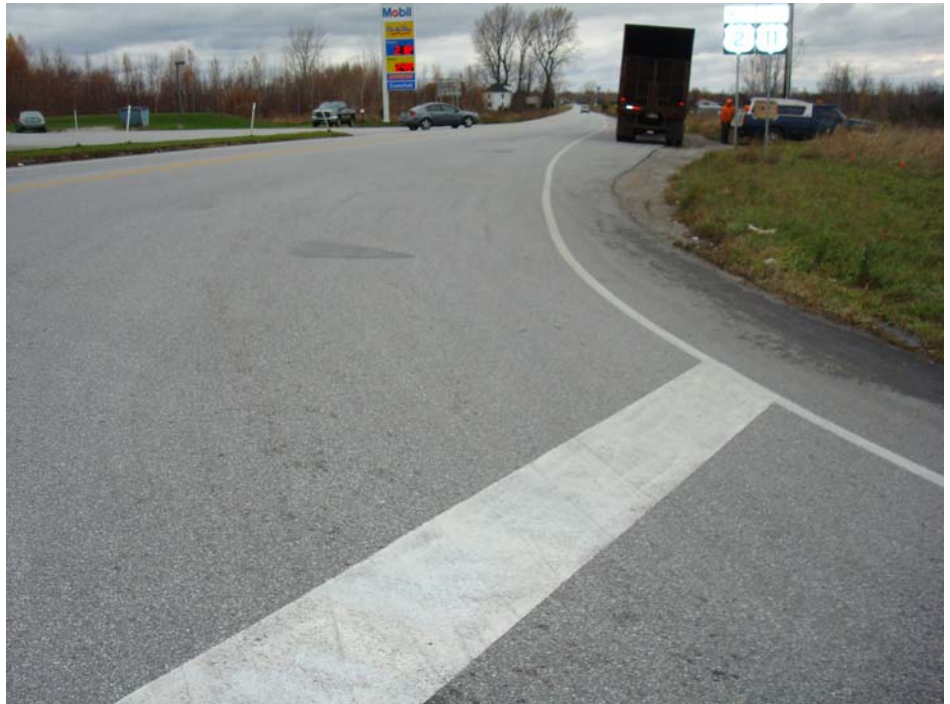
Concern: Potential Corner Sight Distance Issue, Northeast Quadrant

Trucks have been reported to park across the gas station on US 2 in the shoulder. There is also an individual who regularly sells potatoes in the pull off area.

(The picture to the right does not show this as being a problem).

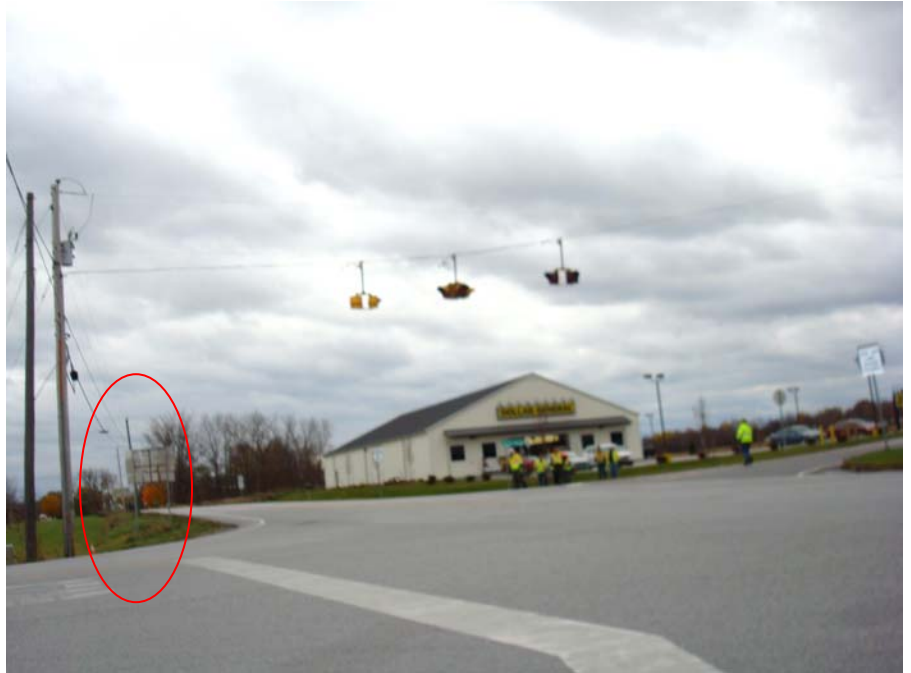
Concern: Potential Corner Sight Distance Issue, Southeast Quadrant

Tall grass during the summer months in this quadrant is reported to reduce the corner sight distance for motorists who are stopped on VT 78 and who are looking to the south (i.e. left towards US 2).

Mow twice a year in this area.
District and Town to work together and coordinate.

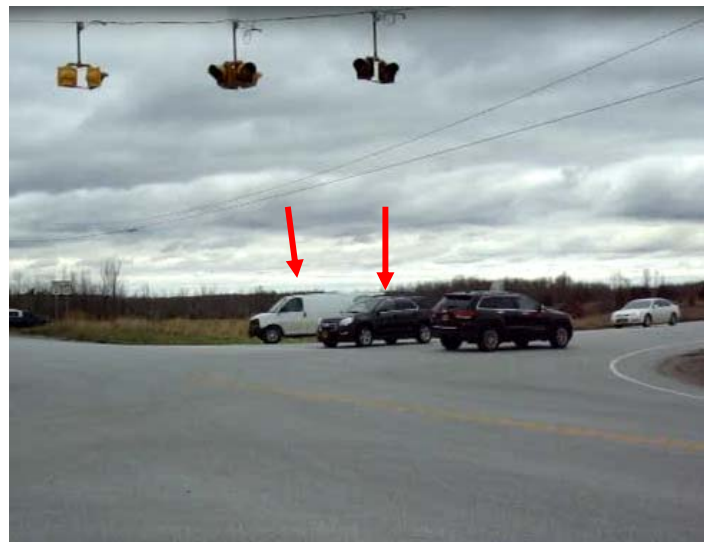
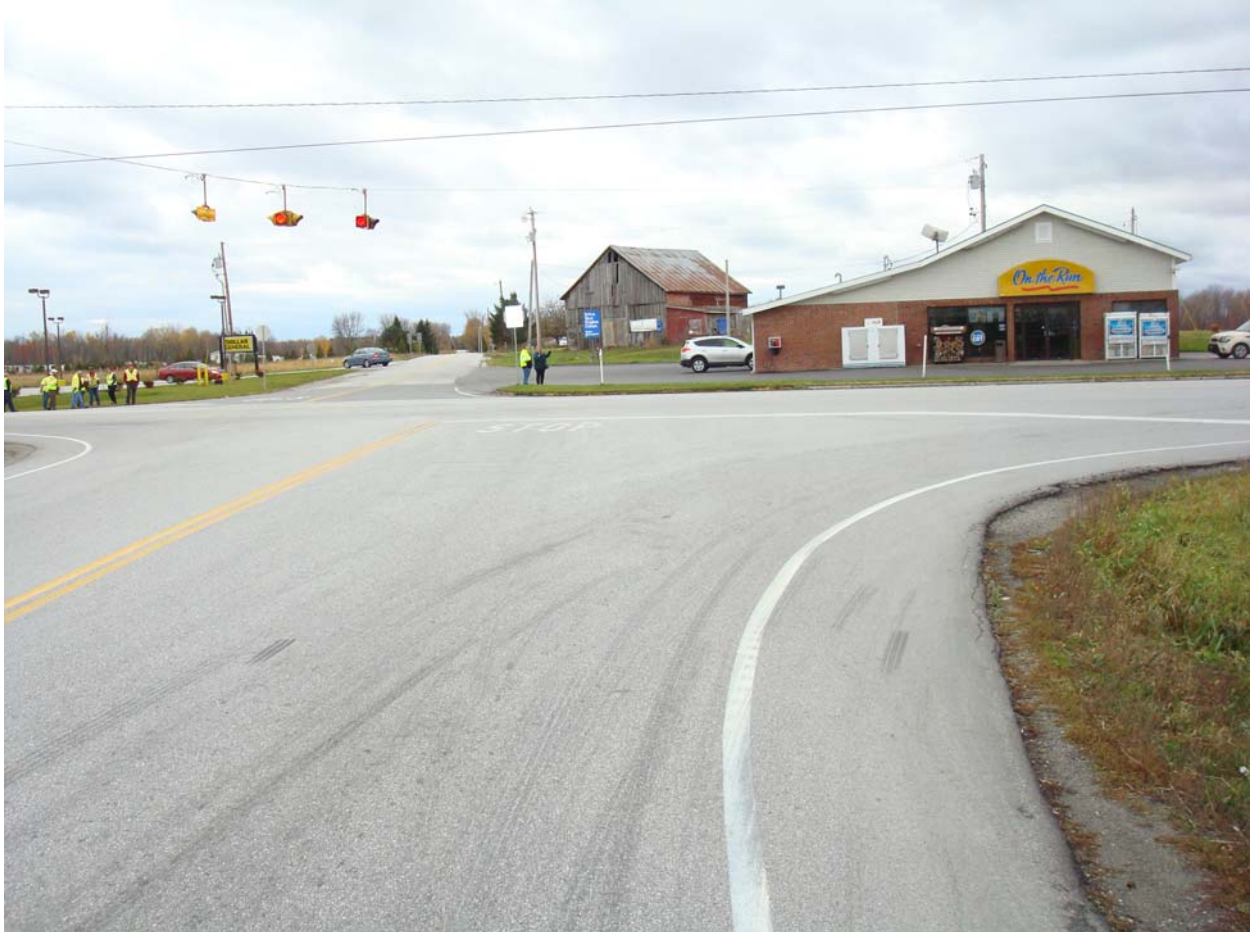
Concern: Potential Corner Sight Distance Issue, VT 78 Approach (Side-by-Side Vehicles)

The VT 78 approach is wide and while it is not marked as such, there is enough room for motorists to form two lines, one for left and through traffic and one for making a right turn. When vehicles are side-by-side, this potentially prevents motorists from being able to see oncoming traffic on US 2.

Reduce the width of the approach with cross hatched pavement markings to create only one lane. This would still permits trucks to use part of the pavement to make right turns.

A longer term solution could be to construct a truck apron.

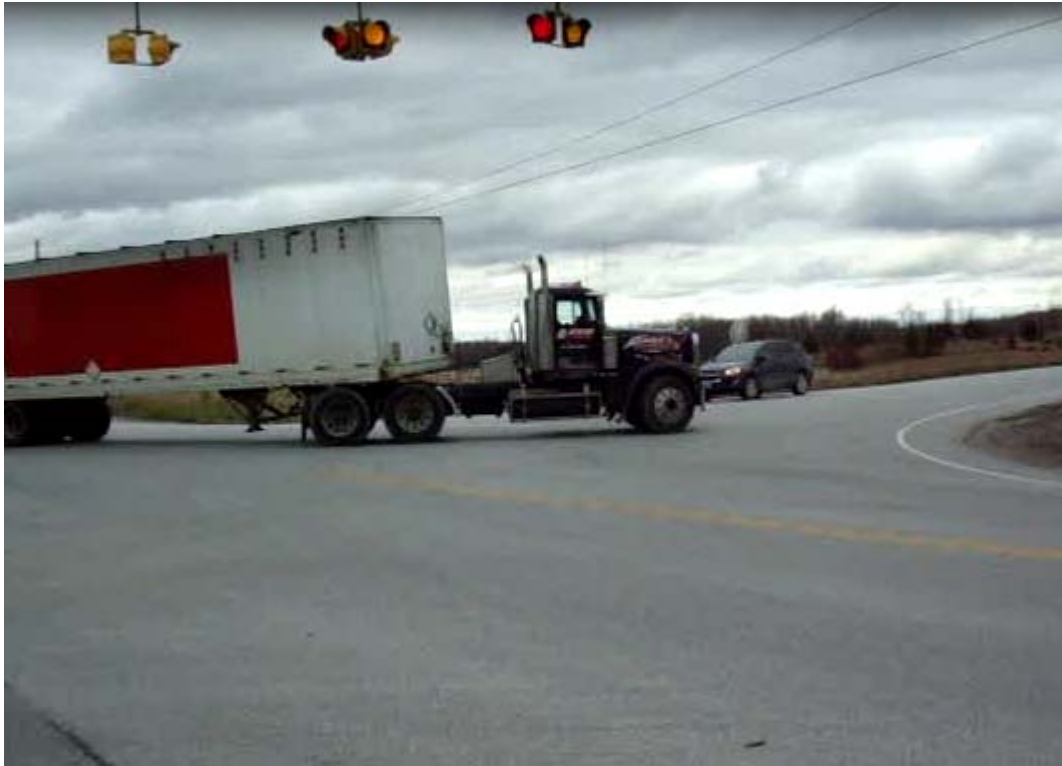
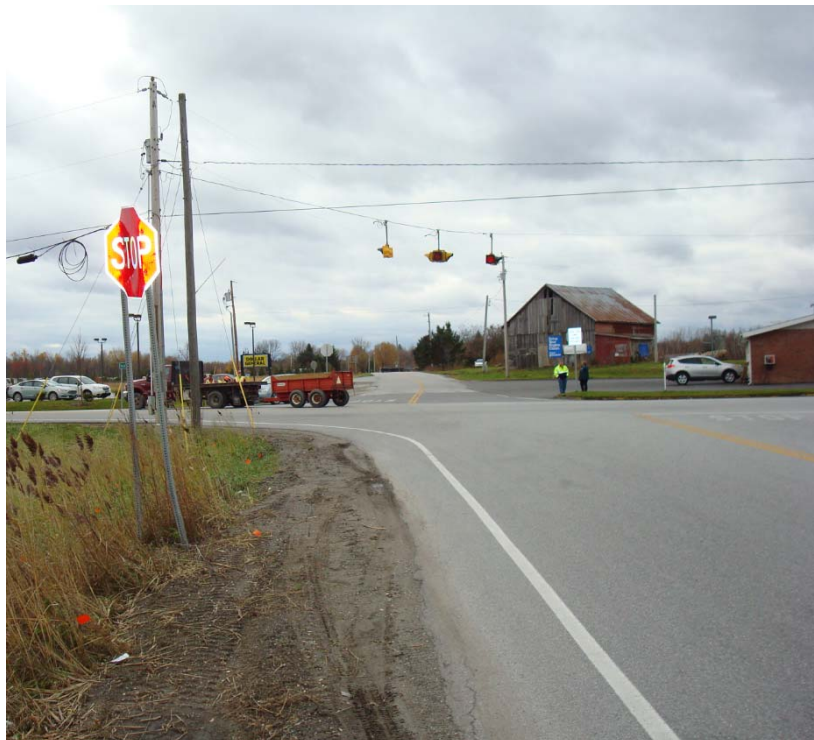
Concern: Left Turning Truck Conflicts, VT 78 Approach

Trucks that are coming from the north and making a left turn onto VT 78 from US 2 are often conflicting with approaching traffic on VT 78 as they complete their maneuver. As they make their turns, trucks are sometimes off tracking outside the paved surface.

Shift the centerline to the right on VT 78 to give more space for US 2 trucks to make a left turn. The disadvantage would be that crossing traffic would be crossing more at an angle and be exposed longer.

Construct a wider paved shoulder on the south side of VT 78.

A long term solution could be to construct a roundabout.
