Draft Environmental Assessment

HARTNESS STATE AIRPORT

Runway Safety Area, Obstruction Removal and Apron Improvement Project

Hartness State Airport Springfield, Vermont

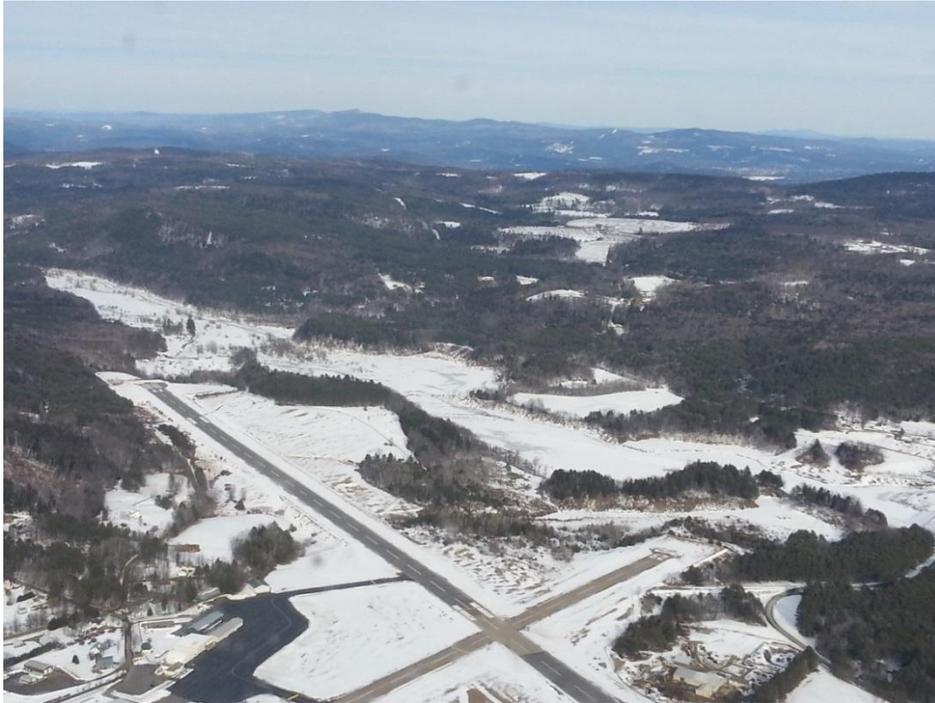
Photo 5-1 Aerial showing stub taxiways and apron

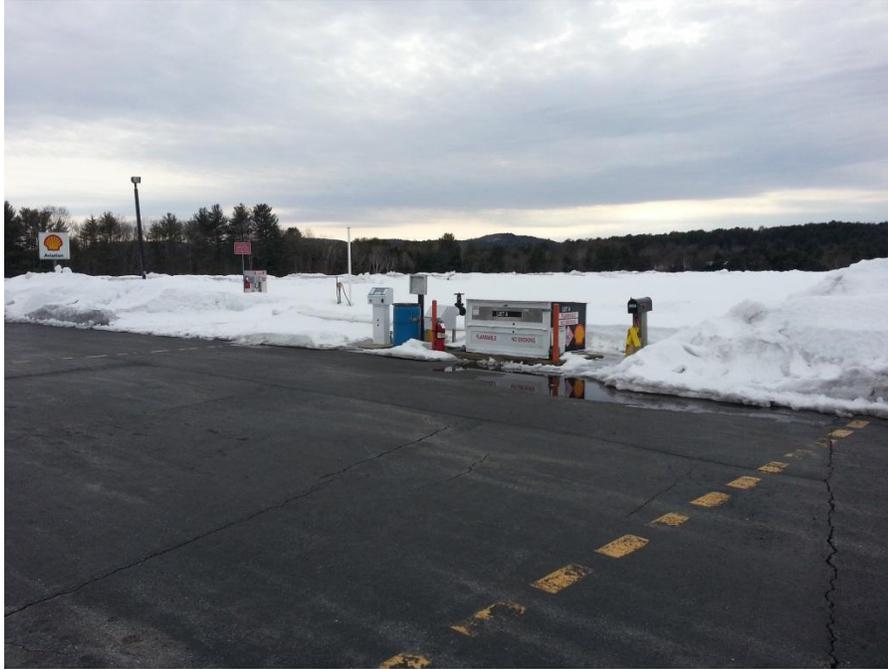
The aviation fuel farm is located at the southwest corner of the terminal ramp. It is owned and operated by VTrans. The fuel farm has underground storage tanks, with the capacity to store 10,000 gallons of Jet A fuel and 10,000 gallons 100LL aviation fuel (Avgas).

Photo 5-2 Fuel Farm

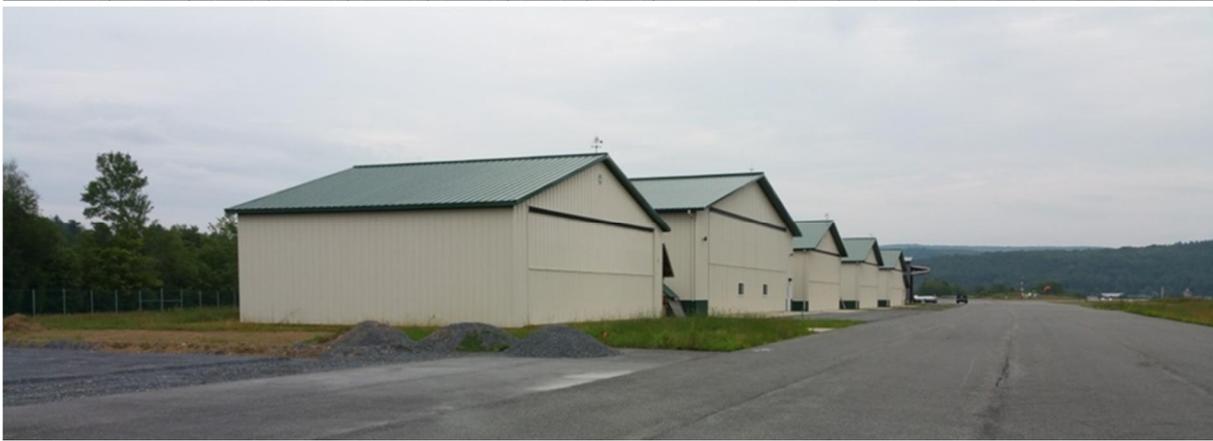
Photo 5-3 Typical Hangars

Aircraft storage hangars offer based and transient aircraft a safe and secure form of storage. More and more aircraft owners are opting to store their aircraft in a hangar versus outside on a tie-down. There are several types of aircraft storage hangars available at Hartness State Airport. These are in the form of conventional box type hangars and T-hangars. Aircraft storage hangars are described in detail on the following page.

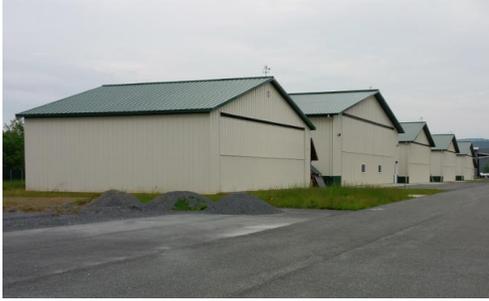
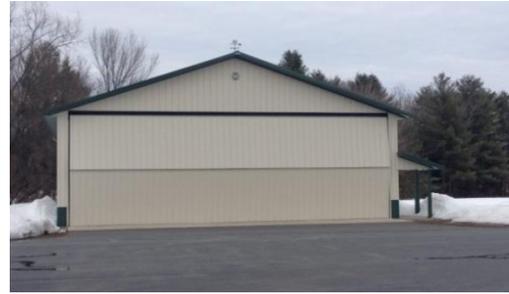
Photo 5-5 Private Hangars

VTrans leases land to numerous hangar owners. The hangars are all box type conventional hangars and are capable of storing several aircraft of various sizes in each hangar (see photos below). Currently, all the hangars are occupied. The hangars are all located along the northwest edge of the terminal apron, with the exception of one which is located adjacent to the taxiway.

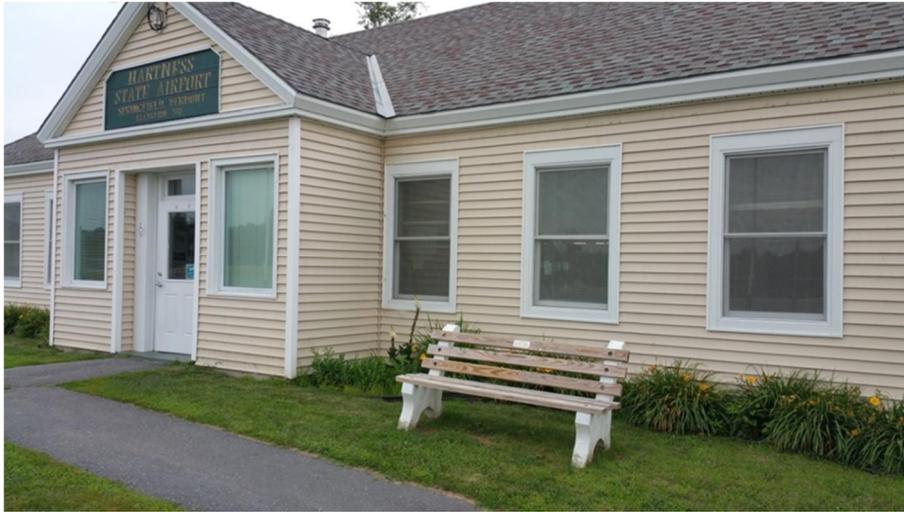
Photo 5-6 Terminal Building

The airport terminal building is a 2,000 square foot one-story structure, 25 feet wide by 60 feet long. The terminal building includes a pilot lounge, a telephone, a conference area, restrooms, and counter space for a fixed based operator. In addition, artifacts and pictures detailing the history of Hartness State Airport and the Springfield area are maintained within the terminal building.

The terminal building is used as meeting space for the Springfield Airport Commission meetings as well as by the pilots and airport administration for airport events and day-to-day airport administrative tasks. VTrans and the Airport Commission have stated that the building does not meet the spatial needs of the airport community and it should be expanded. The airport has seen growth in corporate activity over the last several years and has begun extensive outreach programs to attract additional users to Hartness State Airport, all of which require additional and updated meeting space.

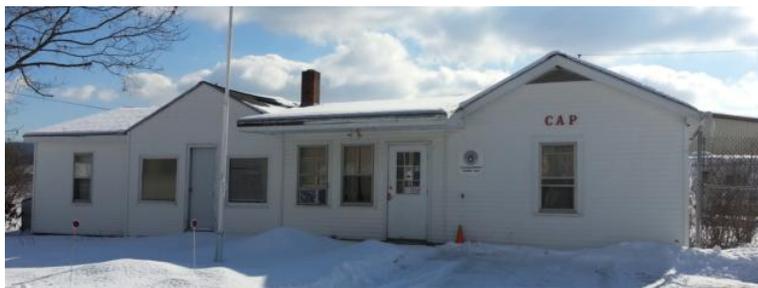
Photo 5-7 Civil Air Patrol Building

The Civil Air Patrol (CAP) Building is primarily utilized for meetings and training activities. The building has limited office space. The Civil Air Patrol is the official auxiliary of the United States Air Force and is tasked with conducting the majority of civilian search and rescue missions in the US. The CAP also has a cadet program which introduces youth to aviation. The location of the CAP building does not afford the users with direct access to airside facilities such as apron space or taxiways. Members of the CAP conduct extensive glider training at Hartness State Airport as well as cadet orientation flights. Activity at the CAP building has decreased over time, and options for the CAP building to be either relocated or renovated should be addressed, as it a difficult environment to conduct the CAP mission from. A new facility should have space for a communications room, classrooms, sufficient storage and office space.

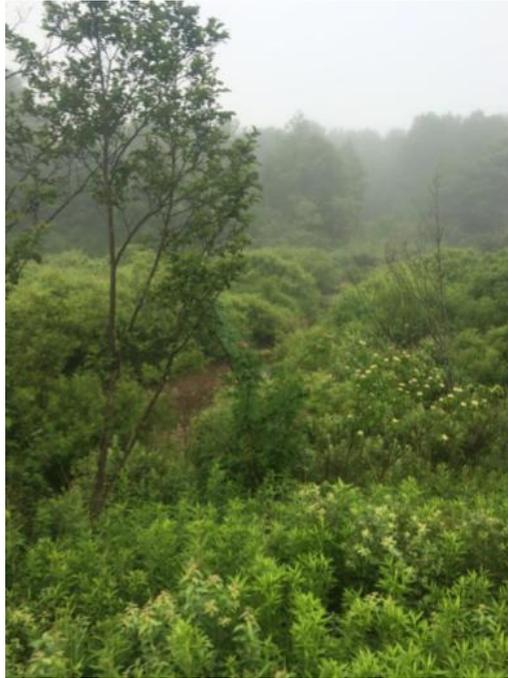
Photo 5-8 Wetland A

Wetland A is situated prior to the Runway 11 threshold and is a Class II wetland as shown on the ANR Wetland Inventory Map. The wetland is associated with an unnamed stream. The stream is fed by several seeps along the slopes of the stream valley. The dominant wetland plant is Box Elder (*Acer negundo*). This wetland would have a 50 foot regulated buffer. (See **Photo 5-8**).

Wetland A is associated with an unnamed stream located off the approach end of Runway 11 and meanders through this Class II wetland. (Source: EIV)

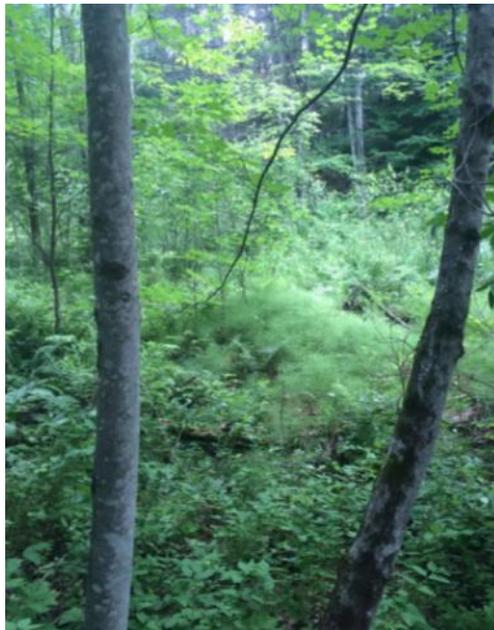
Photo 5-9 Wetland B

Wetland B is located off the approach end of Runway 5 is a Class II wetland. (Source: EIV)

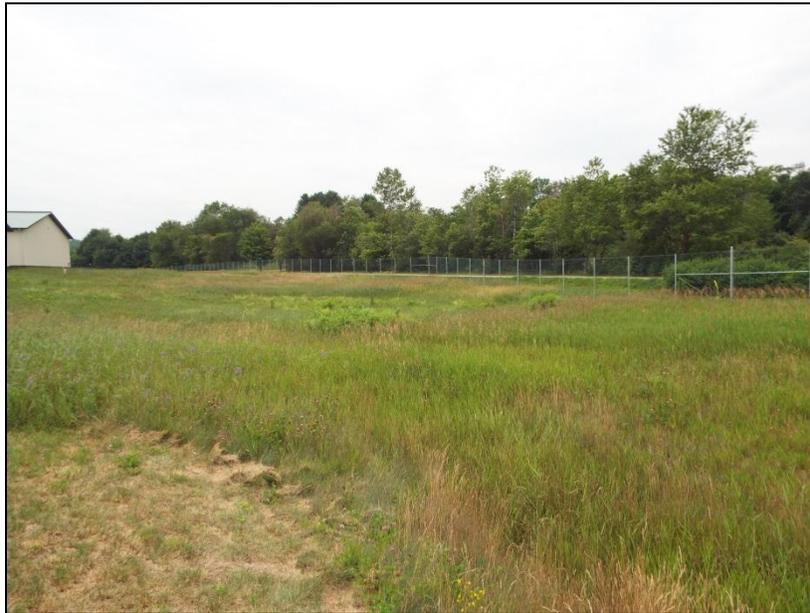
Photo 5-10 Wetland C

Wetland C is located behind the hangars in an area that is routinely mowed. This wetland is a Class III wetland because it is not shown on the VSWI map and is not contiguous or connected to the VSWI mapped wetland. It is also not the same type or size of a mapped wetland and is not a vernal pool. The wetland has a mono culture of grasses and rushes and appears to have developed in response to the drainage outlet for the apron drainage system. As mentioned above in Section 5.17, no listed plant species, specifically Pursh's bulrush were found. Class III wetlands are not regulated by ANR and do not have a buffer. The ACOE may take jurisdiction. (See **Photo 5-10**).

Wetland C is a mowed area that collects runoff.

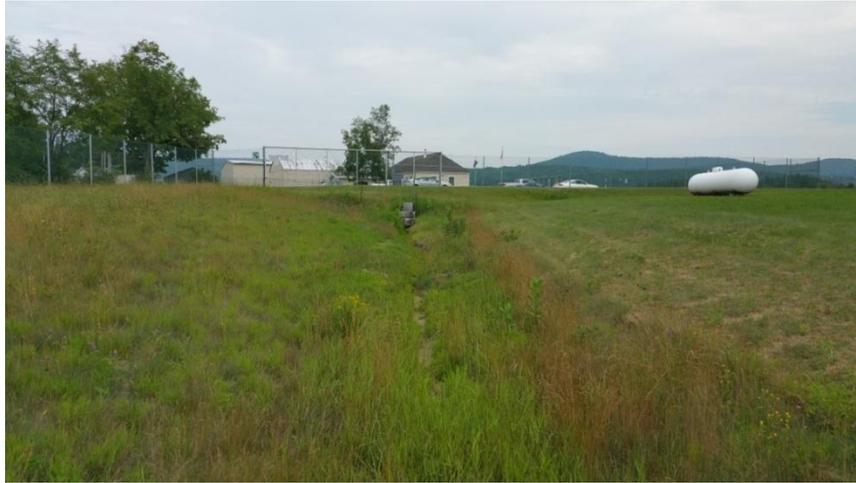
Photo 5-11 Wetland C

Drainage outlet and swale flows to **Wetland C**.

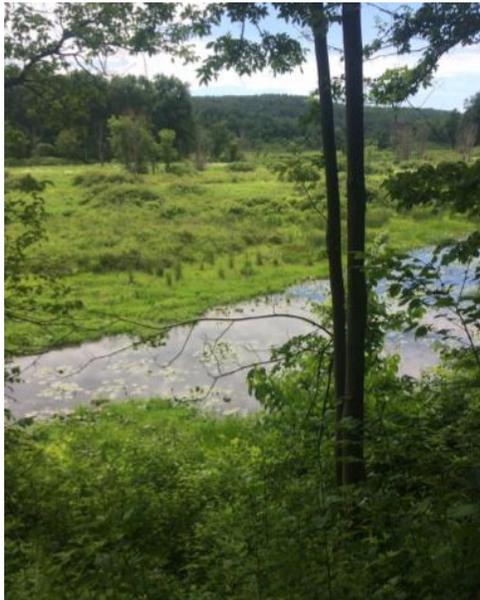
Photo 5-12 Wetland D

Wetland D is located off the end of Runway 23 and consists of two linear seeps. It would be considered Class II because it is contiguous to the mapped wetland that is associated with the Springfield Reservoir/Black River wetland system. The area is on a slope and dominated by Jewel weed (*Impatiens capensis*). This wetland would have a 50 foot regulated buffer on either side of each seep.

Wetland D is located off the approach end of Runway 23 and is hydraulically connected to the large wetland system shown in the photo. (Source: EIV)

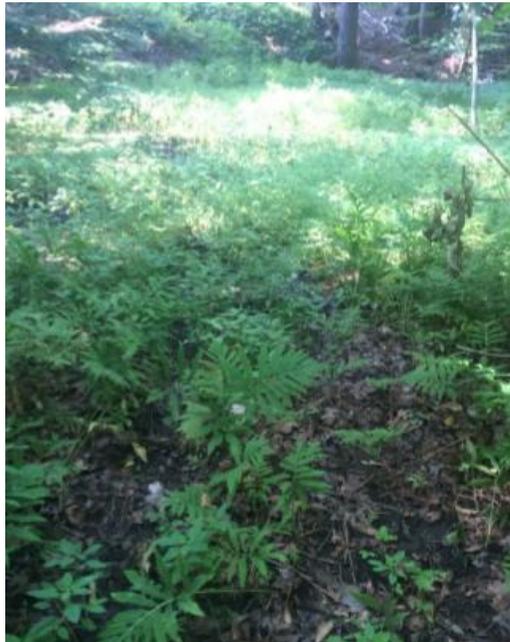
Photo 5-13 Wetland E

Wetland E is located off the approach end of Runway 11 on the other side of Route 106. Wetland E is a Class II wetland with a 50 foot regulated buffer and is shown on the VSWI map. It is a gently sloping wetland complex that is dominated by two different species of vegetation. These species are Eastern hemlock (*Tsuga Canadensis*) and Spotted Touch-Me-Not (*Impatiens capensis*). There was evidence of standing water and amongst the Spotted Touch-Me-Not there was sensitive fern mixed in. The area of the wetland closest to Route 106 appeared to have been created by the shifting alignment of the road leaving an earthen berm to the West of Route 106.

Wetland E is located off the approach end of Runway 11 is a Class II wetland.
(Source: EIV)

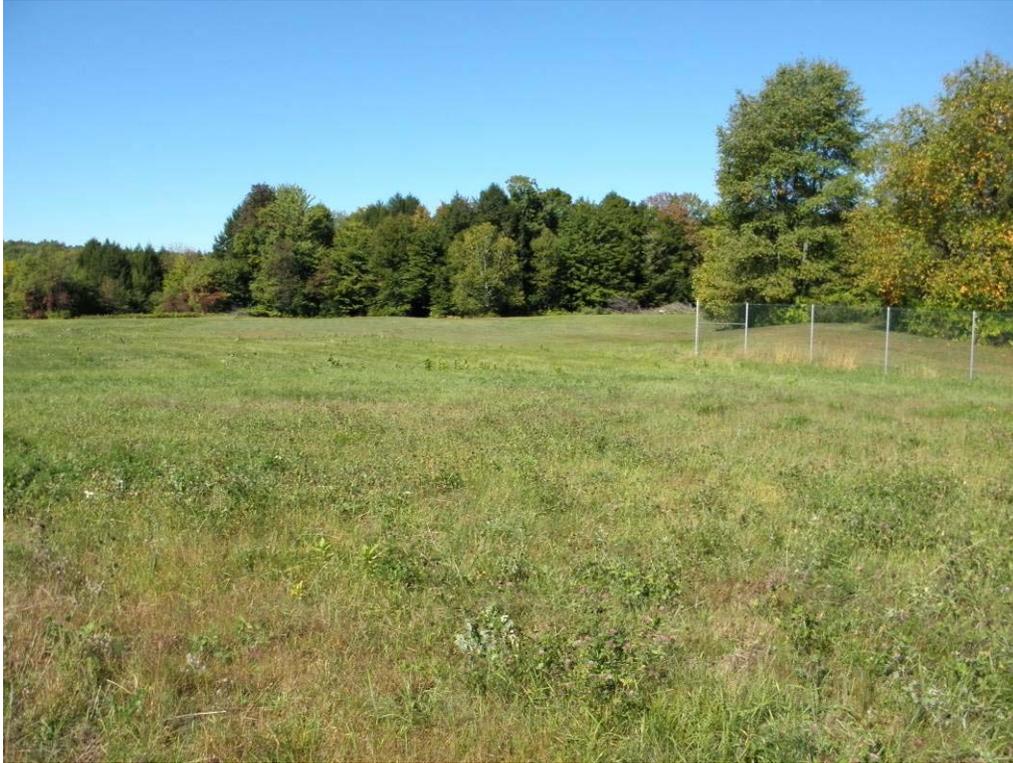
Photo 1. Photo shows the general location of Site VT-WN-452, located north of the Area 1 project area. View is to the west.

In the 1999 archeological assessment, this general area was determined to be sensitive for precontact resources because of its location on a high level terrace overlooking Baltimore Brook (Photo 1). During archeological testing conducted by the University of Vermont Consulting Archaeology Program (UVM CAP), a precontact site -VT-WN-452 was identified, based on the recovery of three pieces of lithic debitage, and a “spurred” scraping implement, possibly dating to the Paleoindian period. In 2008, a limited archeological Phase II evaluation of site VT-WN-452 was conducted by UVM CAP for the proposed Hartness State Airport Hangar Expansion and Access Road project (UVM CAP 2008). Based on the excavation of 67 shovel test pits located east of the site, in which no precontact material was recovered, it was determined that the Native American site VT-WN-452 did not extend into the western portion of the proposed airport project’s APE (Appendix 1).

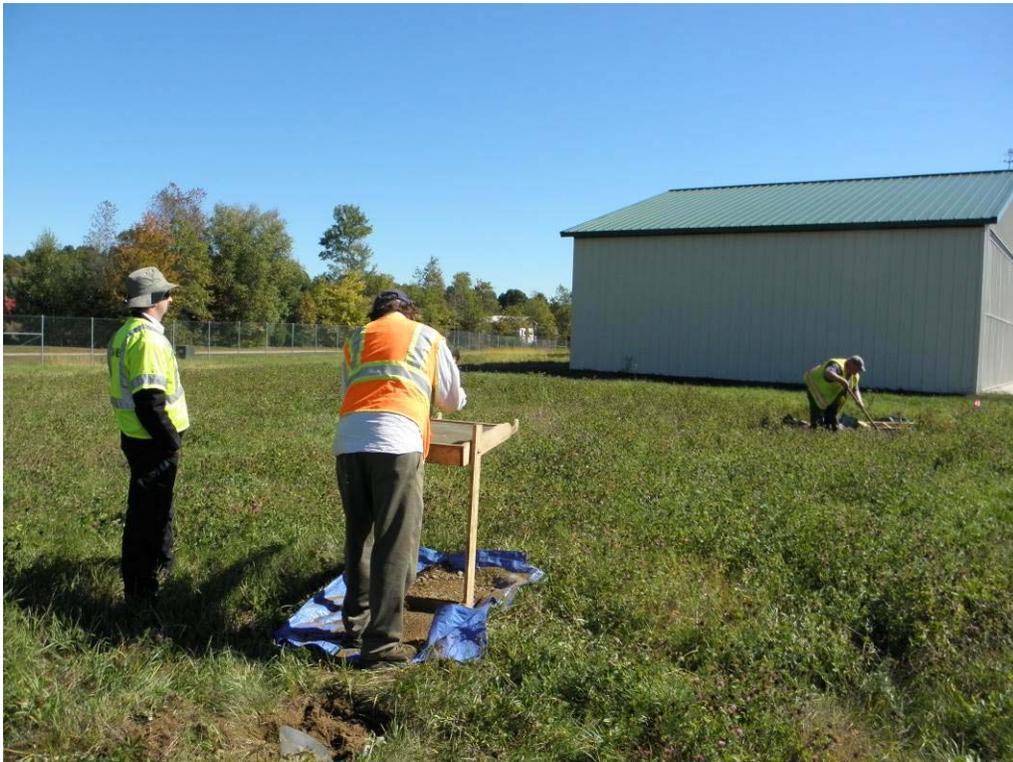
Photo 2. Shovel testing in the proposed location of a new hangar in Area 1. View is to the east..

The present Phase IB archeological investigation conducted by Hartgen included the excavation of four shovel test pits in the location of the proposed new hangar building, directly adjacent to the northernmost hangar (Map 4, Photo 2). The visual inspection of this area suggested that it had been graded and leveled during earlier phases of construction for the hangars, adjacent taxiway and nearby runway. The excavation of the four shovel tests substantiated this evaluation, with the soil stratigraphy comprised of hardpacked silt and cobble fill overlying subsoil.

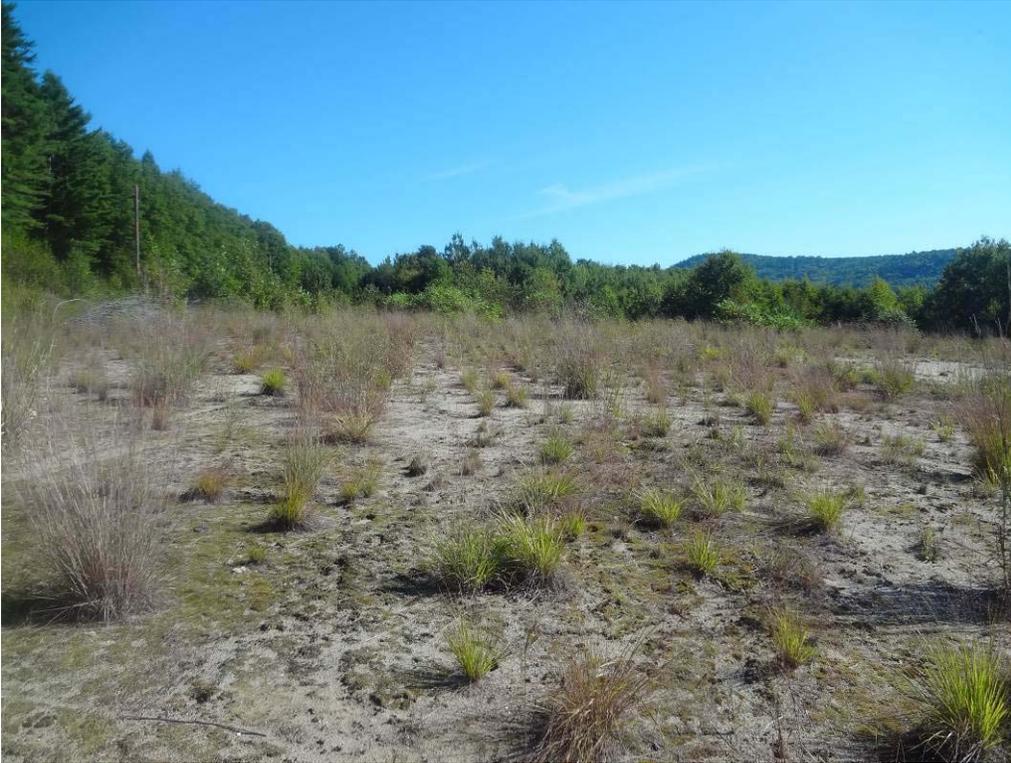
Photo 3. The southern end of Area 2 which had been previously mined for sand. View is to the north.

Area 2 contains sections of sloping terrain near gullies and drainages, as well as level, elevated terraces. The southernmost end of Area 2, located directly north of the runway outside of the airport perimeter fence, has previously been mined for sand and clearcut (Photo 3). The terrain considered to maintain the highest precontact sensitivity in Area 2 are level terraces close to the edge of the landform overlooking seasonal draws or the Black River valley (Photo 4).

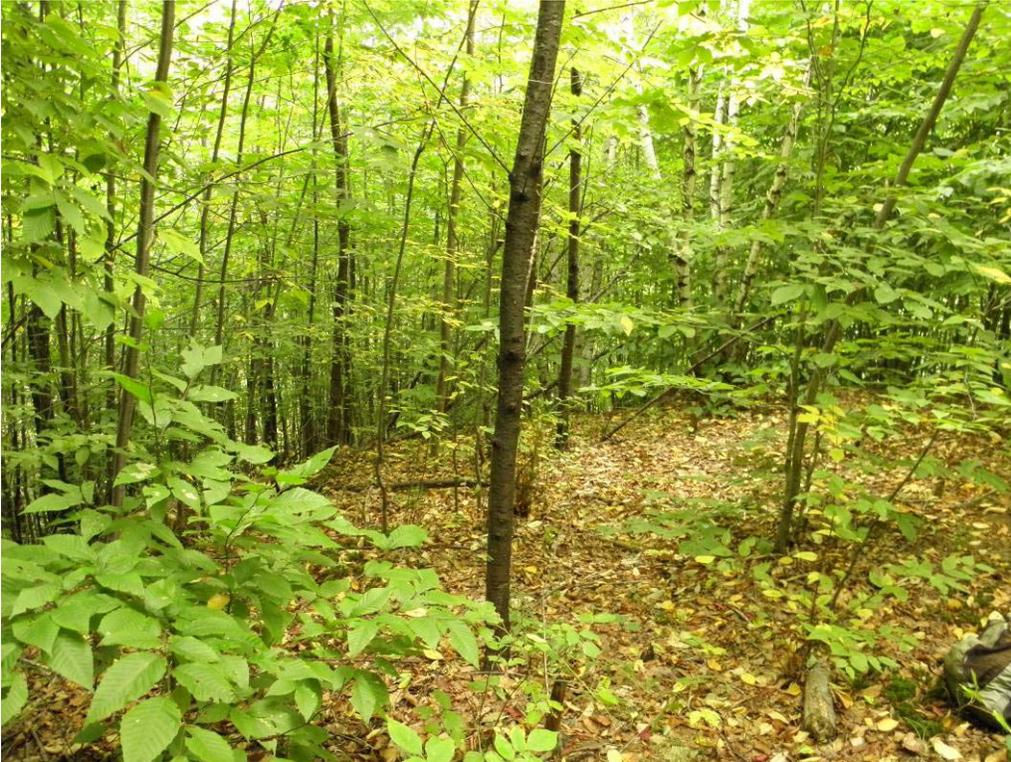
Photo 4 Photo shows the edge of one of the terrace landforms where shovel tests were excavated in Area 2. View is to the east.

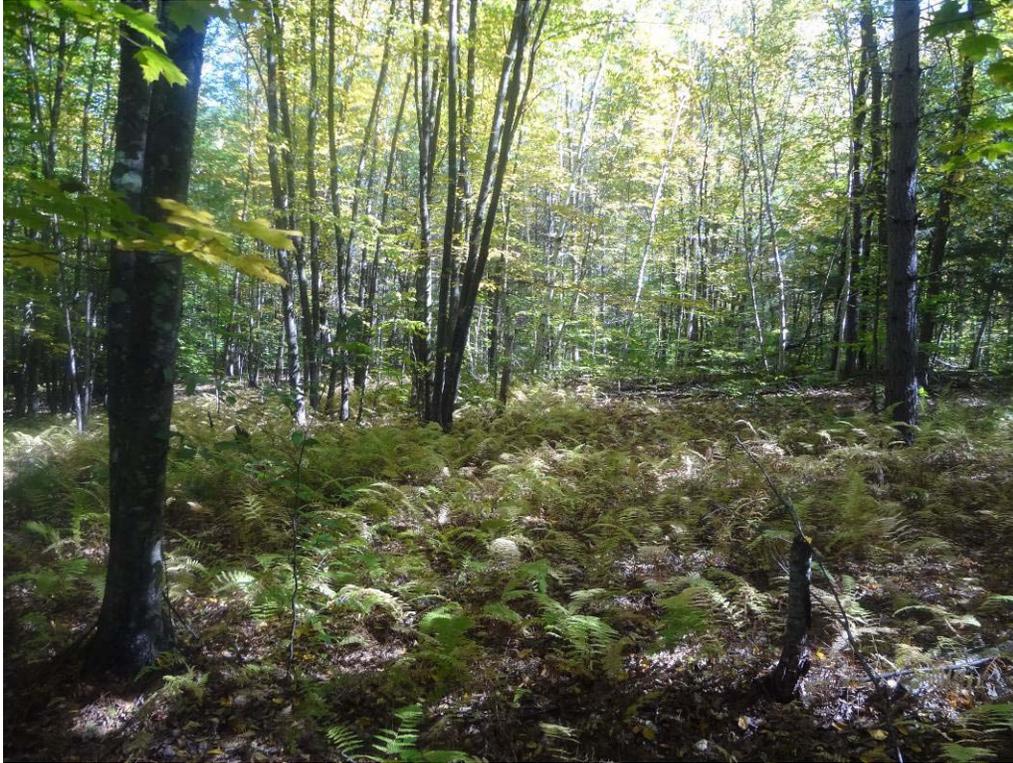
Photo 5. Photo shows a wide terrace where shovel tests were excavated in Area 2. View is to the northeast.

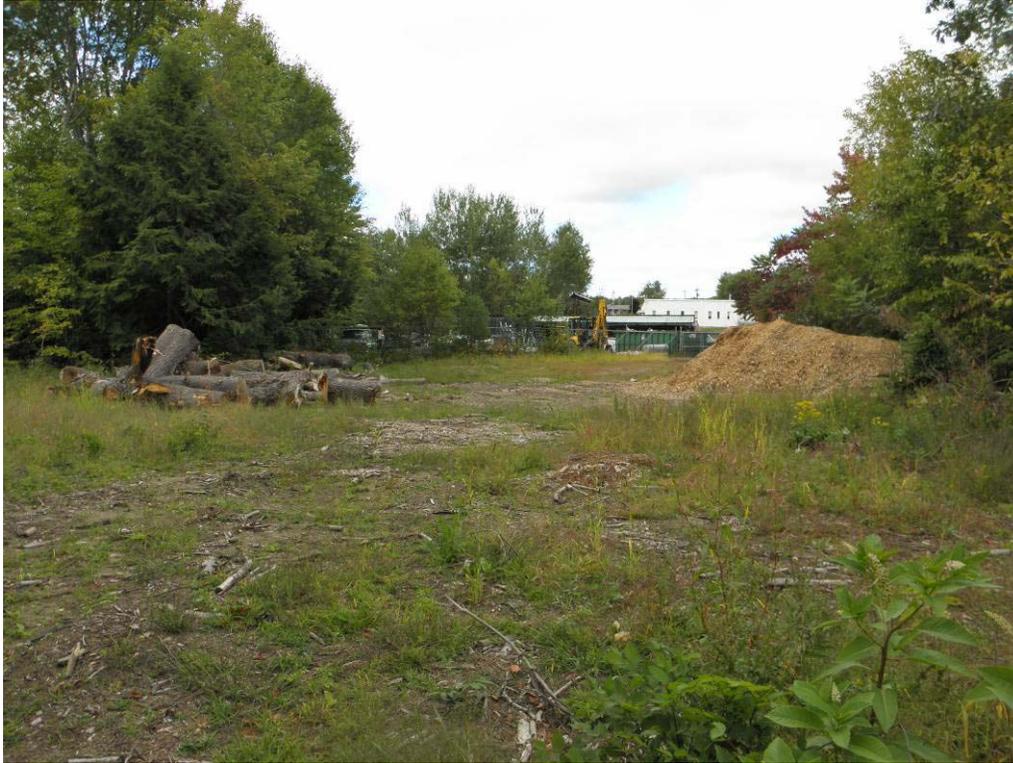
Photo 7. Photo shows evidence of ground disturbance at the western end of Area 3 near the fence company operation. View is to the northwest.

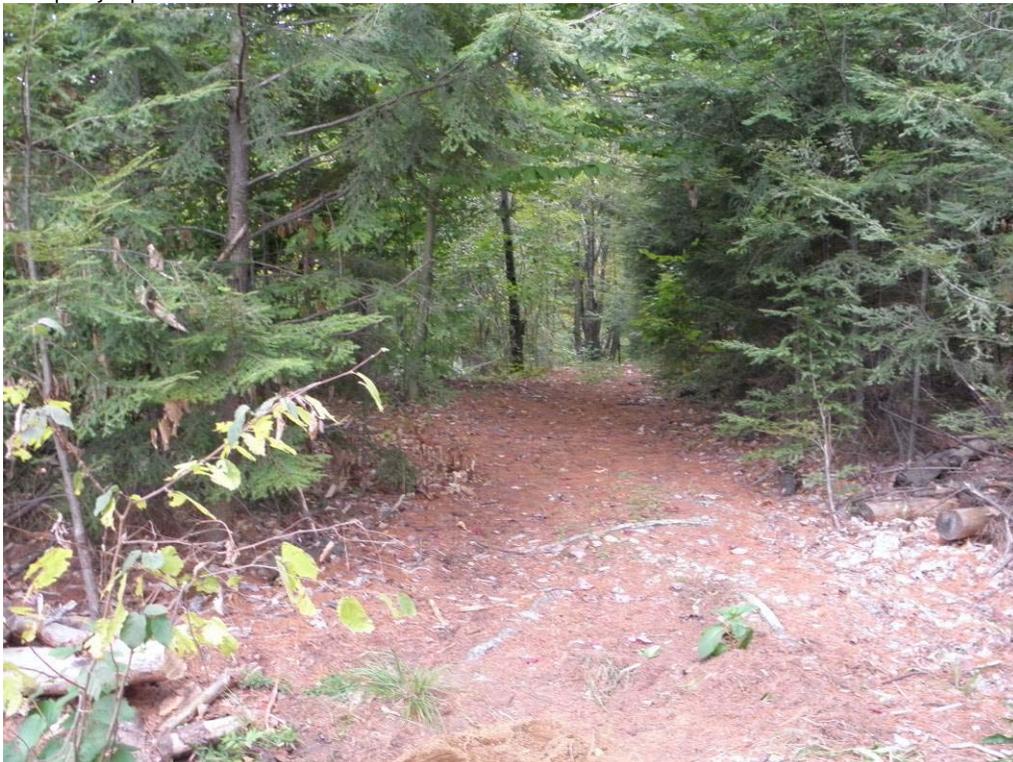
Photo 8 Photo shows a portion of the level terrace landform located in Area 3. View is to the southeast.

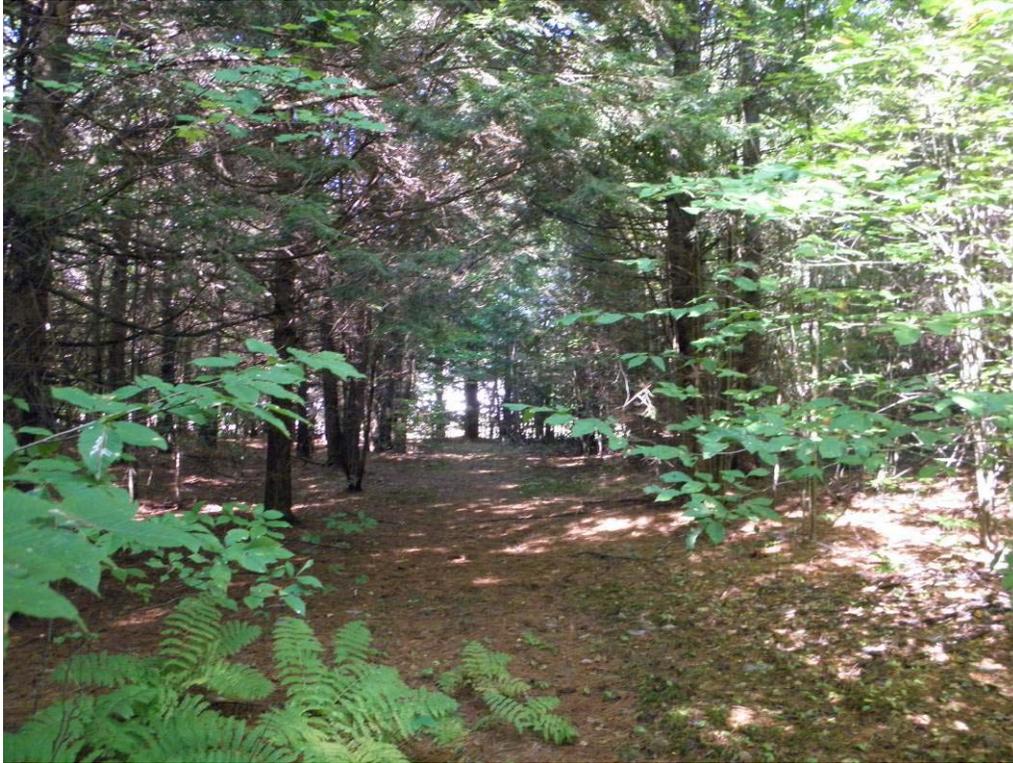
Photo 9. Photo shows the level terrace landform that was tested in Area 4. View is to the west.

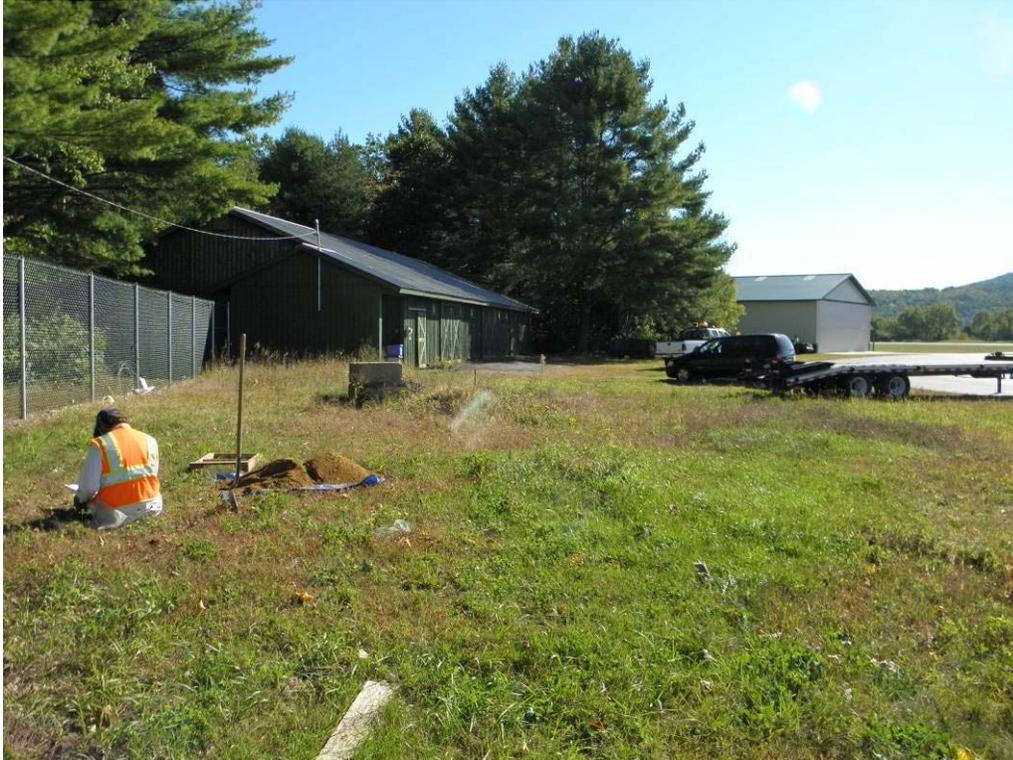
Photo 10. Photo shows the excavation of a shovel test near the northern Fish and Wildlife Building. View is to the north

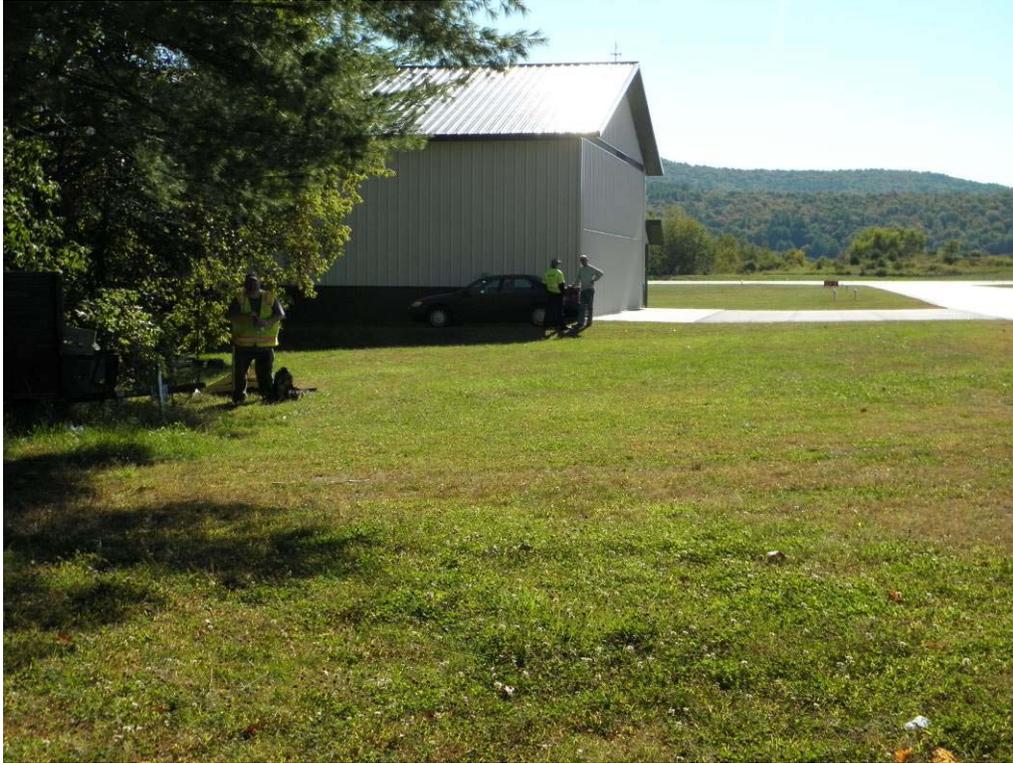
Photo 11. Photo shows the location of shovel tests excavated near the southern Fish and Wildlife Building. View is to the east.

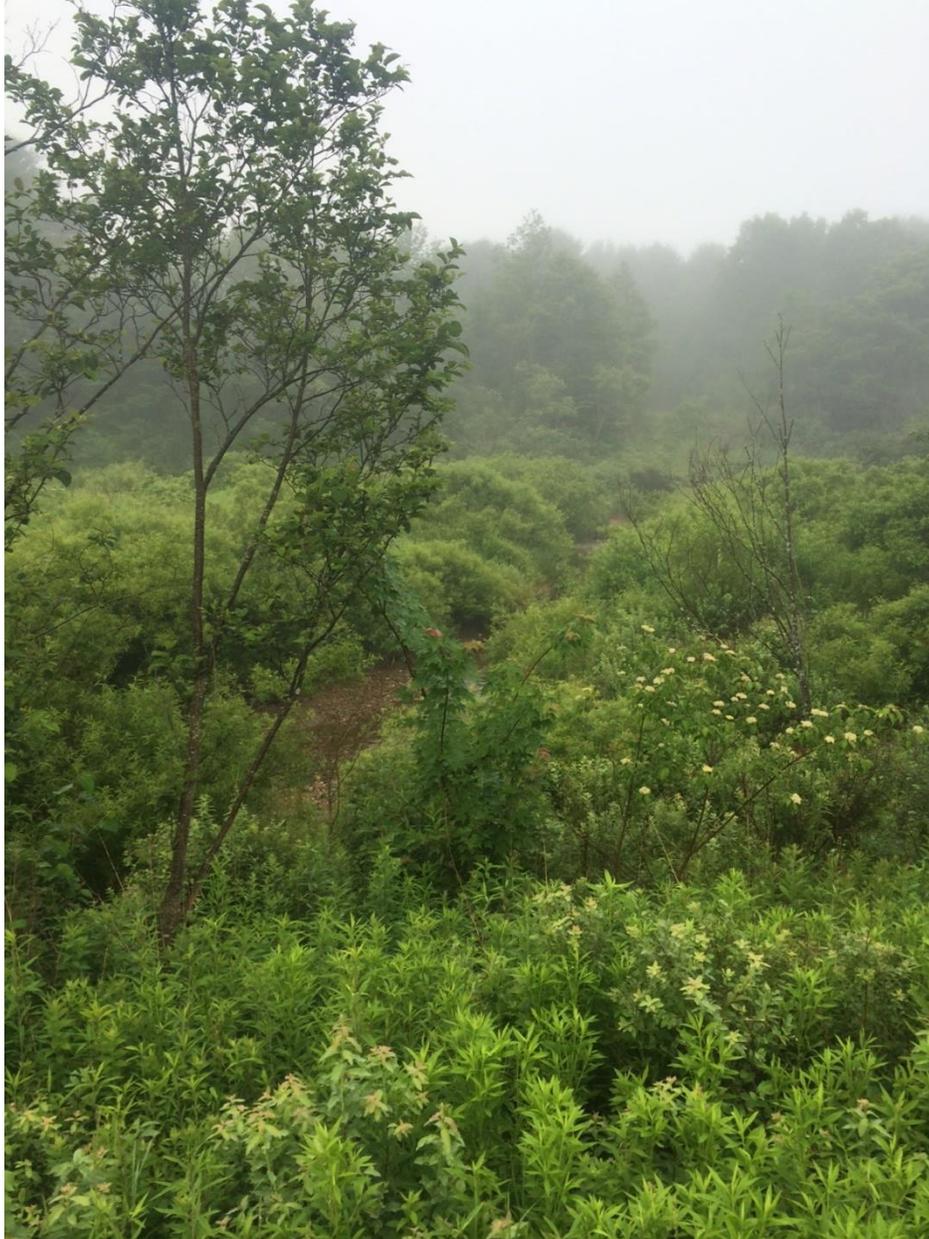
Wetland A

An unnamed stream located off the approach end of Runway 11 and meanders through this Class II wetland.

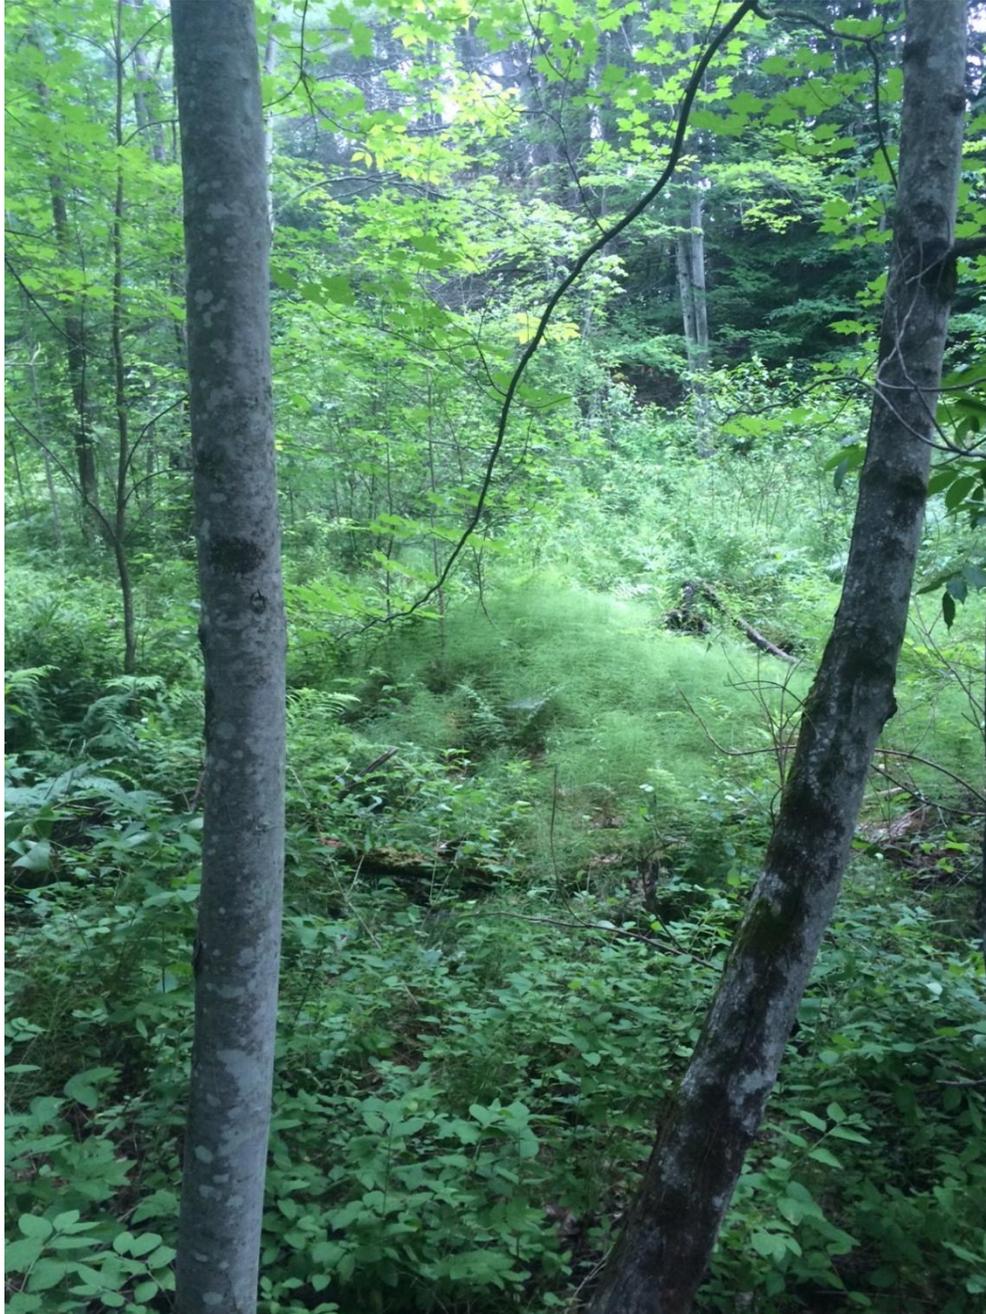
Wetland B

This photo represents the Class II wetland off the approach end of Runway 5.

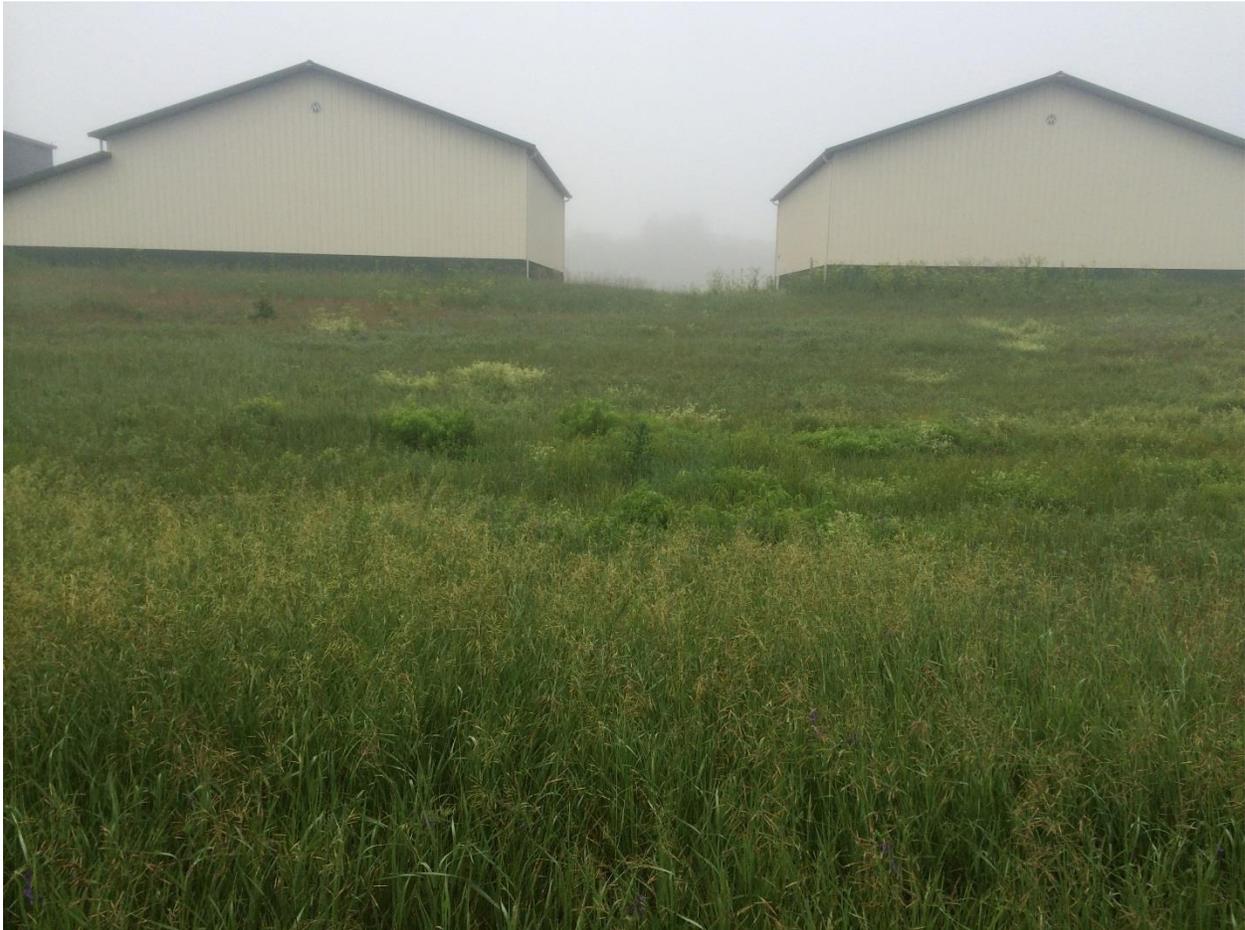
Wetland C

This photo is of the class III wetland located inside the fence of the airport.

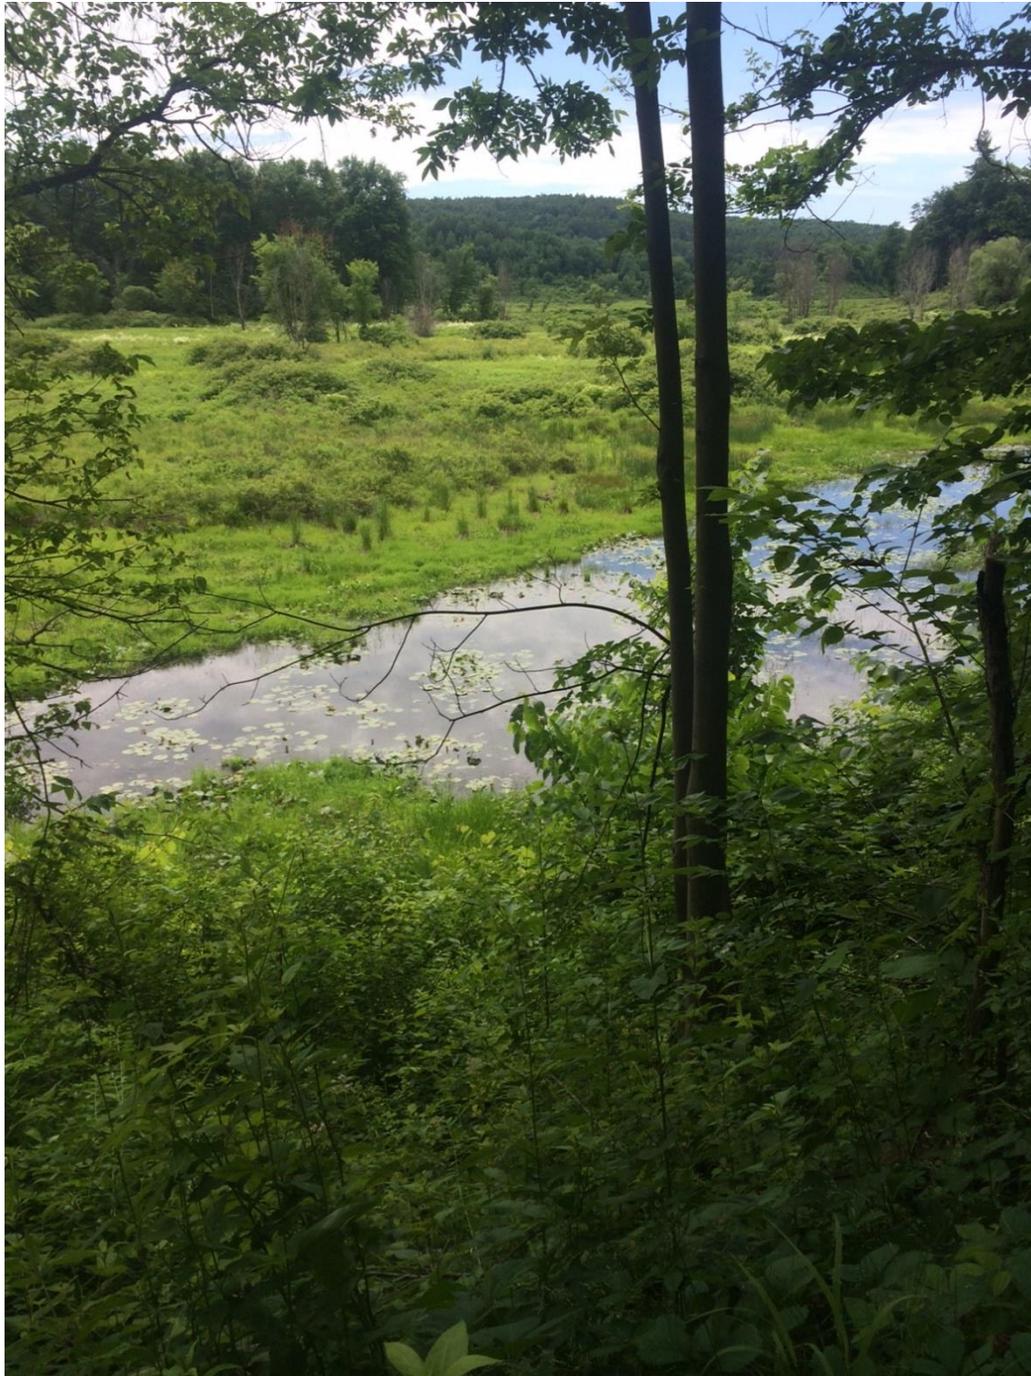
Wetland D

This Class II wetland is located off the approach end of Runway 23.

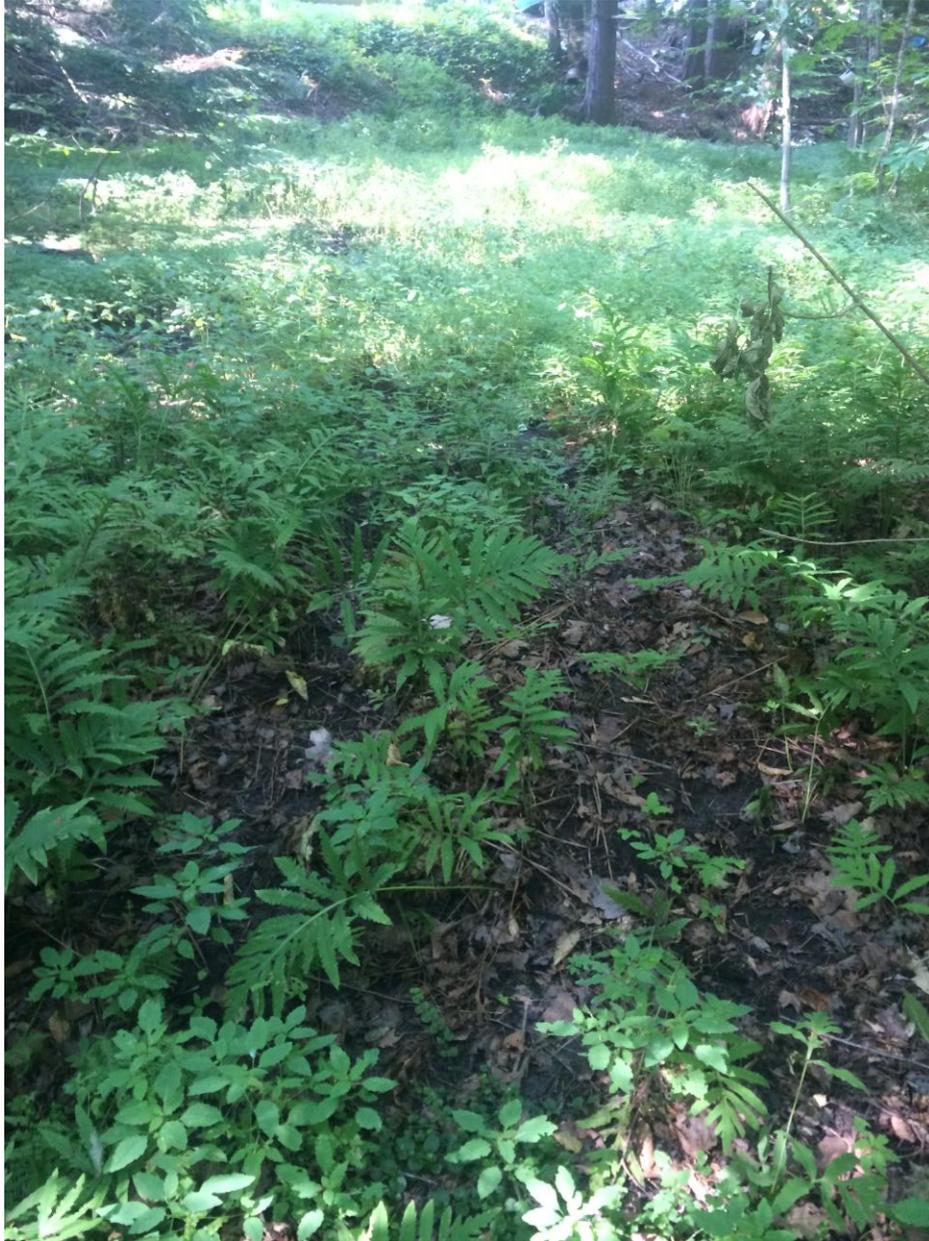
Wetland E

This Class II wetland is located off the approach end of Runway 11, and west of Route 106 and Wetland A.
