Road Safety Audit Review

VT 15 and North Wolcott Rd, Wolcott

September 23, 2020

Vermont Agency of Transportation
Operations & Safety Bureau

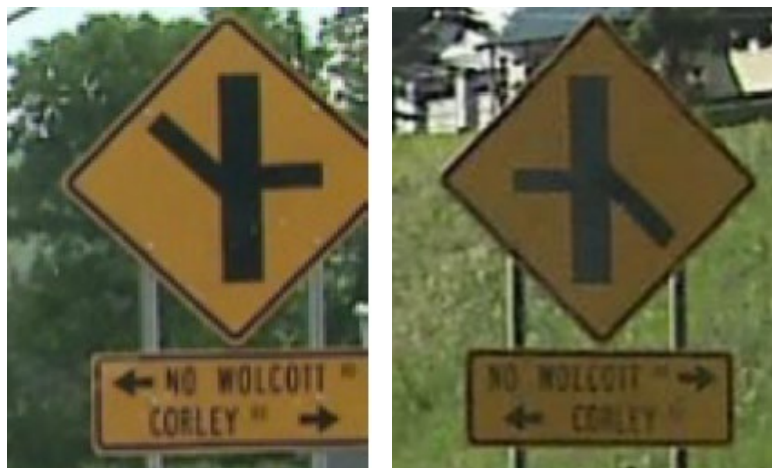
Motorists are warned of the intersection in both directions by an advance modified crossroad sign combined with a street name plaque below it. These assemblies are located in the eastbound direction at mile point 1.940 and in the westbound direction at mile point 2.080. The assemblies are 406 ft and 332 ft from the intersection respectively. The modified crossroad signs are 36" x 36".

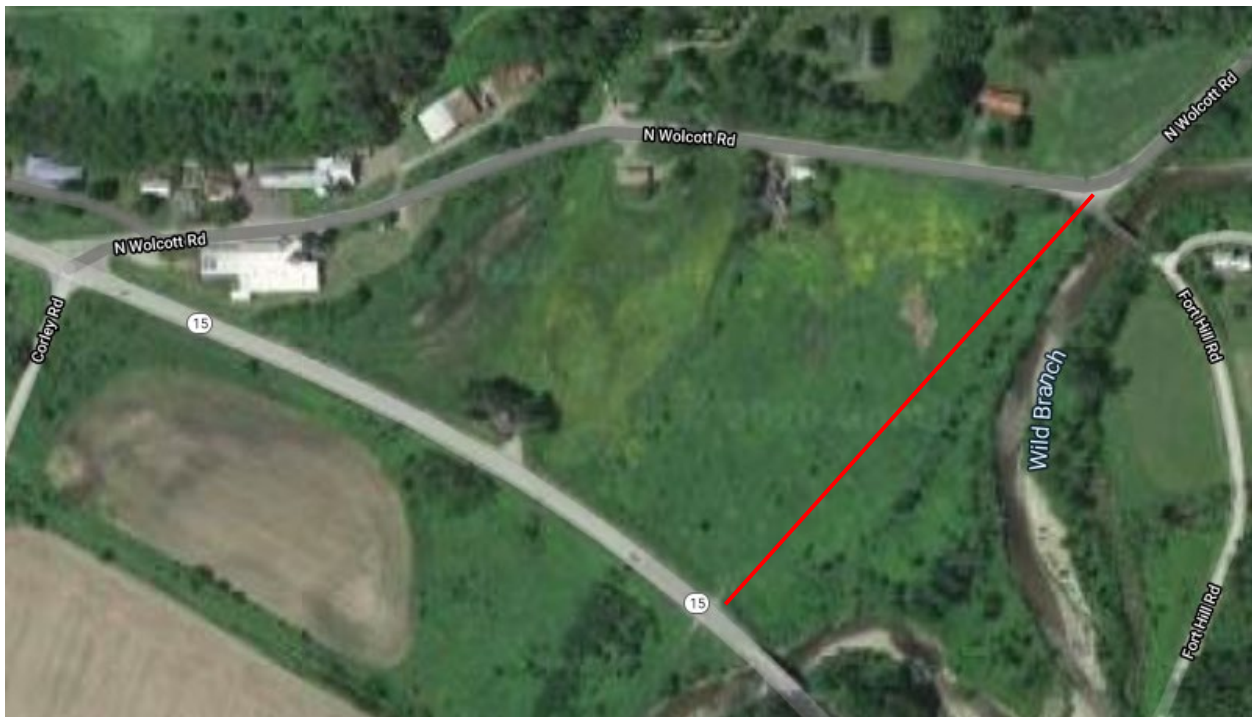
Alternatively to realigning the intersection at its current location, one of the local representatives suggested the conceptual idea of constructing a new road east of the intersection. The red line in the map below shows one option that would go through land currently owned by the Vermont Department of Forests, Parks and Recreation.

- Consider evaluating the realignment of the intersection to improve corner sight distance.

Realigning the intersection by aligning it at 90-degree with Corley Rd so that that the intersection is truly a four-way intersection is one option.

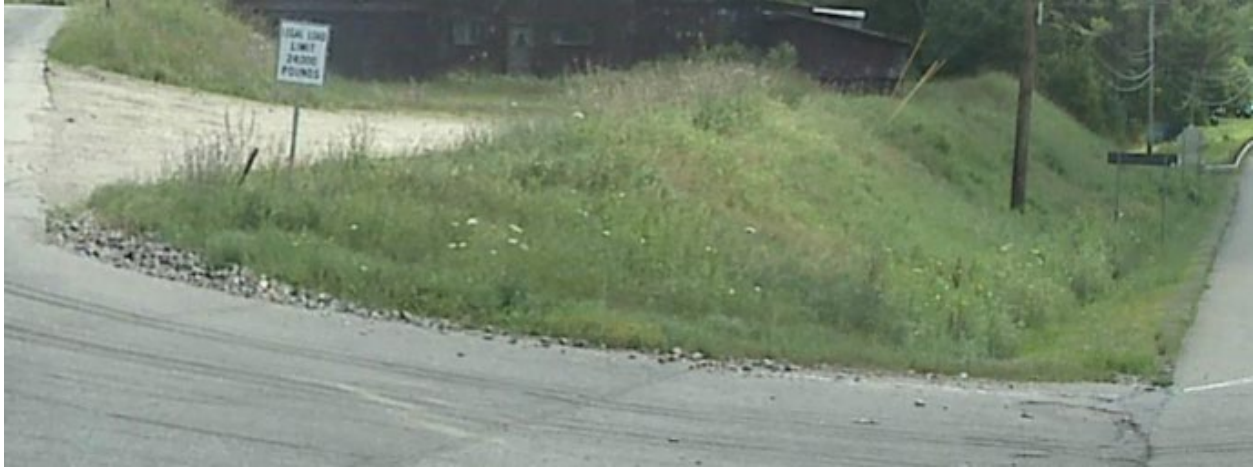
Concern: Stones dislodged by vehicles that make the westbound right turn onto North Wolcott Rd rolled onto VT 15 and are a hazard to motorcycles and bicyclists

The existing grade of the stone-lined area adjacent to the northeast corner matches the grade of the pavement. Because of this, the stones are easily thrown onto the roadway when a vehicle cuts off the corner.

- Consider (Town) refreshing the white edgeline markings around the radii to help vehicles stay in the travel lane.
- Consider (Town) providing ditching along the edge of pavement.
- Consider mountable curbing as another alternative to ditching.

If mountable curbing is considered, it should be engineered to ensure that no water flows into VT 15 and creates a new safety issue.
