Road Safety Audit Review

Town:	Weathersfield	Date Reviewed:	October 5, 2016
Route:	VT 131, US 5 and VT 12	Mile points:	VT 131: 8.28-8.60 US 5: 5.12, VT 12: 0.39

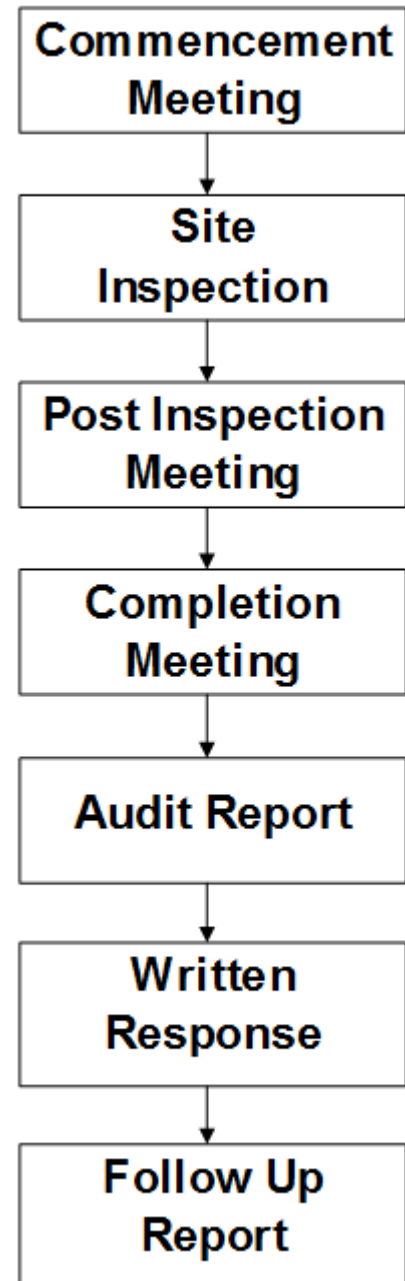
Figure 1 - Road Safety Audit Process

The RSAR process is composed of several steps as shown in Figure 1. The process starts with a **Commencement Meeting** during which the Audit Team reviews data and gathers community concerns. A **Site Inspection** is then performed by the Audit Team. The site visit involves the identification of safety deficiencies as seen in the field. The Audit Team will usually drive through the location of interest to “get a feel” for the area, traveling through each approach in the case of intersections. The team is to then drive at a slower speed to make observations. If needed, the team will also walk the location. Following the site inspection, the Audit Team holds a **Post Inspection Meeting**. It is during this meeting that the team members discuss their observations and identify safety issues. The team is to reach a consensus on the importance of each safety issue mentioned. Only those issues for which a consensus is reached are included in the RSAR findings. A RSAR report (Written Report) is prepared.

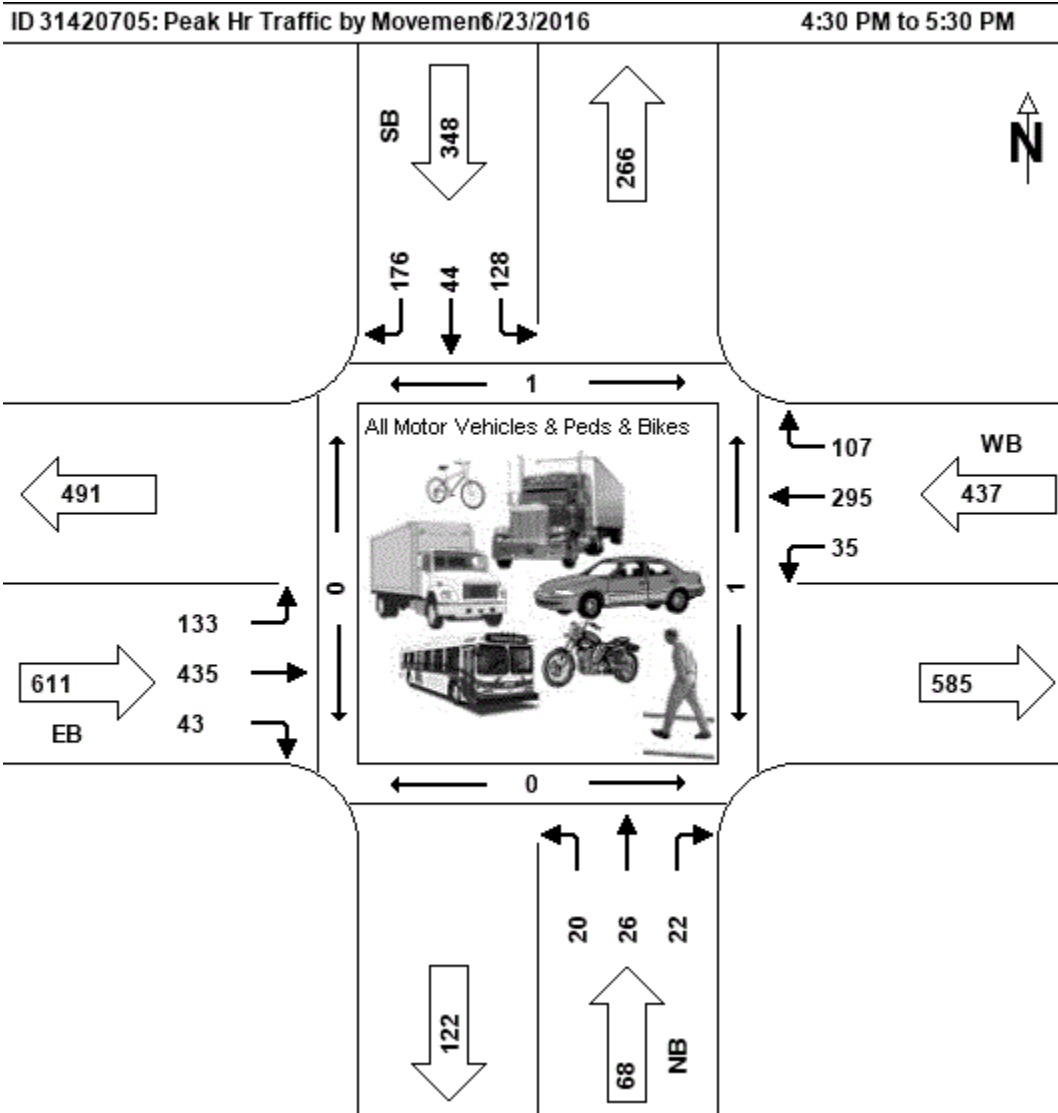
A traffic count was performed at the intersection of US 5, VT 131 and VT 12 in June 2016 by VTrans. The heaviest peak hour was found to be the 4:30 to 5:30 pm time period. The diagram for this period is shown below. During this time period, traffic is heaviest traveling eastbound on VT 131 with 611 vehicles. Of these, 133 are making a left turn and 435 vehicles are driving through the intersection. The second heaviest movement is from VT 12 with 437 vehicles (235 continuing through and 105 making a right onto US 5 northbound). Traffic traveling southbound on US 5 towards the intersection is mostly make a right turn onto VT131 westbound or a left turn onto VT 12 eastbound.

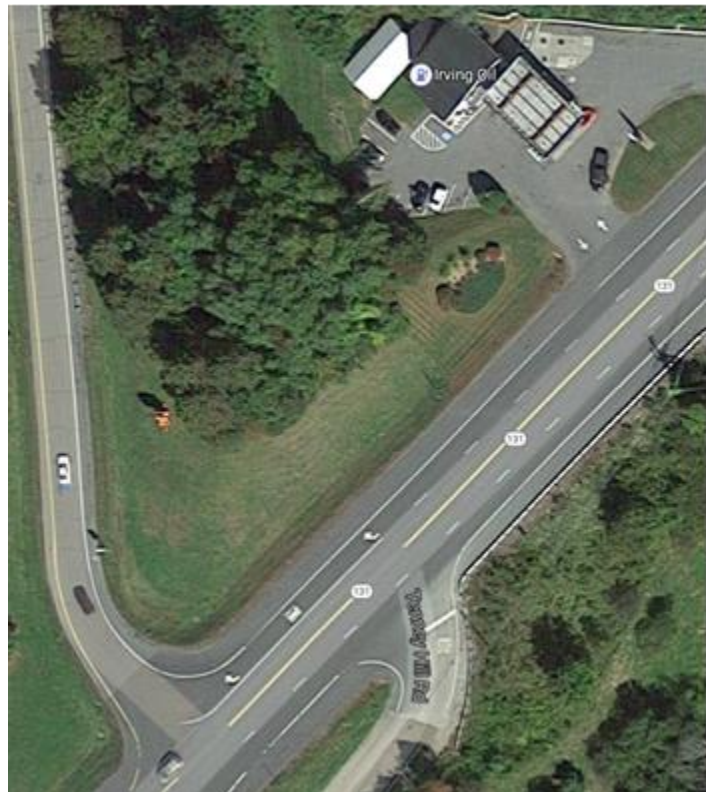
Concern: Right Turn Lane at NB I-91 On Ramp

The vertical crest on VT 131 limits the visibility to the on-ramp right turn lane.

Install an advance lane assignment sign east of the crest.

Extend the right turn lane east of the crest (by about 80 feet). Do this in conjunction with the new upcoming Jiffy Mart on the site of the Irving Station.

Reduce the number of accesses to the Irving Station site from two to one (with the upcoming Jiffy Mart).

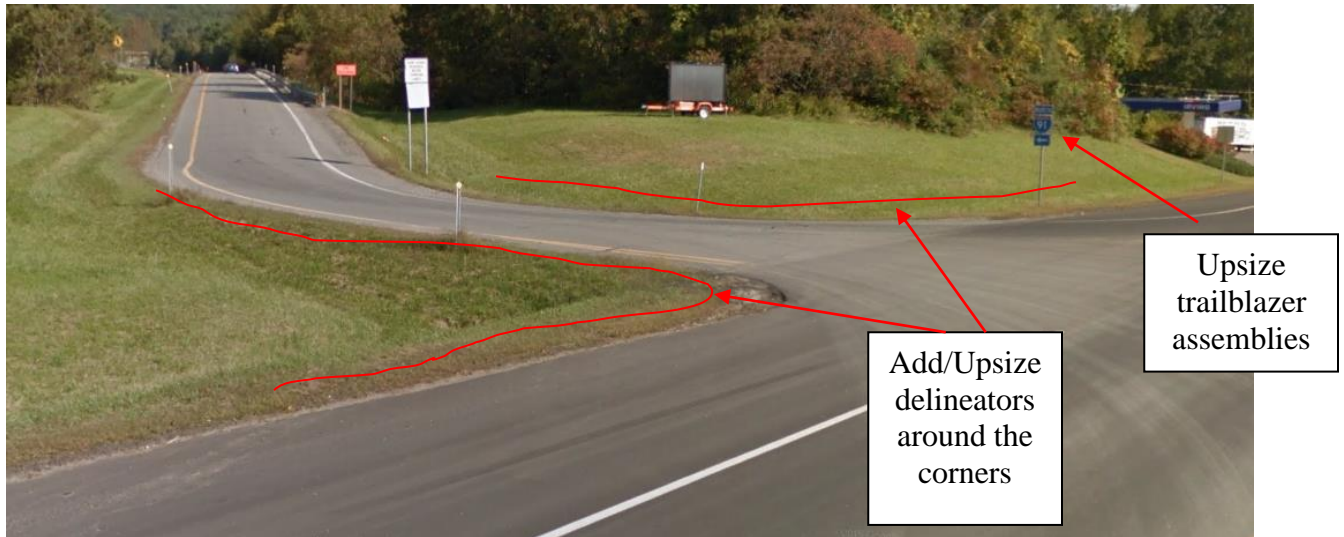
Concern: Visibility of I-91 NB on Ramp

There have been issues reported concerning the visibility of the I-91 northbound on ramp and not being able to determine where to make the turn when it was foggy or during nighttime. This is an issue that has been mostly affecting eastbound motorists on VT 30.

Install 6" x 8" delineators around the two corners of the intersection.

Upsize the I-91 trailblazer assemblies that are located at the ramp to improve detection by turning motorists. Upsize both assemblies for both directions.

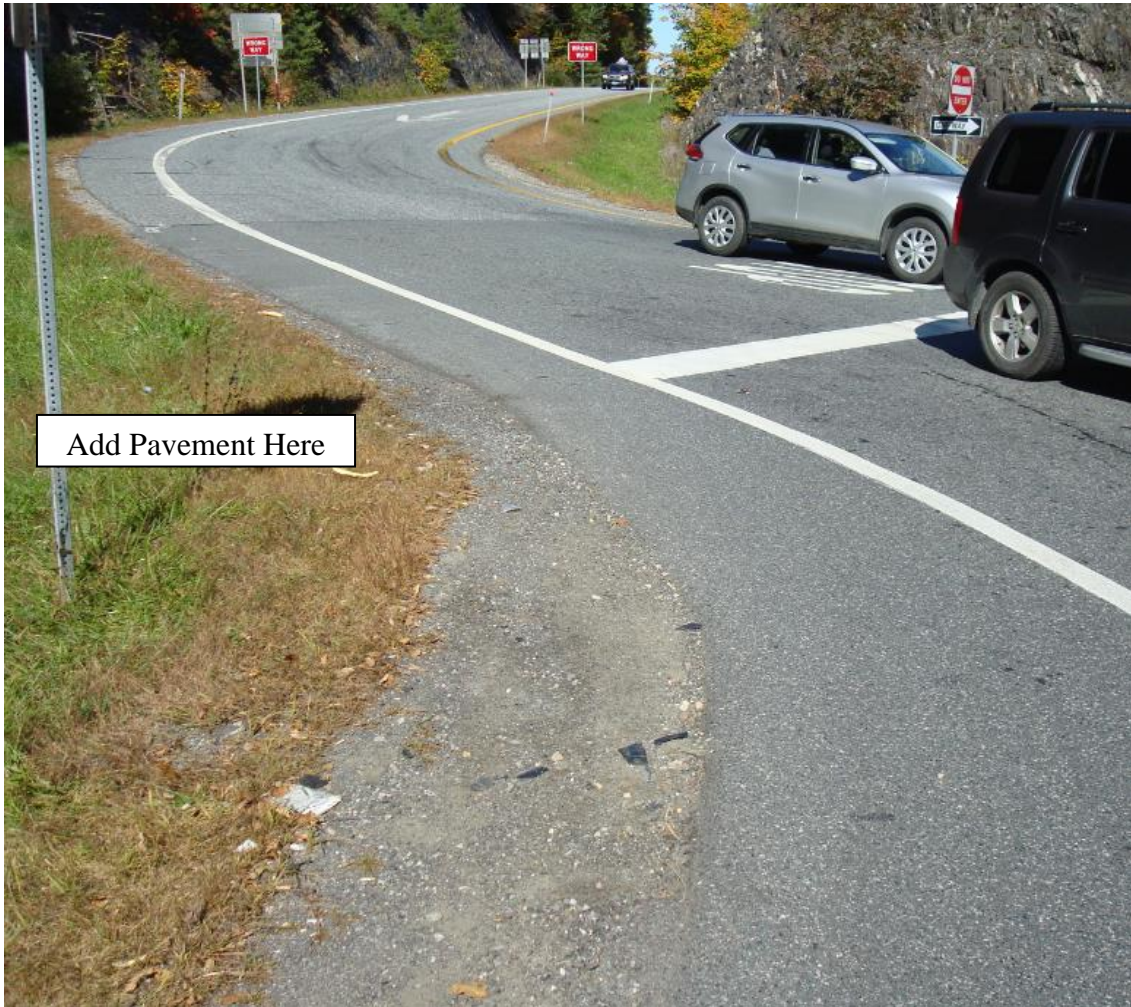
Concern: SB I-91 Off Ramp

Approaching VT 131 from the southbound off ramp, motorists partially lose sight of the intersection because of the quick hook on the ramp and the presence of some trees (that also conceal signs).

At the intersection with VT 131, corner sight distance to the right is limited by the ledge, and to the left, it has been anecdotally reported as being occasionally limited by a vehicle that stopped off the shoulder in the northeast quadrant.

Reporting of long trucks having to go to the left in order to make a right turn and crashing with a passenger car also making a right turn at the same time.

Remove the trees that are growing out of the ledge on the left side of the ramp (these are interfering with signage and the view of the end of the ramp).

Consider making a left and a right turn lane at the end of the ramp.

Add some pavement on the right corner (to give more room for trucks to make a right turn).
