Office of Highway Safety

Road Safety Audit Review

Town:	Weathersfield	Date Reviewed:	September 3, 2015
Route:	VT 131 @ Weathersfield Center Road	Mile points:	VT 131: 6.202, S0135: 8.42

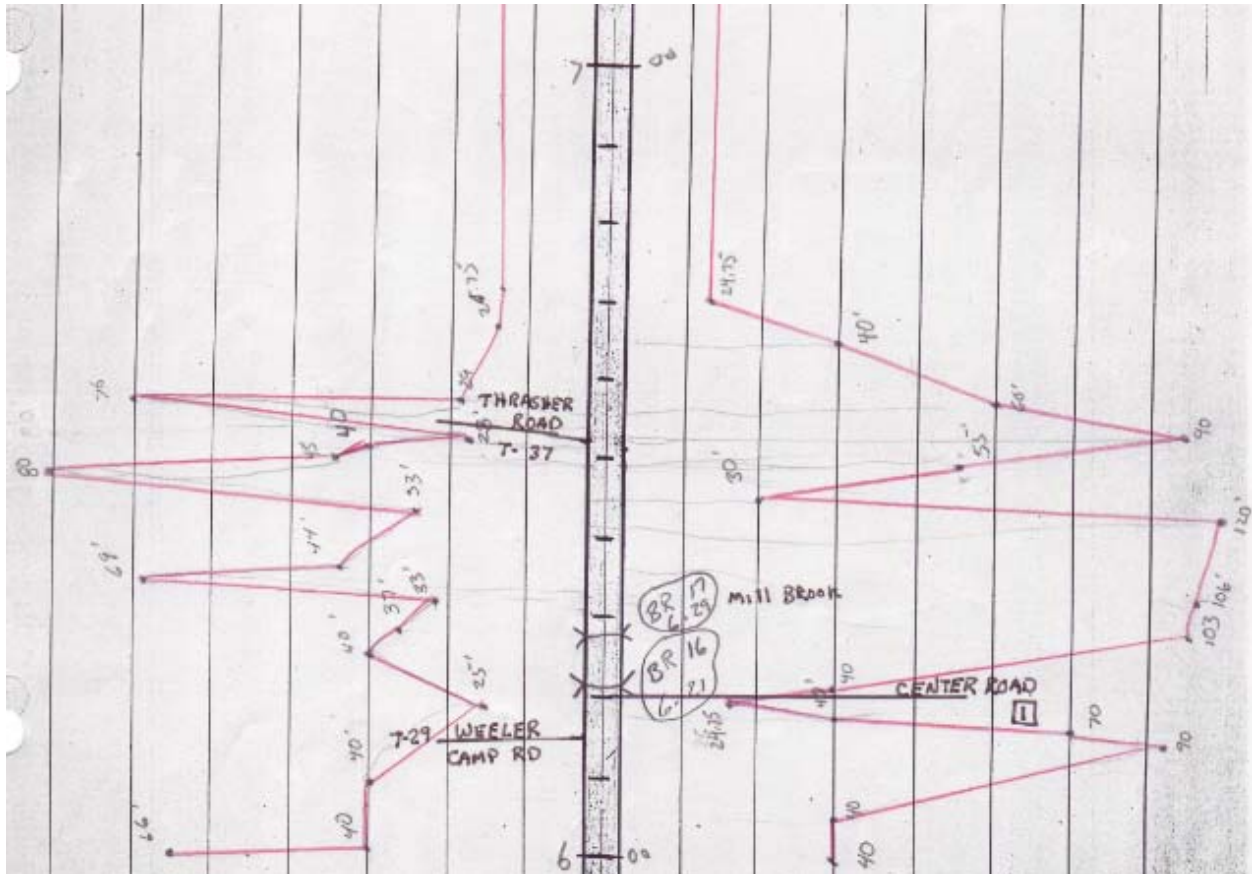
Right-of-way information was provided by the District and is depicted on the next figure. As can be seen, VTrans owns up to 90 feet on the south side between mile point 6 and mile point 6.2.

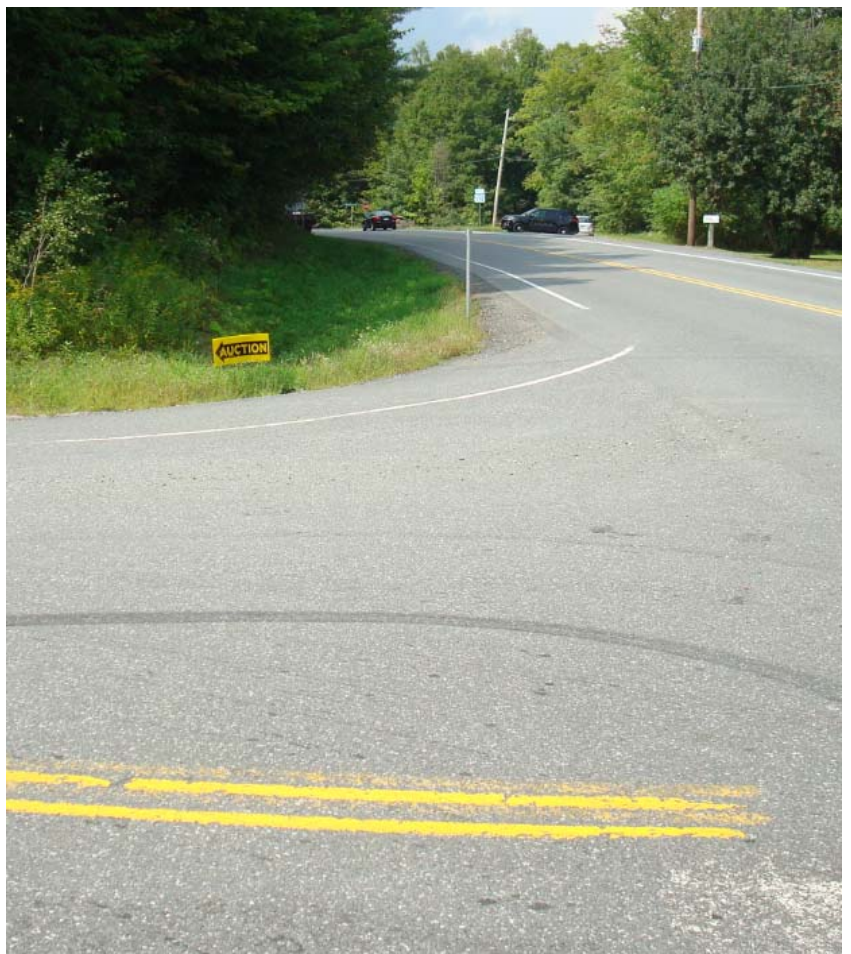
Concern: Corner Sight Distance Issue, Southwest Quadrant

The corner sight distance when stopped on Weathersfield Center Road and looking to the left (or west), is inadequate. This is caused by the embankment in the inside of the curve.

Clear trees, cut back the bank and do some slope work on the south side of VT 131 to improve corner sight distance.

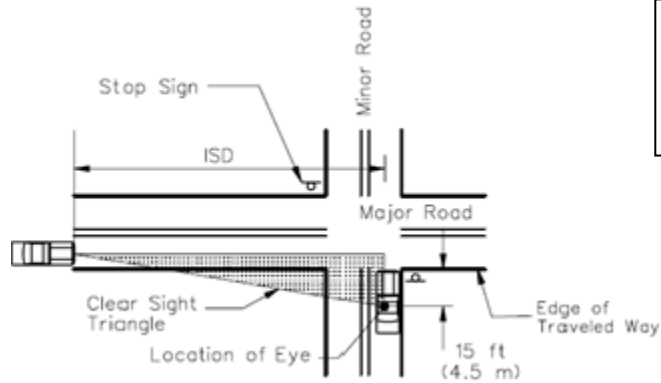
Clear Sight Triangle Concept

Note, Intersection Sight Distance (ISD) on the diagram, for 40 mph, is 445 feet as per AAHSTO and 555 feet for 50 mph.

Install a dynamic warning system (like the one at Rice lane and VT 67a in Bennington) that would warn traffic on VT 131 that a vehicle is stopped on Weathersfield Center Road. Alternatively, install the system so that a vehicle on Weathersfield Center Road is informed that an eastbound vehicle on VT 131 is approaching the intersection.

Add an advisory plaque to the eastbound advance warning intersection assembly that would match the speed for the corresponding available corner sight distance (about 420 feet, advisory speed would be 35 mph/40 mph).

Install (or relocate the existing sign) a street name sign on the north side of VT 131 across from Weathersfield Center Road so that the sign is visible by motorists traveling eastbound on VT 131. In this context, the sign would serve to indicate where the intersection is.

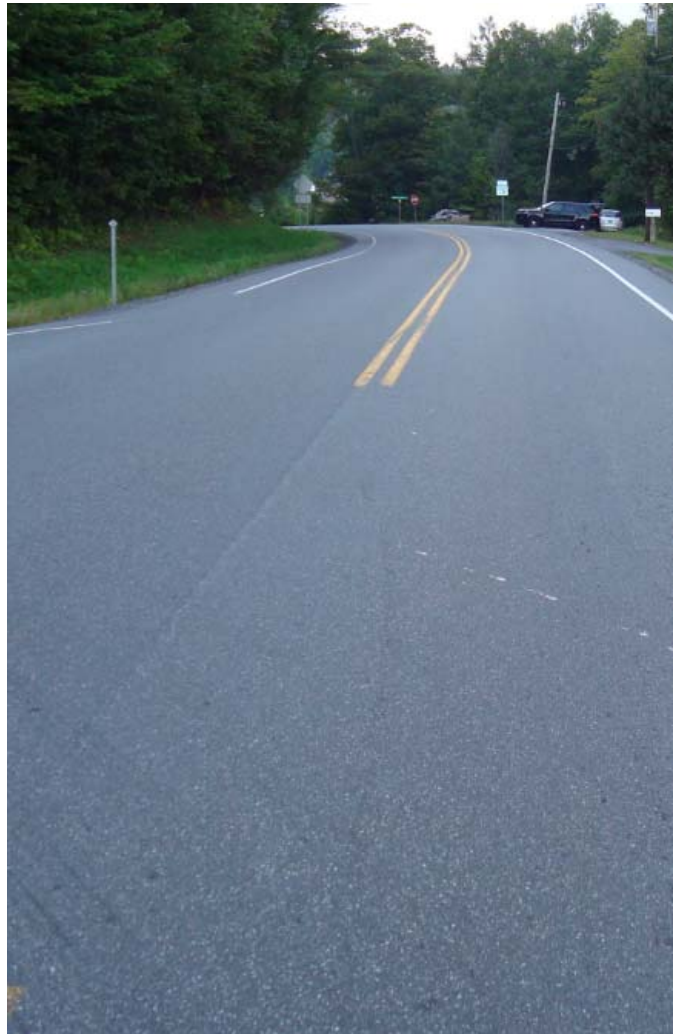
Concern: Potential Sight Distance Issue, for Westbound Left Turners

The embankment and the curve ahead are contributing to the sight distance issue.

Clearing trees, cutting back the bank and doing some slope work on the south side of VT 131 could help gain extra sight distance.

Install a side road sign (behind the guardrail near mm 6.253) to alert that motorists might be stopped in the road waiting to turn.

Volumes per hour do not warrant a left turn lane. However, removing left turners from the through traffic would help reduce crashes associated with one of the key patterns at this intersection.

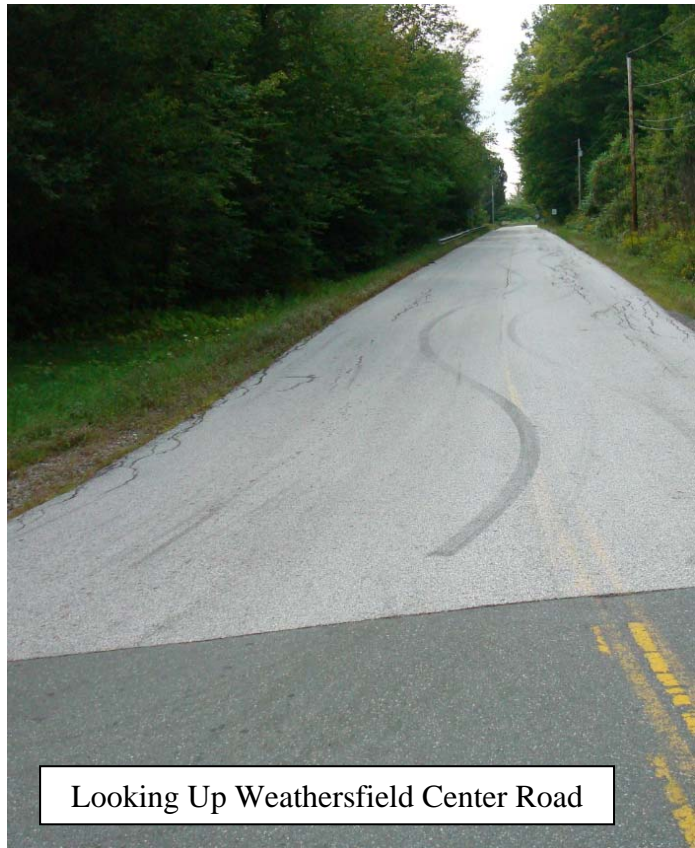
Concern: Vehicles on Weathersfield Center Road are sliding through the intersection

When Weathersfield Road is icy or snow covered, crash history indicates that road conditions would make some motorists unable to stop at the stop sign at the bottom of the steep grade as they continue across the intersection against the guardrail.

The limited crash history concerning this issue showed that this type of crashes would be common in late evening (10:00 pm). Consider this information in the winter maintenance plan.

Install a double arrow across VT 131, facing Weathersfield traffic to provide additional guidance that the road is ending.

To reduce the incidences of crashes occurring on an icy road surface, the use of an anti-icing overlay could be installed. An alternative could be to warn motorists when the road surface is icy by using a dynamic ice warning system that would have some form of flashing mechanism with the message ICING MAY OCCUR WHEN FLASHING (Detection of icy conditions would be achieved with a non-intrusive road surface sensor capable of detecting ice on the road surface).
