Office of Highway Safety Road Safety Audit Review

Town:	Marshfield	Date Reviewed:	August 22, 2017
Route:	VT 215 (Cabot Road)	Mile points:	VT 215 MM 0.0 – 0.26

Road Safety Audit Review

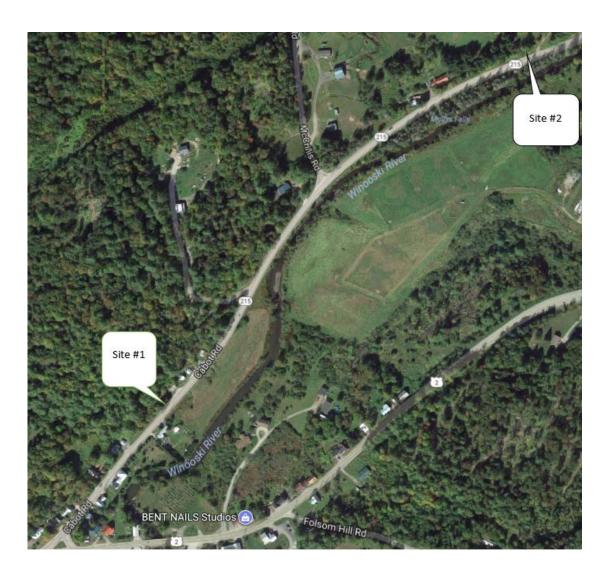
CVRPC conducted a speed study in July 2017. Data was collected in both directions at two sites. As shown on the next map, one of the sites was located 0.2 mile north of the McCrillis Rd intersection in the 35 mph speed limit zone while the other site was located in the 25 mph zone, about 860 feet north of the US 2 intersection.
