Office of Highway Safety

Road Safety Audit Review

Town:	Guilford	Date Reviewed:	June 13, 2019
Route:	US 5	Mile points:	5.80 – 6.57

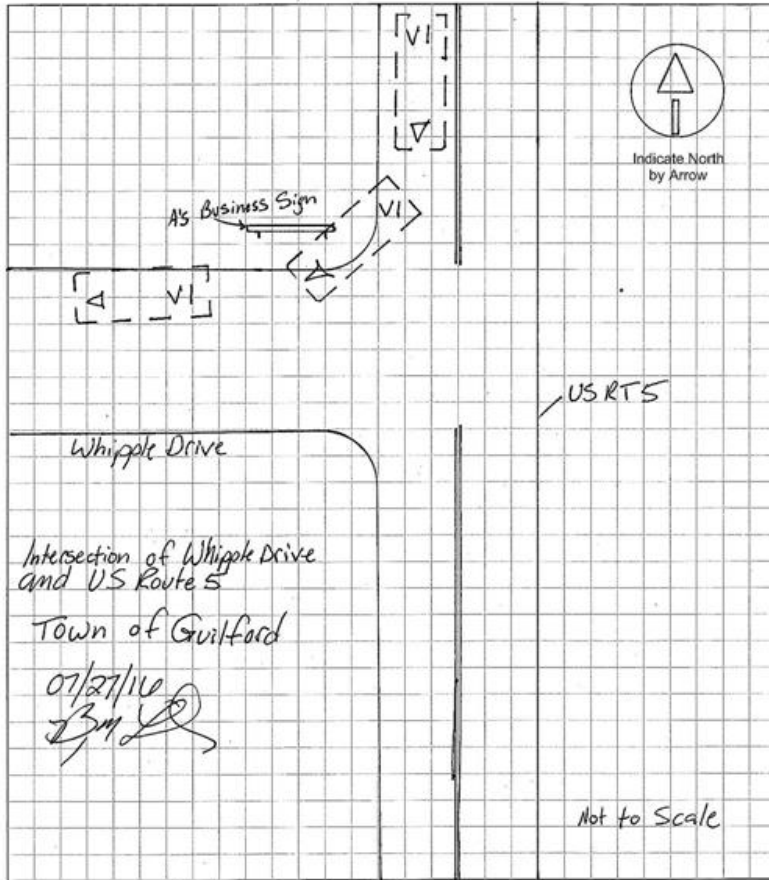
Incident Number 16D000613

On July 27, 2016 at approximately 0945 hours, a one car motor vehicle crash located on US Route 5 at the intersection of Whipple Drive. The weather at the time consisted of clear skies and the gravel roadway was clear and dry.

Statements- Operator # 1 advised he was traveling southbound on US Route 5 at approximately 5 miles per hour and turned onto Whipple Drive, so he could have a tire changed on his tractor trailer truck. Operator # 1 advised he did not believe he had crashed into anything.

Investigation- Investigation revealed that Vehicle # 1 was traveling southbound on US Route 5 and turned onto the Whipple Drive, when Operator # 1 did not turn wide enough onto Whipple Dr. to clear the A's Auto business sign at the intersection, completely destroying the sign. Vehicle # 1 continued down Whipple Drive and parked just outside of the A's garage.

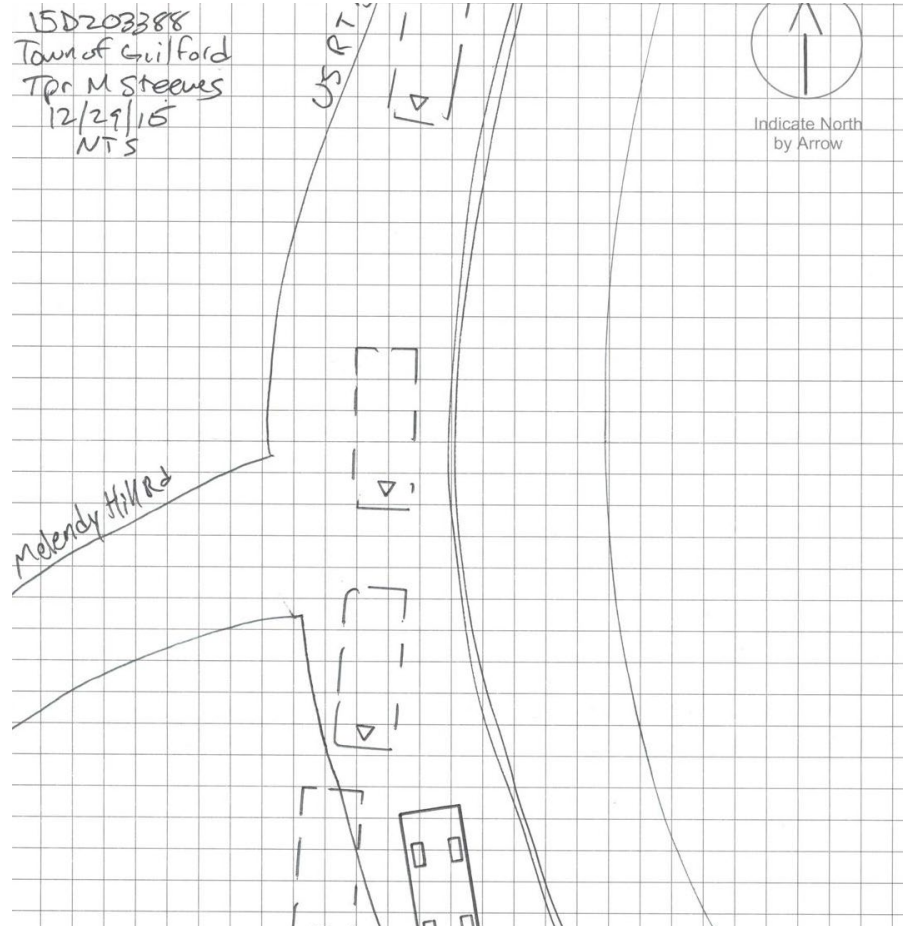
On 12/29/15 at approximately 1156 hours, a single vehicle crash on US RT 5 near Melendy Hill Rd. The blacktop road at the time was slush covered and it was sleeting. A 1992 Volvo 240 on its roof at a position of uncontrolled rest, facing south.

Statements Op 1 advised that she was traveling south on Route 5 at approximately 15 mph. She advised that as she was negotiating a left curve in the road, an oncoming large pickup truck was out of control and coming into her lane. She advised that she traveled off the west side of the road, up an embankment which caused her car to roll onto its roof.

Investigation revealed that op 1 was traveling south on US RT 5 at a speed consistent with her statement of 15 mph. Op 1 advised she swerved intentionally to avoid an oncoming vehicle. Officer was unable to locate the vehicle and did not get a complete description other than a large pickup truck. From the tire tracks left in the slush, it did not appear that Op 1's vehicle slid off the road, but was intentionally driven to the far edge of the road. After leaving the roadway, Op 1's vehicle traveled a short distance up an embankment and overturned, back onto the road surface.

Conclusion The crash was a result of Op 1 swerving off the road to avoid a hazard.

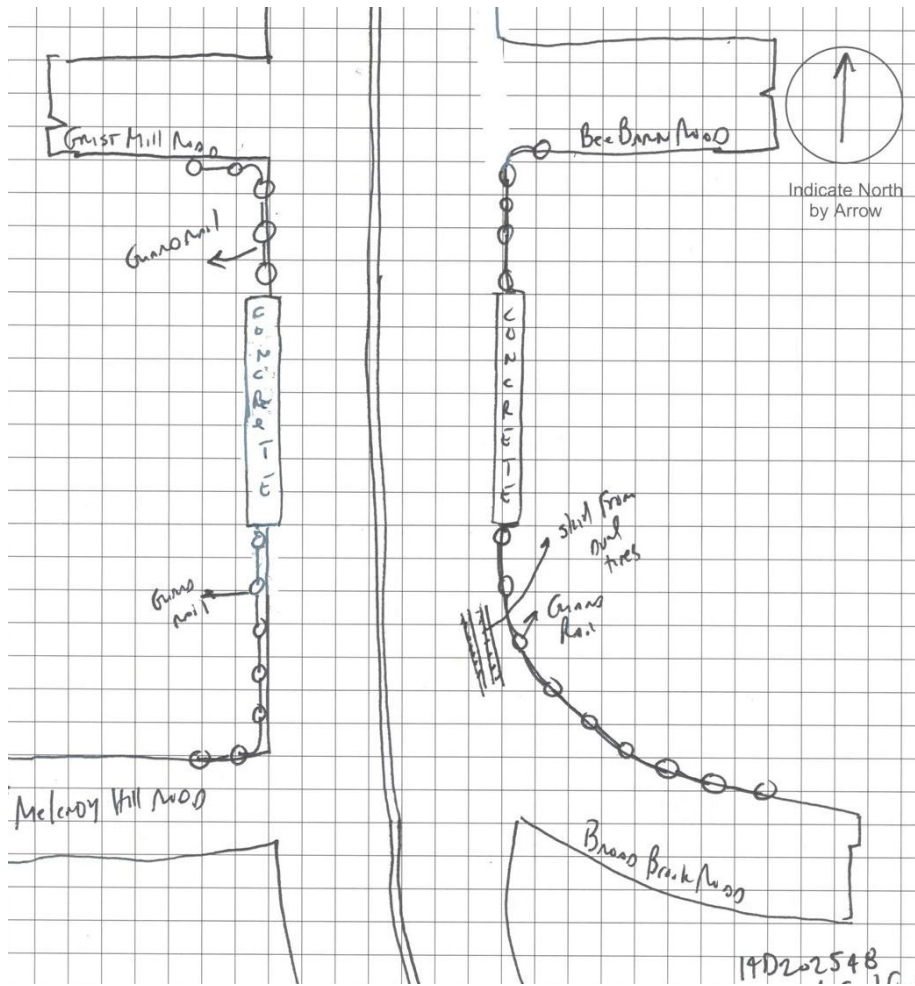
This two vehicle traffic crash occurred on the concrete bridge on Route 5 between Grist Mill Road and Melendy Hill Road. At the time of the crash, the blacktop roadway was dry . The weather was sunny and warm.

STATEMENTS: Op 1 advised that he was headed north on Route 5 at approximately 40 miles per hour. Advised that after he crossed the bridge he was hit by vehicle #2. Indicated that he believed the rear part of the cab of his truck was struck by vehicle #2. The operator of vehicle #2 advised that he was hit by vehicle #1 after he crossed the bridge. Also advised that he believed that vehicle #2 was speeding at the time of the crash.

Vehicle #1 had no visible damage from this crash, but did have an area on the driver side rear of the cab cowl that had a scuff mark on it. Vehicle #2, the driver’s side mirror had been smashed, and mirror glass had been ground into the rubber gasket on the rear part of the driver side front window. It also appeared that there was damage to the upper area of the driver side front door.

Officer was unable to identify the exact point of impact but was able to determine the following information. He located mirror debris (glass and plastic) on the bridge. He found plastic and glass in the southbound and northbound travel lanes. The larger amount of the debris was in the southbound lane. The heaviest concentration of the debris was approximately 15 feet onto the bridge from the northern end of the bridge. Based on his observation of the debris, he concluded that this was likely the point of impact. He also located a skid mark created by a dual wheel just south of the southern end of the bridge.

Officer opinion that the primary cause of this traffic crash is likely two-fold. First, the operator of vehicle #1 advised that he was traveling 40 in a posted 35 mile per hour zone. Second, the overall design of the roadway. The bridge on Route 5 is narrow for a commercial vehicle (tractor trailer) and a passenger vehicle or truck to cross at the same time. Since both operators provided conflicting information about where each vehicle was at the time of the crash and the fact that the exact point of impact cannot be determined, Officer was unable to determine which vehicle may have crossed the center line. If officer's observations of commercial vehicle traffic hold true, it is likely that vehicle #1 would have been partially in the southbound travel lane at the time of the crash.

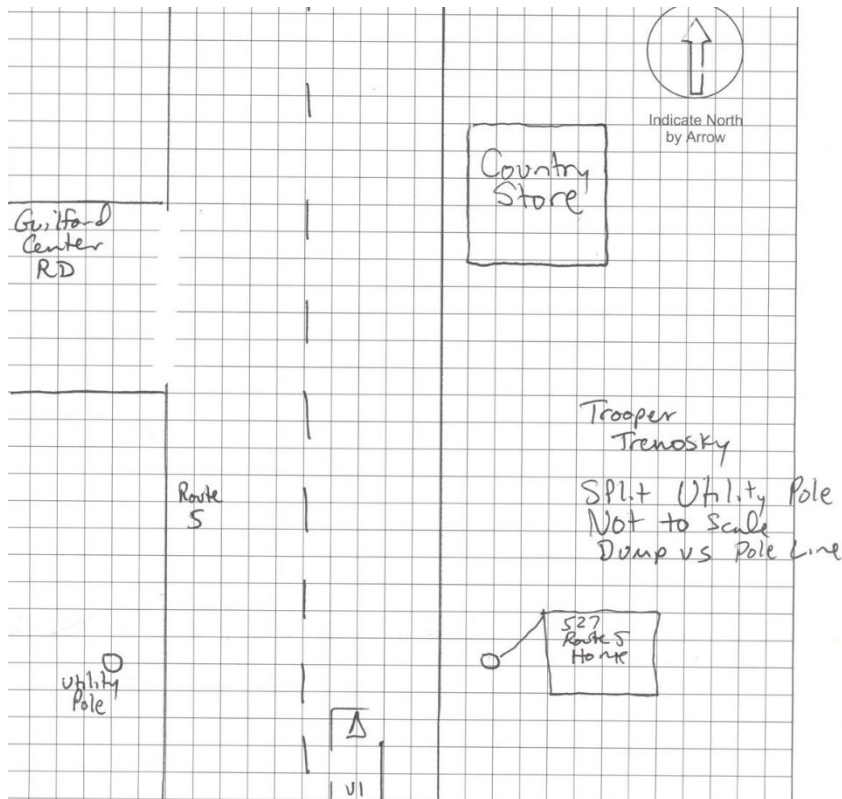
On February 11, 2015 at approximately 0054 hours, a split telephone pole and a wire down. The roadways were dry and no precipitation was falling at the time. No vehicles or other individuals were present at the scene. Operator #1 advised that he was traveling north on Route 5 and as he neared the intersection of Route 5 and Guilford Center Road he observed a transformer "blow up." Op 1 was unsure what had caused it but when he returned to the scene, advised that he must have left the lever to his "PTO" on which caused the bed of the truck to stay up. Advised that he inspected the bed of the dump truck after traveling past the blown transformer and observed that it had minor damage to the head board. The investigation revealed that Operator #1 was operating a family dump truck on Route 5 in the Town of Guilford carrying/dumping snow for a local contractor. As Operator #1 was traveling north on Route 5 and nearing Guilford Center Road he observed a blown transformer. Operator #1 was unsure what had caused it but continued north till he got to the Interchange by I-91. Operator #1 reported that he inspected his truck at this location and observed minor damage to the head board. Officer suspected that when he observed the blown transformer he felt the tug of the bed strike the power line wire which ultimately caused a utility pole to split. Operator #1 advised that he failed to properly put down his "PTO" lever which rises and drop's the bed of the dump truck. The bed of the truck was up as it travelled north and it struck a wire that went from one utility pole on the West side of Route 5 to another on the East side. Both utility poles were affected and power was cut to several hundred residents in the area. Conclusion: Officer believe that the primary cause of this crash was an inexperienced CDL operator. Operator #1 failed to engage the "PTO" lever correctly, ultimately raising the bed of the truck which struck a line on a utility pole. No evidence was found that the line had been hanging down further than it should have been. Officer inquired from the GMP personnel if this was possible and they stated it was not.

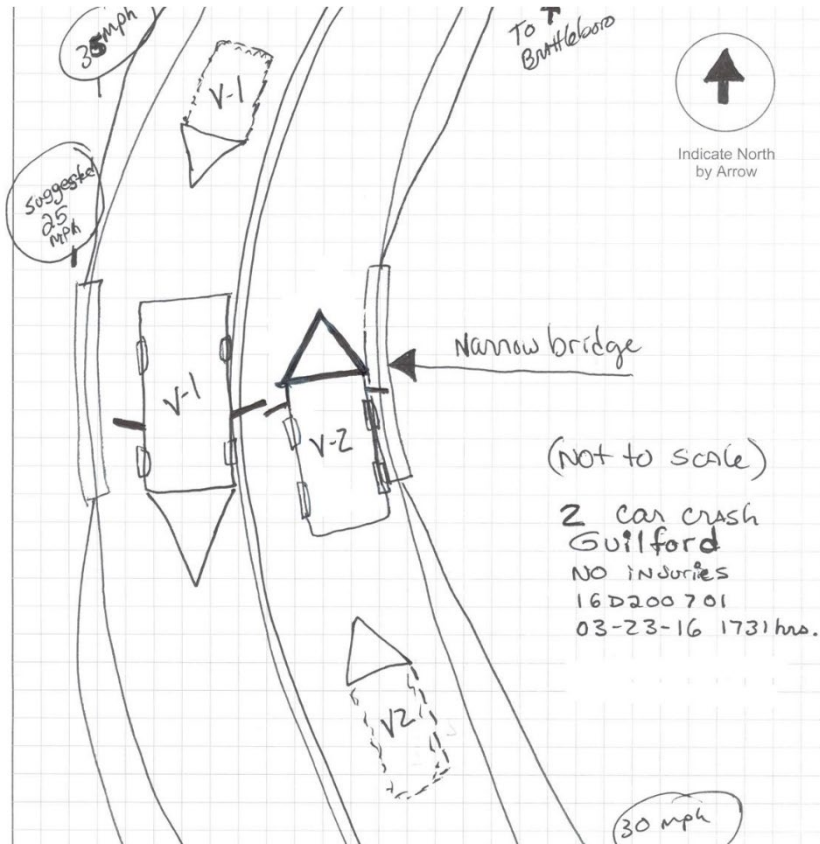
On 03-23-16, at 1731 hours, a two-car crash on Rt 5 at Grist Mill Rd in Guilford, VT. The speed limit at this location is 35 mph. At the time of the crash, the black top roadway was dry and the weather was clear. There was damage to both truck's driver side mirrors. There was also damage and signs of contact with the curb on V-2 rear passenger side wheel. There were no injuries reported at this crash.

STATEMENTS: OP-1 was traveling south bound on RT 5 approximately 35-40 mph as he approached the narrow bridge at Grist Mill Rd. OP-1 said he knew it would be tight and as he traveled over the bridge his driver side mirror struck the other vehicles mirror and OP-1 mirror folded in. OP-2 was traveling northbound approximately 20-25 mph when he saw V-1 coming the opposite direction and taking up the whole road "I moved as far right as possible." "I moved so far to the right I struck the curb." As the vehicles passed the mirrors struck. V-2's mirror was destroyed.

INVESTIGATION: Upon arrival officer observed the posted speed limit to be 35 mph. There is another sign recommending 25 MPH (yellow and black suggested speed) as you approach the bridge. The narrow bridge where the crash occurred is visible as you approach. The statements, including OP-1 himself suggest that OP-1 was traveling faster than reasonable considering OP-1 was driving a large truck with wide mirrors extending from the vehicle.

CONCLUSION: Officer found OP-1 at fault for this crash. It is my opinion that the primary cause of this traffic crash is: Op#1 traveling too fast for the conditions and hazards then existing i.e.: (the narrow bridge) while operating a wide truck with wide mirrors.

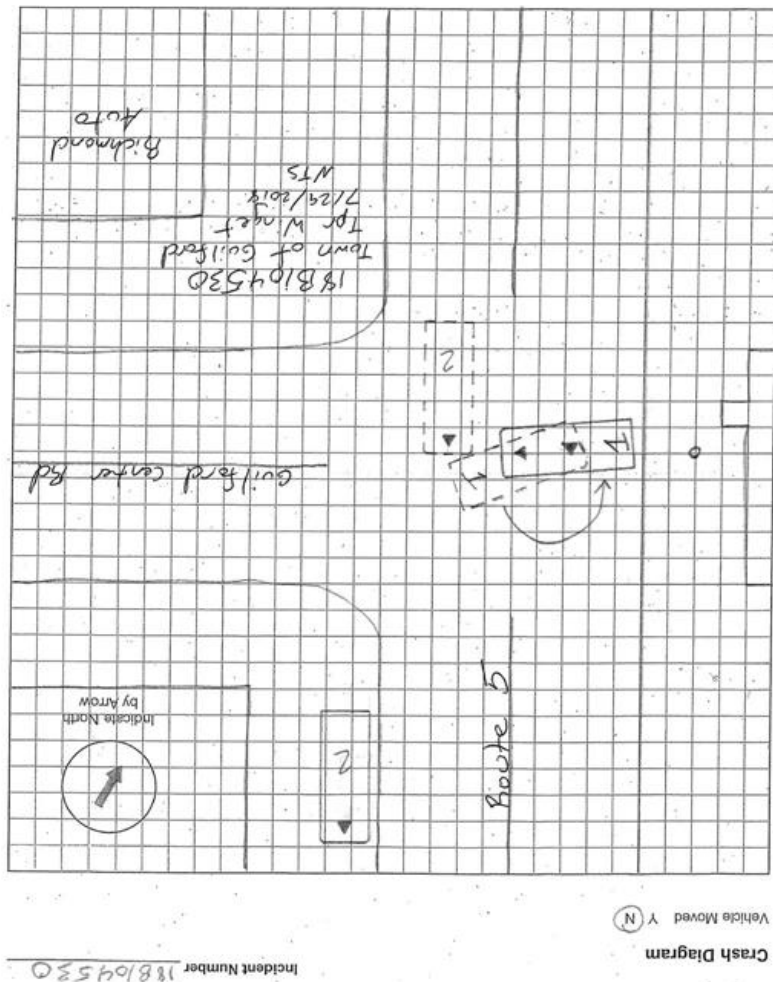
On 7/29/2018, at 1427 hours, at the intersection of Guilford Center Road and Coolidge Highway, (Route 5 for the report of a two vehicle crash. The speed limit in this area is 35 mph. At the time of the crash, the blacktop was dry and the weather was sunny.

Operator 1 was traveling East on Guilford Center Road. She came to a complete stop at the end of Guilford Center Road and looked both ways before turning left and pulling out onto Route 5 to travel north. Stated she saw vehicle #2 traveling south on Route 5. Thought she had enough time to make the turn before vehicle #1 got to the intersection, but was struck in the left rear corner of her car. Witness 1 was directly behind Vehicle #1 at the end of Guilford Center Road where it intersects with Route 5. Vehicle #1 began crossing Route 5 in an attempt to travel north on Route 5. As Vehicle #1 began crossing the southbound lane of Route 5 she was struck by Vehicle #2. Vehicle #2 was travelling southbound on Route 5. Stated that, in his opinion, Vehicle #1 was at fault for the crash as she pulled out in front of Vehicle #2.

INVESTIGATION: Reveals that vehicle 1 failed to yield the right of way and turned left onto Route 5 in front of vehicle 2. Security surveillance videos from Richmond Auto aided in the investigation of this crash since operator 2 left the scene of the crash. Operator 1 stated she looked both ways before turning and was traveling at approximately 5 mph at the time of the crash. There was a skid mark on the blacktop at the point of impact between the two vehicles. Vehicle 1 was towed away by A's Auto and Brattleboro towing towed away vehicle 2.

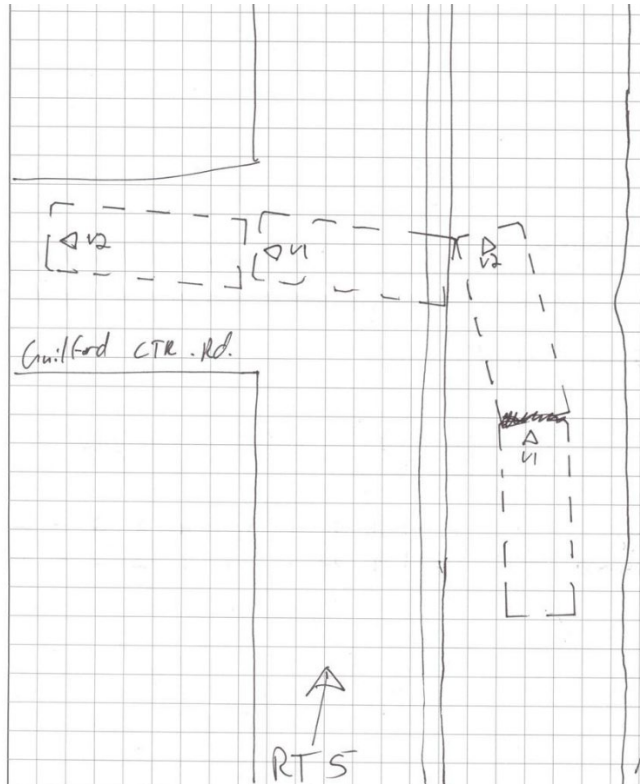
On 01/19/2014, at approximately 1258 hours, Guilford Center Road and Route 5, Guilford, for a report of a motor-vehicle crash involving two vehicles.

STATEMENTS OP1 said he was travelling northbound on Route 5, behind V2. V2 turned on its blinker and attempted to turn left onto Guilford Center Road. V1 crashed into the rear of V2 while travelling at approximately 15 miles per hour.

INVESTIGATION V1 was travelling northbound on Route 5, pre-collision. V2 was travelling northbound on Route 5, pre-collision. V1 drove into the rear of V2 and came to a controlled position of rest in a nearby parking lot, post-collision.

CONCLUSION Based on the above investigation, I believe this crash occurred because V1 was following too close to V2, and crashed when V2 attempted to make a left turn onto Guilford Center Road.

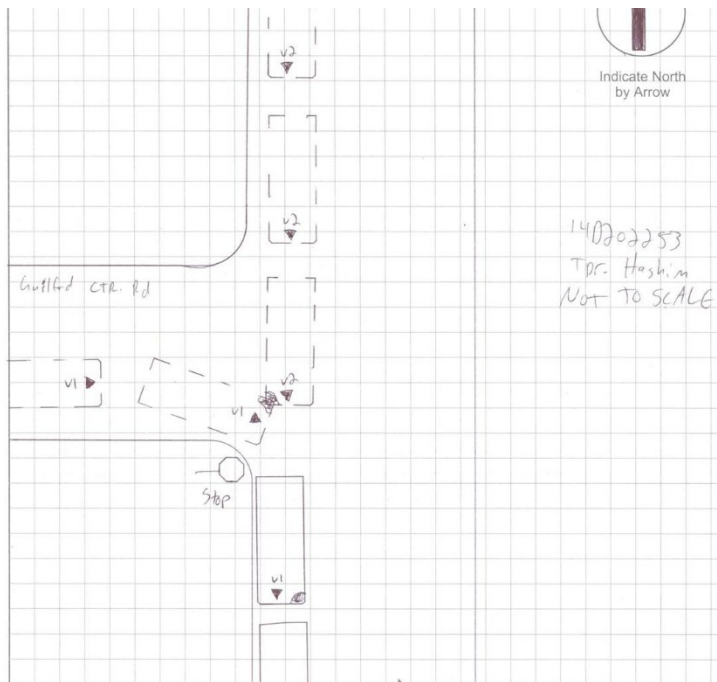
On 08/05/2014, at approximately 1918 hours, the intersection of Coolidge Highway and Guilford Center Road, in the town of Guilford, for a report of a motor-vehicle crash involving two vehicles.

OP2 said he was travelling southbound on Coolidge Highway at approximately 35 miles per hour. He said he observed OP1 stop at the stop sign; however, she pulled out of the road prematurely and crashed into his vehicle.

Based on the above investigation, I believe this crash occurred because V1 failed to yield to oncoming traffic while turning onto a road.

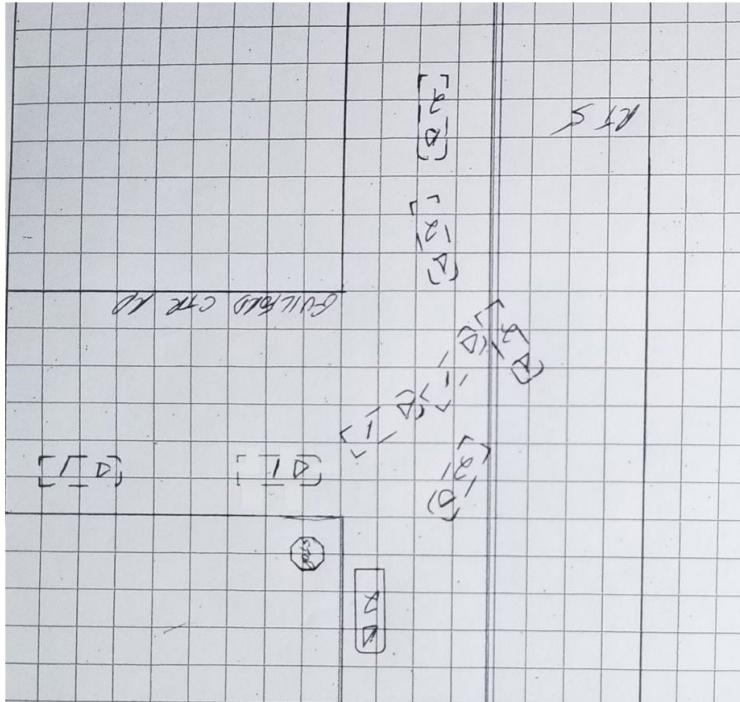
On 12/20/18 at 11:37, a two vehicle crash on Calvin Coolidge Hwy (RT 5), at the junction of Guilford Center Rd., in Guilford, VT.

OP1 said she was traveling on Guilford Center Rd. and stopped at the stop sign at the junction of RT 5. She said that she couldn't remember if she used a turn signal but that she turned left onto RT 5 to travel north. She said that she saw V2 at the last second and both vehicles hit each other.

The cause of the crash was due to OP1 turning left into oncoming traffic.

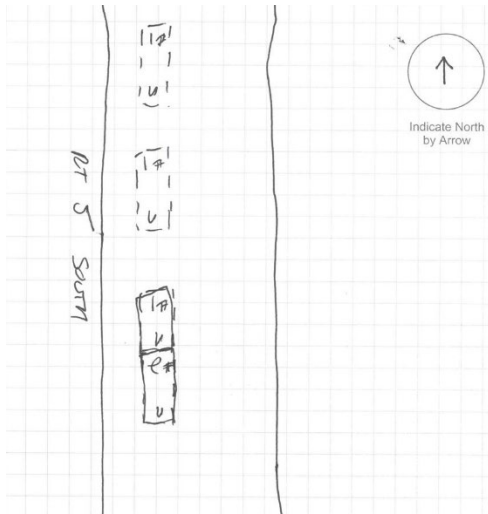
On 5/10/15 at 1531 hours, a two-vehicle crash on RT 5 in Guilford in the area of the Country Store. No injuries were reported. Weather conditions were sunny with dry, paved blacktop.

Op 1 told me she was traveling southbound when she rear ended the vehicle in front of her. Said she was distracted and didn't see the vehicle was stopped making a left hand turn.

Op 2 said she was traveling southbound when she signaled and slowed to make a left hand turn. Said she was then rear ended.

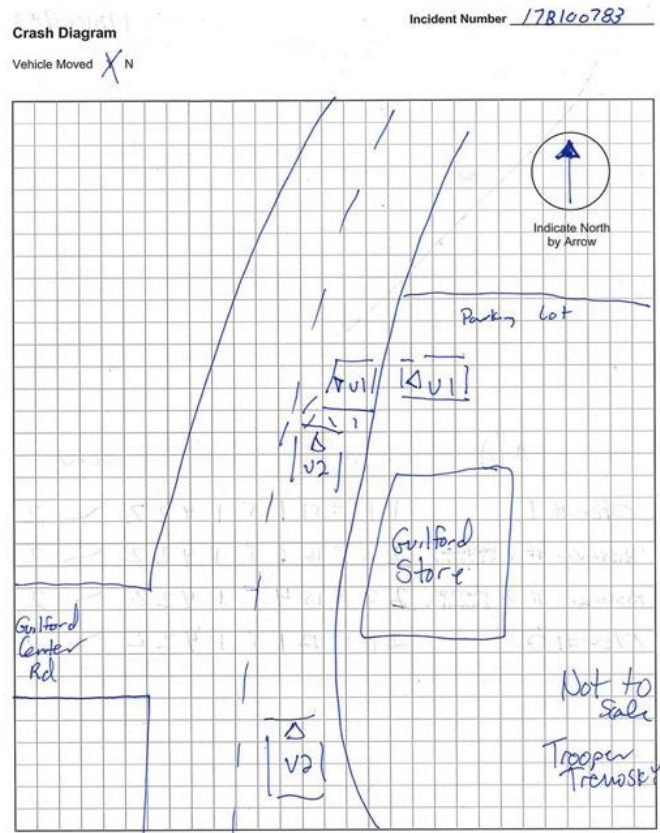
On 02-18-17 at approximately 1357 hours a two vehicle crash on Route 5 in the town of Guilford.

Operator #1 advised that she was pulling out of the Guilford store parking lot when a vehicle struck her vehicle as she made a left hand turn onto Rt. 5. Operator #2: advised she was traveling north on Rt. 5 when she observed Vehicle #1 pull out into her lane and strike her.

Investigation: Operator #1 was exiting the Guilford Country Store parking lot located on Route 5 in the town of Guilford when she failed to yield to a vehicle traveling north on Rt. 5. Operator #1 faced a slight disadvantage because the Guilford Country Store sits fairly close to Rt. 5 obstructing the view of traffic coming north on Rt. 5. Operator #2 was traveling north on Rt. 5 and as it made its way past the Guilford Store, Operator #1 pulled out in front of the moving vehicle. Operator #1 failed to yield the right of way to Operator #2. The roadways were dry and the weather was clear.

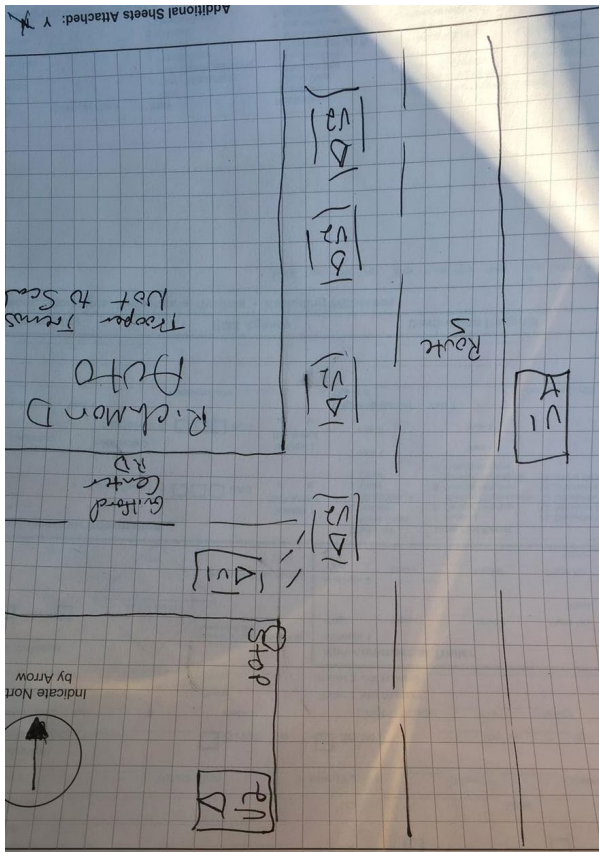
On 09-04-17 at approximately 1256 hours, a two-car crash on Route 5 at the intersection of Guilford Center Road and Route 5. Both operators reported that they sustained no injuries from the crash. The roadway was dry and the skies were clear.

Operator #1 advised that he was coming from the Guilford State Fair, made the stop at the intersection of Guilford Center Road and Route 5 when a vehicle struck his driver's side. Advised the vehicle was traveling south on Route 5 and had its directional signal on. Operator #2 advised he was driving his rental vehicle to the Guilford State Fair and following a GPS unit as he was not from the area. As he neared the intersection where the crash occurred, he placed his directional signal prior to the intersection but didn't quite know where the GPS was telling him to turn. As a result, he continued south and as he was about in the middle of the intersection, Operator #1 pulled out in front of him.

Investigation: Operator #2's account of what occurred made the most sense. Operator #2 was traveling south on Route 5 and a bit distracted from a GPS unit but still had the right of way as he was not stopped at a Stop sign. Operator #2's mistake was keeping his directional on which may have indicated he was turning onto Guilford Center Road or a driveway south of Guilford Center Road. Operator #2 was indeed traveling to the Guilford State Fair and may have reduced speed indicating this to Vehicle #1 but Vehicle #1 failed to recognize he changed his mind as to where he was making a turn.

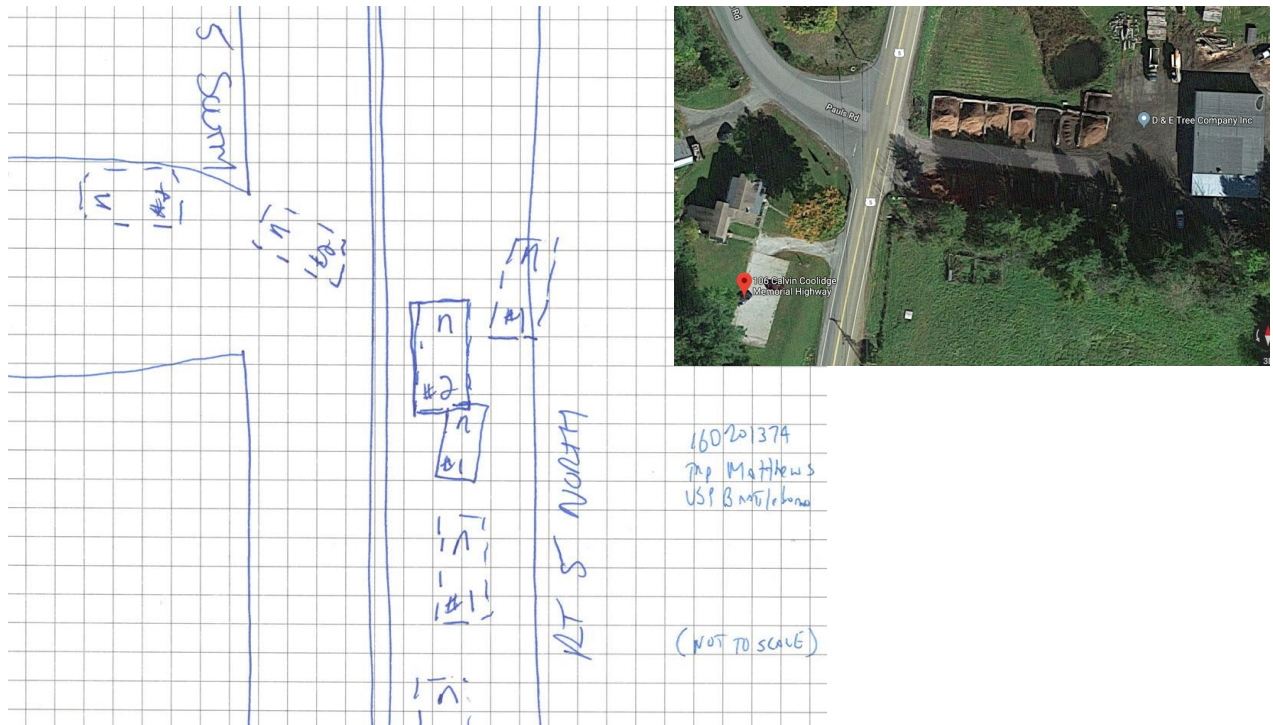
Could be at Paul's Road or at the 106 driveway.

On 6/4/16 at approximately 1226 hours, a two vehicle crash on RT 5 in Guilford. Weather conditions were partly cloudy with paved blacktop road conditions.

Op 1 was driving northbound on RT 5 at about 35 MPH when she struck the vehicle in front of her that was stopped to make a left hand turn. Said she did not notice the vehicle turning and must not have been paying close enough attention. Op 2 said was traveling northbound when she slowed and stopped in anticipation of making a left hand turn. Said that she had her turn signal on. Said she was struck from the rear by op 1.

Based on the above facts and circumstances, Op 1 determined the following: Op 1 was traveling northbound when, due to inattention, she did not notice Op 2 was slowing down in front of her and coming to a stop. Op 1 was unable to slow down or correct her path of travel before crashing into Op 2.

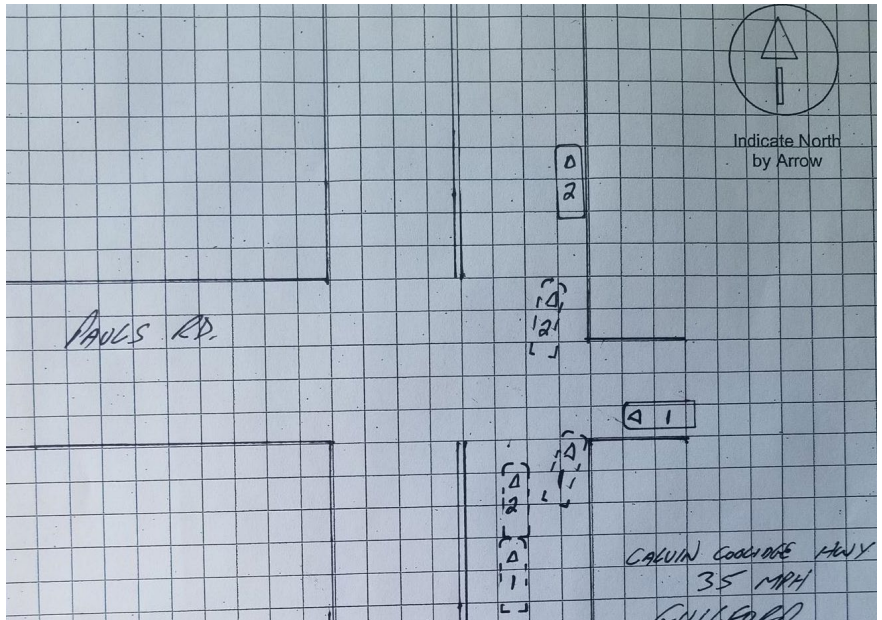
On 5/25/18 at 08:29 witness 1 called 911 to report she witnessed a two vehicle crash on RT 5 at the junction of Paul's Rd. in Guilford.

OP1 said that a school bus had stopped and that V2 had also stopped. OP1 said that he had looked up and hit the gas pedal instead of the brakes and he rear ended V2. OP1 said that he did not see if V2 had a turn signal on.

The cause of the crash was due to OP1 using the accelerator instead of the brake pedal and hitting V2.

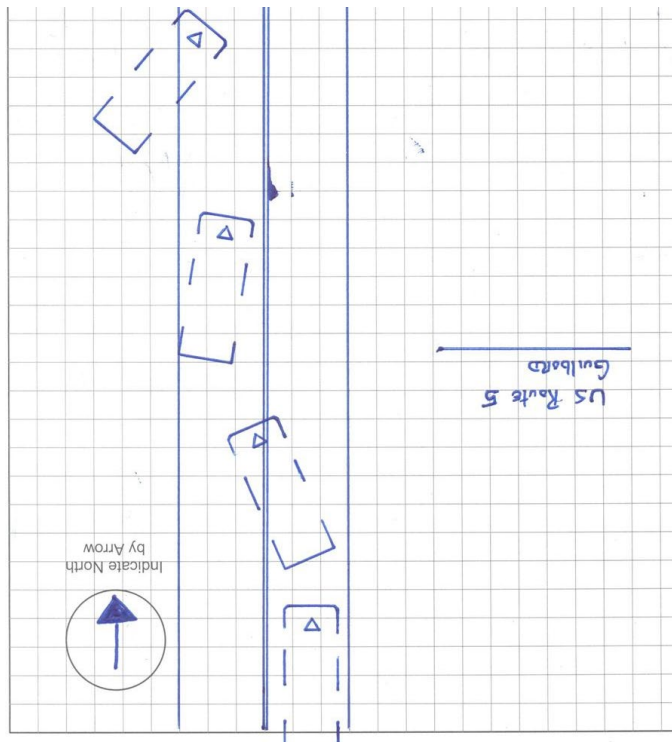
Investigation revealed that a school bus traveling north on RT 5 had stopped at the junction of Paul's Rd. V2 was behind the bus and stopped. V1 stopped behind V2. V1 then accelerated into the rear end of V2.

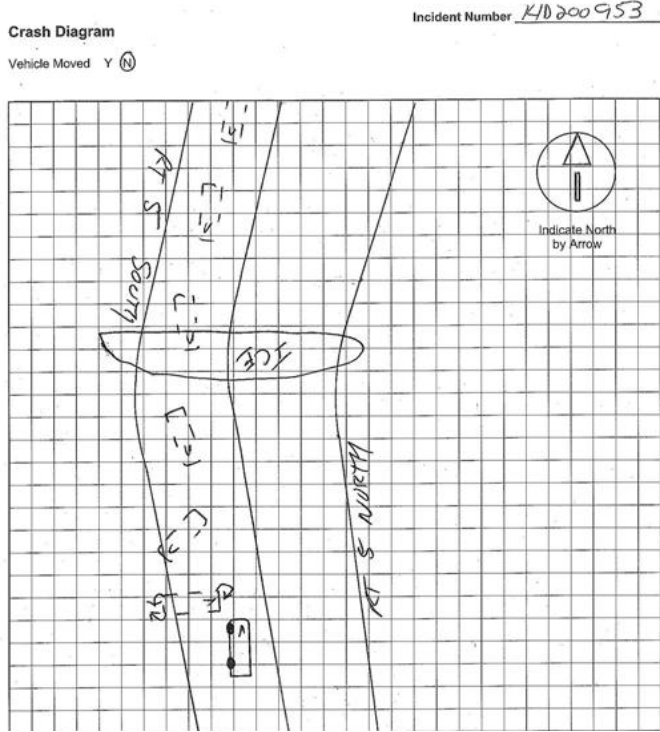
Near the town line of Guilford and Brattleboro on Route 5. The 911 call was placed because Op 1 crashed his vehicle into a line of a telephone pole. No structural damage was sustained to the telephone pole or the line.

Op 1 advised that as he travelled north-on Route 5 a deer crossed his path which caused him to swerve. Swerved right which sent his vehicle down an embankment. The vehicle travelled approximately 100 feet and came to a stop against the Telephone pole anchor line. The vehicle sustained damage to its front end which probably made it into a totaled vehicle because of its low sale value of 700 dollars. Op 1 advised that he was not going to be reporting it to his insurance company and most likely purchasing a new vehicle. No injuries were sustained as a result of this crash.
