# Office of Highway Safety

## Road Safety Audit Review

<b>Town:</b>	Coventry	<b>Date Reviewed:</b>	October 27, 2016
<b>Route:</b>	VT 105	<b>Mile points:</b>	VT 105 MM 0.792-1.092

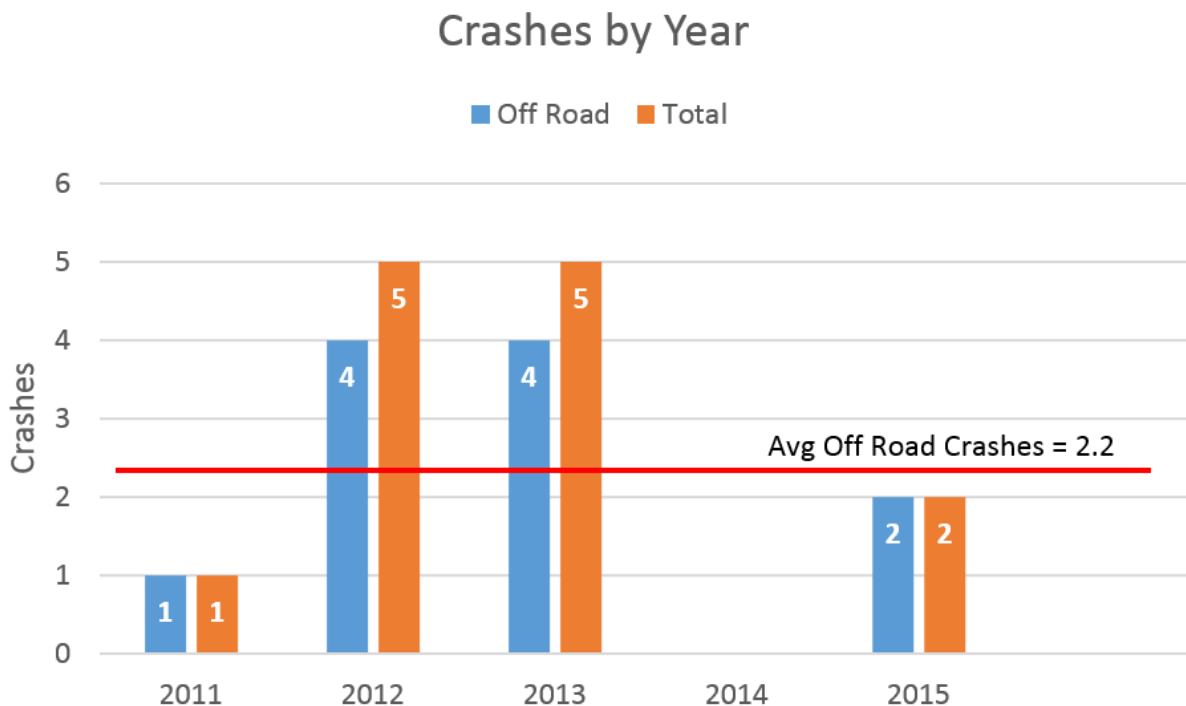
The crash history was reviewed along this segment for the five-year period covering the years 2011 to 2015. A total of thirteen crashes were reported during this period.

The principal crash pattern at this location is a single vehicle that went off the road. This crash pattern represents eleven out of thirteen crashes within this section (85%).
