Road Safety Audit Review

VT 30, Newfane Village

September 22, 2020

Vermont Agency of Transportation
Operations & Safety Bureau

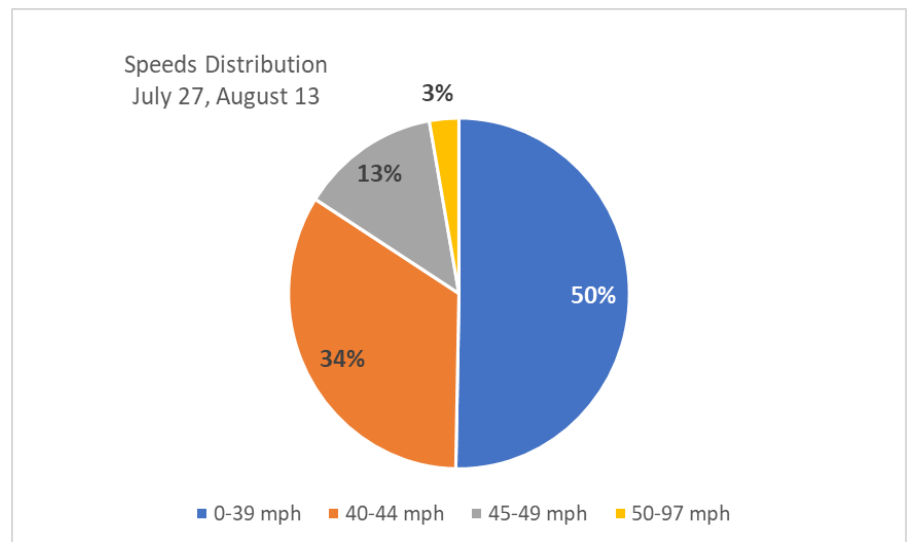
The Village of Newfane reported that during the month of July, the Windham County Sherriff's Office placed a speed cart at the north end of the Village on VT 30, across from 638 VT 30, by Kennett & Son's Auto Repair, and that between July 27, and August 13, 10,306 vehicles passed the cart heading south of VT 30 with the following results: Of the 10,306 vehicles, 291 vehicles (2.8%) registered speeds of 50 MPH to 97 MPH, 1,363 vehicles (13.2%) registered speeds between 45 MPH and 49 MPH, 3,448 vehicles (33.8%) registered speeds between 40 MPH and 44 MPH with the remaining vehicles (50.4%) traveling under 39 MPH.

From this speed distribution, the speed that 85% of the southbound motorists are driving at or below

(the 85th percentile speed) on VT 30 by Kennett & Son's Auto Repair (that is, just north of the crest of the hill) can be estimated to be at least 44 mph.

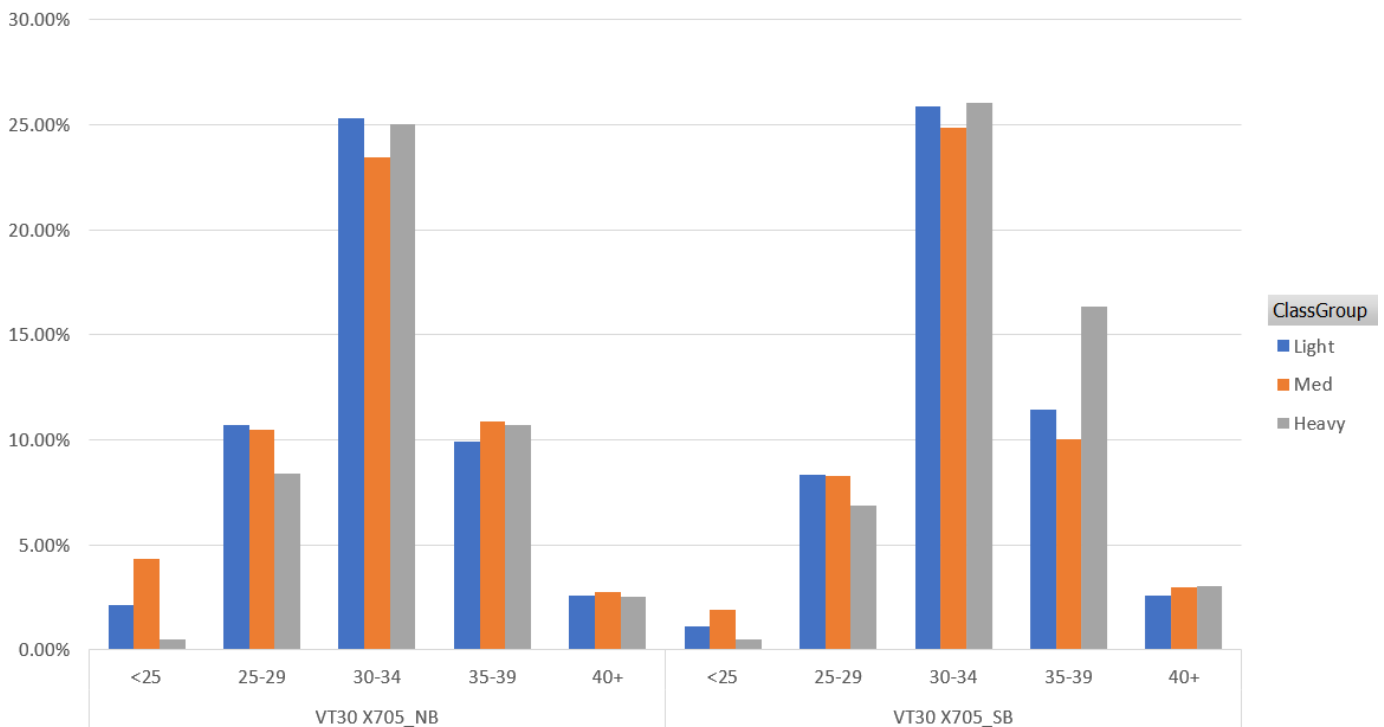
The graph below summarizes the proportion of vehicles by speed and class groups by direction of travel on VT 30 in front of the county courthouse. In the graph, the light class group represents motorcycles, passenger vehicles and pick-up trucks, the medium category denotes busses and 2 to 4-axle single unit trucks while the heavy category designates tractor-trailers.

The graph illustrates that the proportions of vehicles for each of the three class groups within a speed category are usually close to each other. The graph shows that there is an exception and that the proportion of heavy vehicles in the 35 to 39 mph speed range for the southbound direction is larger than the other two class groups.

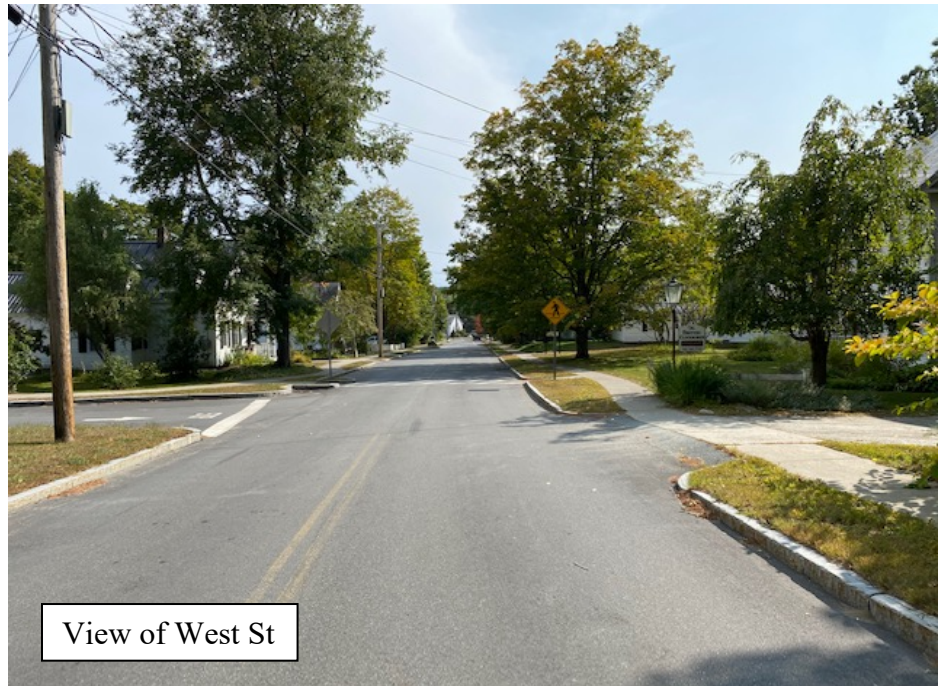
View of West St

West St is characterized by sidewalks separated by grassy curbed islands, crosswalks and crosswalk extensions.

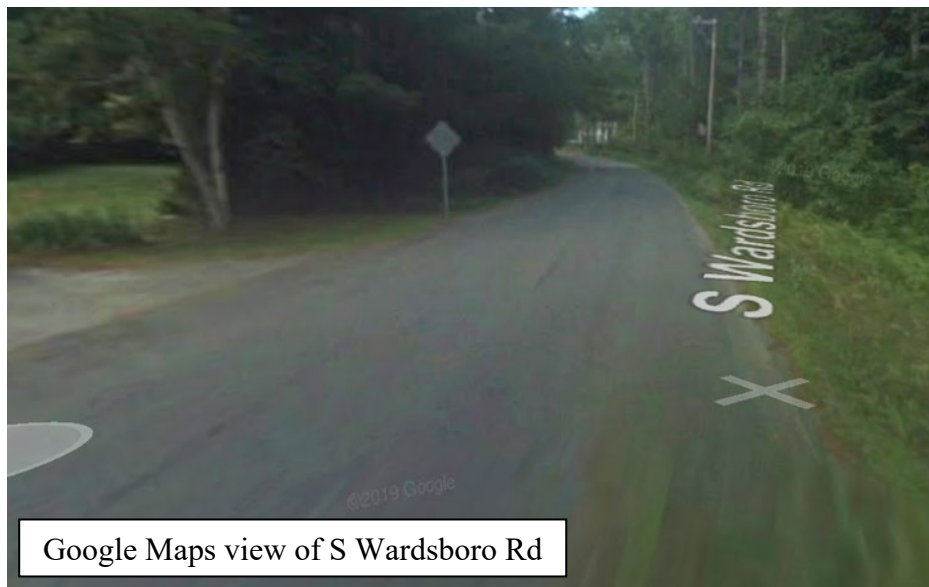
Google Maps view of S Wardsboro Rd

As West St becomes South Wardsboro Rd the character of the road changes. The sidewalk on the south side of the street continues for a short distance up to the house located at 9 South Wardsboro Rd. From that point west, the road becomes more rural.

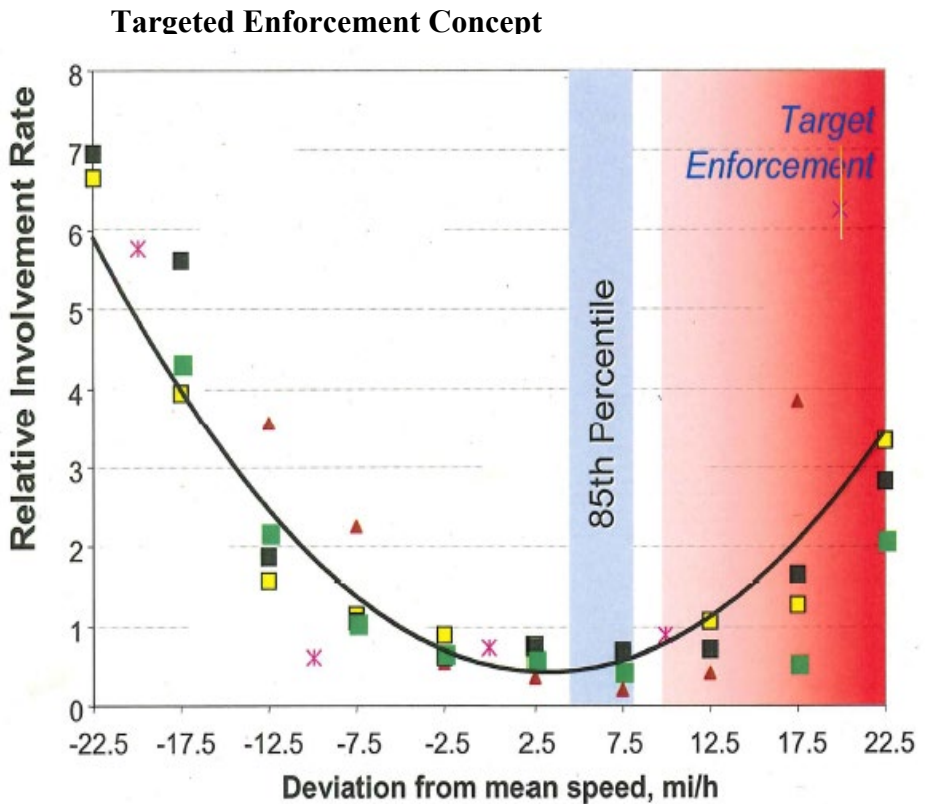
The next graph shows that the crash involvement rate increases as traveling speeds deviate from the 85th percentile speed. This means that targeting motorists that are traveling above the 85th percentile speed will apprehend motorists that are more likely to cause a crash. Crash involvement starts to increase more drastically 5 mph above the 85th percentile speed or around the 90th percentile speed.

- Conduct recurring speed limit enforcement campaigns for the high-risk drivers (target drivers at or above 5 mph above the 85th percentile speed 43 mph).

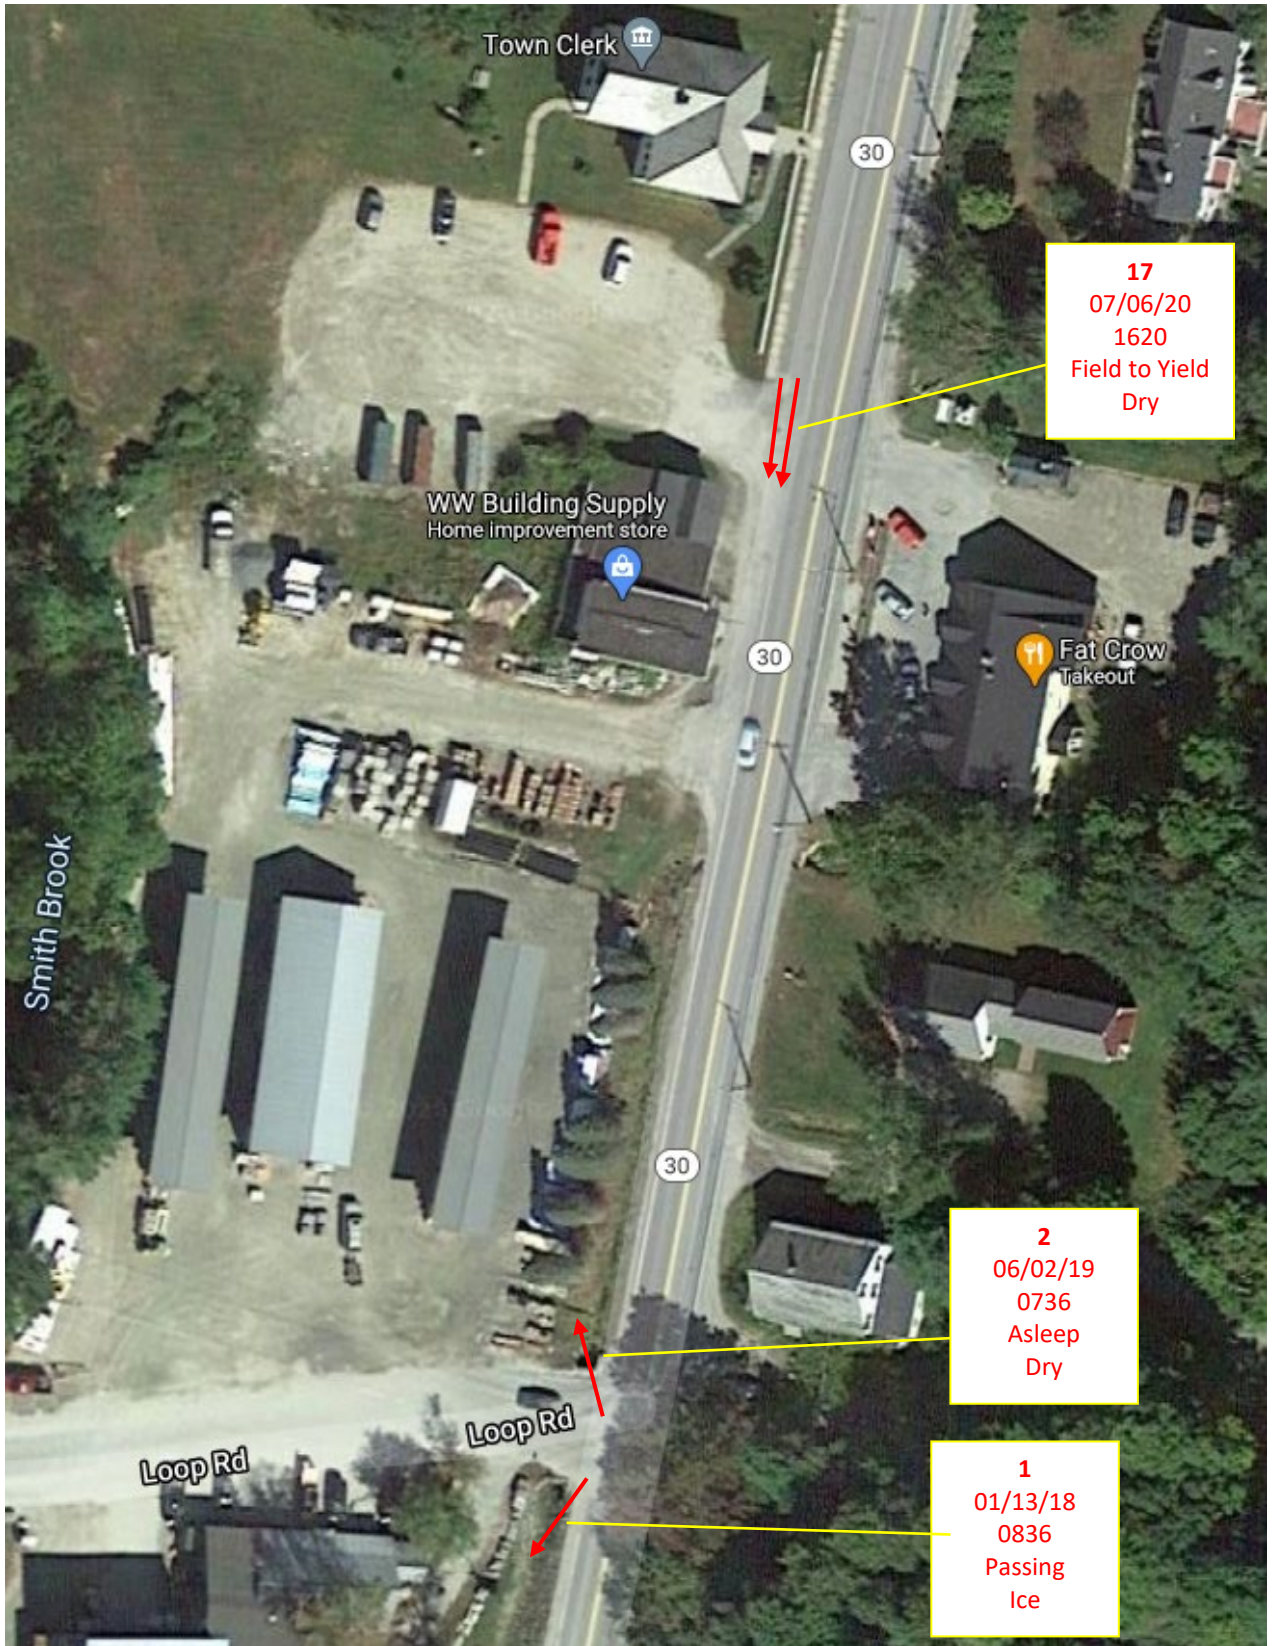
17
07/06/20
1620
Field to Yield
Dry

2
06/02/19
0736
Asleep
Dry

1
01/13/18
0836
Passing
Ice
