Road Safety Audit Review

Town:	Milton	Date Reviewed:	October 19, 2016
Route:	Westford Rd & Main St (mm 0.63) Main St and Railroad St (mm 0.47)	Mile points:	0.47 to 0.69

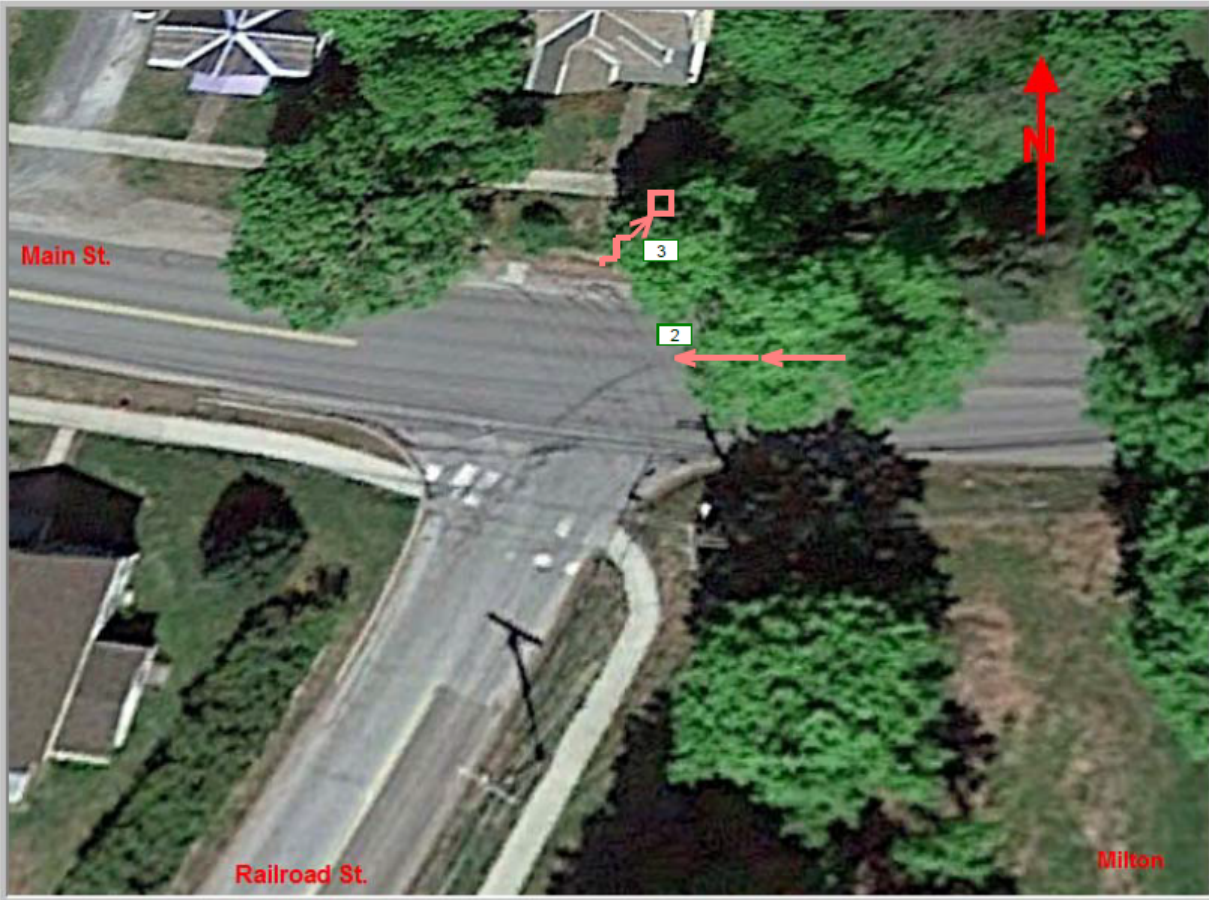
COLLISION DIAGRAM

Crash Number	Road	Marker	Date	Time	Weather	Injuries	Fatalities	Type	Description
1	Main St at Railroad St	0.47	10/8/2015	22:02				Single Vehicle	Officer was conducting patrol in a Marked Milton Police Cruiser. Was traveling sb on Railroad St. Near the area of McMullen Rd, observed a vehicle traveling nb which appeared to be exceeding the posted speed limit. Activated patrol car's radar and observed the target speed of the approaching vehicle was 43 MPH. Officer continued to follow the vehicle with my patrol cars lights activated as it went over the railroad tracks and around a corner. The vehicle appeared to speed up. Officer activated patrol car's siren in addition to the blue emergency lights. The vehicle then accelerated to a higher speed. At the intersection of Railroad St and Main St, the vehicle failed to yield for the stop sign and continued through the intersection without stopping, colliding with an embankment. Officer subsequently conducted SFST's on the defendant at the Milton Police Department and determined she was not under the influence of drugs or alcohol.

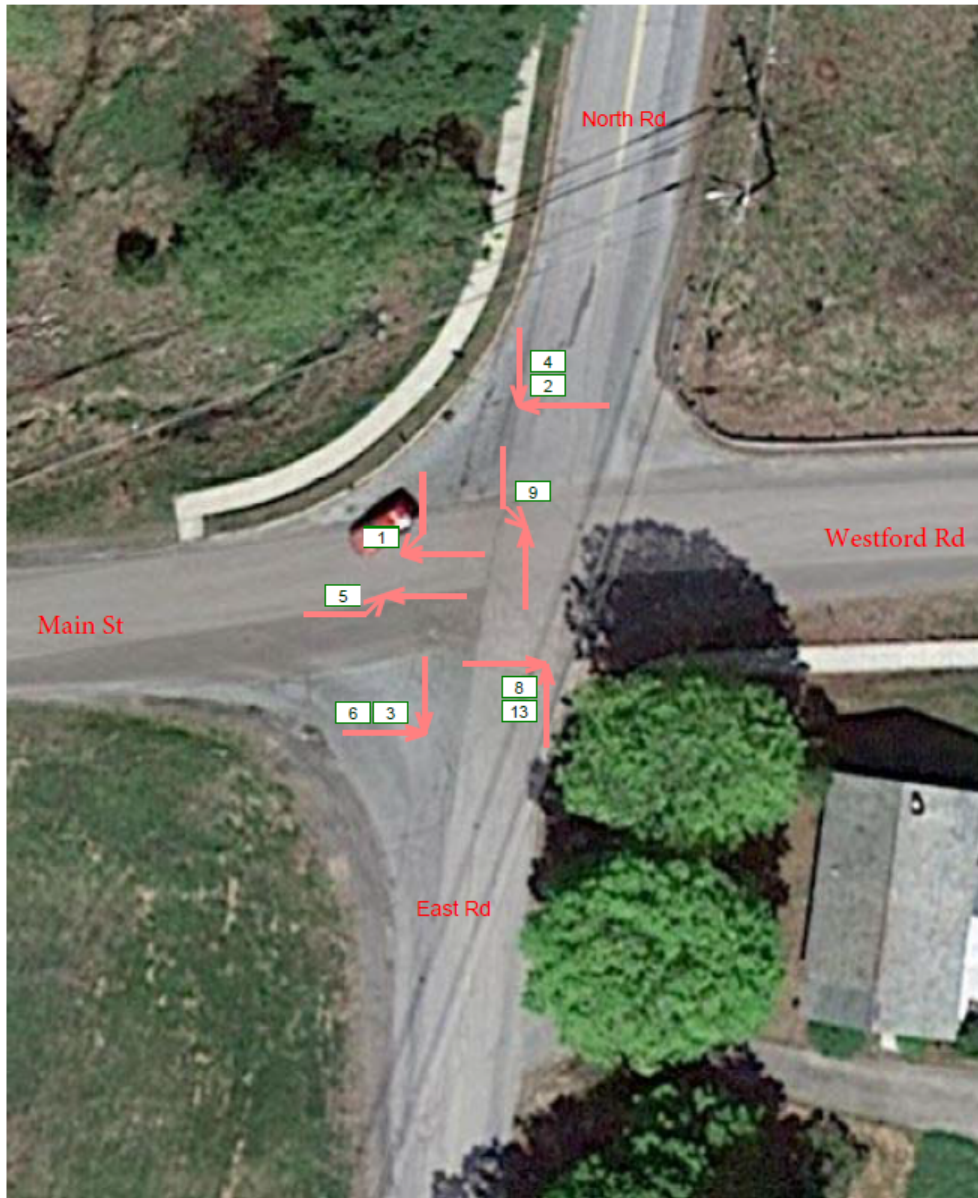
Key Number = 1

Crash Number	Road	Marker	Date	Time	Weather	Injuries	Fatalities	Type	Description
1	Westford Rd	0.63	3/13/2011	17:22	Cloudy	1	0	No Turns- Thru moves only- Broadside ^<	On 03/13/2011 I responded to the intersection of Westford Road and East Road in the Town of Milton for a reported two-vehicle collision with possible injury. I was the first to arrive on scene. Upon arrival, I observed multiple vehicles in the southbound lane of Westford Road/Main Street. All four roads at the time of the incident were paved and were wet. The weather was overcast and it was light out. I first spoke with Operator #2. She told me that she had been traveling west on Westford Road. As she approached the intersection where the accident occurred, she observed a vehicle turn from North Road onto Main Street without stopping at the stop sign. She told me that she was slowing down when Vehicle #1, which had stopped on East Road, traveled straight through the intersection onto North Road. She said she collided with Vehicle #1, and that she had not moved her vehicle since the collision. I then spoke with two witnesses, they both told me they were traveling behind Vehicle #2. They said Vehicle #1 pulled into the intersection, traveling from East Road to North Road, in front of Vehicle #2. They said Vehicle #2 could do nothing to avoid the collision. I then spoke with Operator #1. He told me he was unfamiliar with the area and the he had just moved into a house in Fairfax. He said he was on East Road stopped at the intersection. He said he saw Vehicle #2 traveling west on Westford Road, but thought there were stop signs on all four roads. He said he entered the intersection, where Vehicle #2 collided with him. Investigation: During my investigation, I found Vehicle #1 had entered the intersection from East Road. Vehicle #1 was traveling north, intending on entering North Road. Vehicle #2 was traveling west on Westford Road. Vehicle

Crash Number	Road	Marker	Date	Time	Weather	Injuries	Fatalities	Type	Description
									<p>#1 entered the intersection in Vehicle #2's path of travel. Vehicle #2 was unable to avoid the collision, and struck Vehicle #1 in the passenger side rear quarter panel area. This caused Vehicle #1 to spin clockwise 180 degrees and come to a position of uncontrolled rest in the southbound lane of Westford Road, facing south. Vehicle #2 traveled approximately 10 feet further after the impact before coming to a position of controlled rest in the intersection, facing northwest. Conclusion: The statements of the operators, witnesses, and evidence at the scene lead this officer to believe the cause of the collision was Operator 1 failing to yield right of way to Vehicle #2, which was traveling on a highway which did not require vehicles to stop before entering the intersection.</p>

Crash Number	Road	Marker	Date	Time	Weather	Injuries	Fatalities	Type	Description
3	Westford Rd	0.63	7/26/2011	15:38	Cloudy	1	0	No Turns- Thru moves only- Broadside ^<	On July 26, 2011, the Milton Police Department responded to a report of a two-car motor vehicle crash at the intersection of Main Street and North Road. Operator #1 indicated she had entered the intersection from North Road traveling southbound. She seemed uncertain if she had stop or not. Operator #2 who advised he had been traveling eastbound on Main Street. He advised as he entered the intersection, he observed Vehicle #1 enter the intersection without stopping at the stop sign. He advised Operator #1 did not slow down and he was unable to avoid the collision. Witness 1 initially advised he believed Vehicle #1 had entered the intersection traveling northbound from East Road, intending to cross onto North Road. When I pointed out to Witness 1 that both operator's statements refuted this and in fact placed Vehicle #1 traveling the opposite direction, he advised he could not be certain and advised "it just happened so fast, it was like it was in slow motion". Witness 1 advised he was unsure if Vehicle #1 had stopped at the stop sign or not. I then spoke with Witness 2 who advised she'd observed the crash. She advised Vehicle #1 pulled in front of Vehicle #2, but was unsure if the vehicle had stopped and then proceeded or simply had continued without stopping. Witness 2 further advised upon speaking with Operator #2, Operator #2 stated she was on her phone at the time of the crash. When I spoke to Operator #2 about this, she denied that she was on the phone at the time the crash occurred. She advised she had called directly after to let her boyfriend know she was involved in a crash. INV: The roadway at the time of the crash was dry and clear. The weather was overcast and it began to rain lightly shortly after the crash occurred as the scene was being cleared.

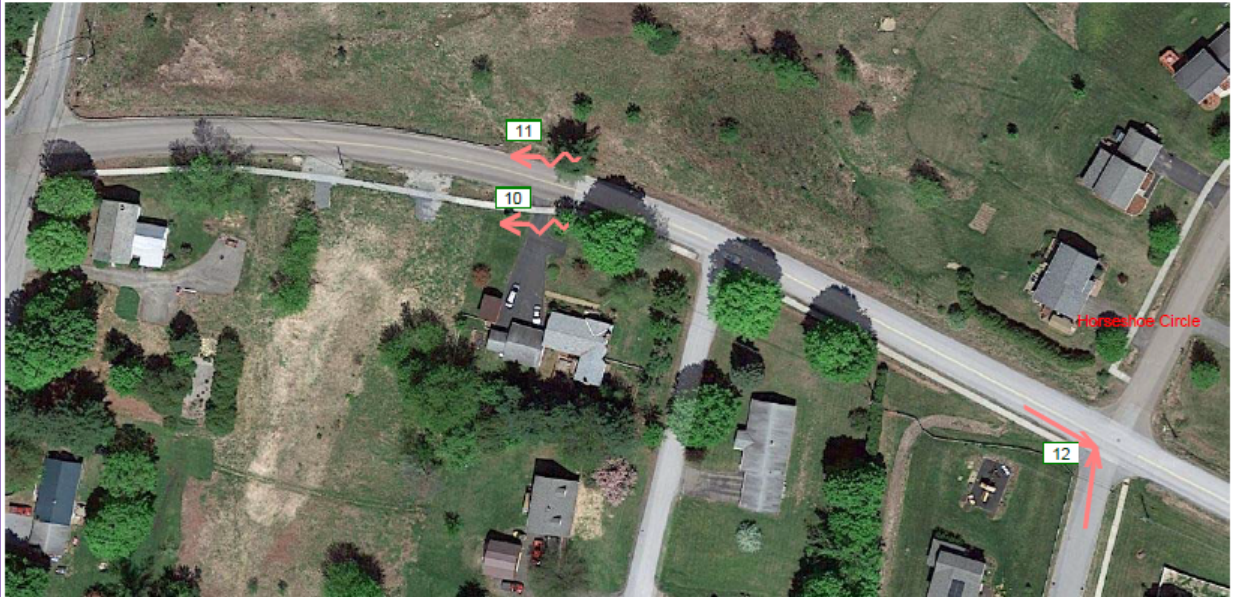
Key Number = 2

Crash Number	Road	Marker	Date	Time	Weather	Injuries	Fatalities	Type	Description
10	Westford Rd	0.72	12/8/2013	7:40	Cloudy	1	0	Head On	<p>On Sunday, December 8th, 2013, Westford Road near the intersection with North Road in the Town of Milton for a report of a motor vehicle crash. STATEMENTS: Op 1 advised she was traveling west on Westford Road when her vehicle left the right side of the roadway, onto the shoulder. Op 1 advised she overcorrected to the left, which caused her vehicle to slide sideways across Westford Road and into the ditch on the opposite side of the road. Operator 1 advised she was traveling at approximately 40 mph. Witness 1 advised he was driving east on Westford Road when he observed Operator 1's vehicle drive off the road onto the shoulder. He advised their vehicles passed each other and he looked in his rearview mirror and observed Operator 1's vehicle sliding sideways across Westford Road and into the ditch. Witness 1 advised he did not believe the vehicle was traveling excessively fast and estimated the speed at 40 mph. Operator 1 said she was traveling west on Westford Road at 40 mph when a tan SUV pulled out of a driveway. Operator 1 advised the vehicle drove slightly into her lane so she drove to the right side of the roadway. She advised her tires left the pavement and she overcorrected to the right, causing her vehicle to slide sideways and go into the ditch on the opposite side of the road. I asked Operator 1 if she had fallen asleep and she advised she had not. INVESTIGATION: There are ditches immediately off the pavement on both sides of Westford Road where this crash occurred. It was light at the time of this crash and the air temperature was approximately 30 degrees Fahrenheit. The road surface was dry and the weather was cloudy with no precipitation. This crash occurred on a moderate downward grade and a slight curve to</p>

Crash Number	Road	Marker	Date	Time	Weather	Injuries	Fatalities	Type	Description
									<p>the left (when traveling west as Operator 1 was). Officer observed curved tire marks across the pavement indicating sliding, rotating tires. These marks would have been caused by a vehicle rotating in a counter-clockwise direction while sliding across the pavement which was most likely due to overcorrection to the left by Operator 1. Officer inspected the shoulder and located tire marks indicating where the vehicle had left the pavement and then returned to the pavement. CONCLUSION: Crash was caused by Operator 1's vehicle leaving the right side of the roadway and Operator 1 overcorrecting to the left, which caused her vehicle to rotate counter-clockwise and slide across Westford Road and into a ditch. Operator 1's vehicle also struck a fire hydrant. Operator 1 claimed a vehicle crossed into her lane forcing her to move to the right and off the pavement to avoid a collision. Operator 1's estimation of her speed was 40 mph, which is 5 mph faster than the posted speed limit on this section of Westford Road.</p>
