Road Safety Audit Review

Town:	Highgate	Date Reviewed:	January 19 2016
Route:	VT 78 @ Machia Road	Mile points:	VT 78: 6.76

The location of this RSAR is the intersection of VT 78 and Machia Road in Highgate.

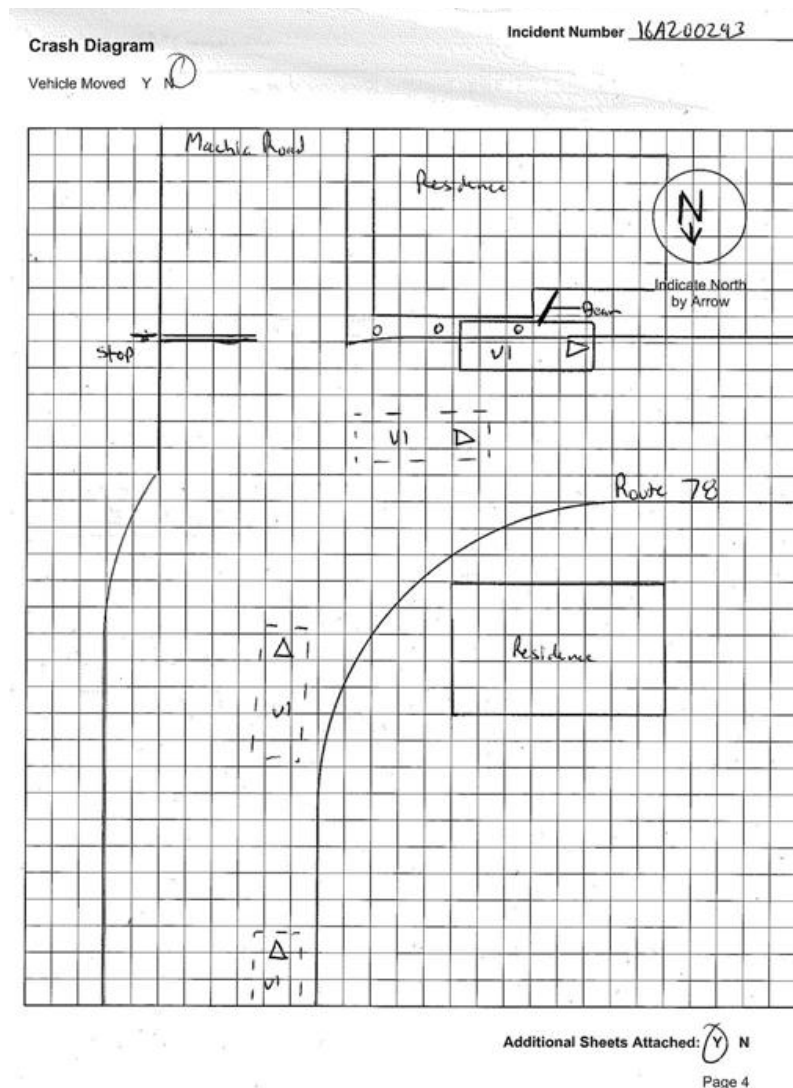
16A20093

On 01/19/16, at approximately 1234 hours, a single vehicle crash without injuries at the intersection of Route 78 and Machia Road. Vehicle 1 was still in contact with the residence at this intersection. This is a tan building with red shutters directly at the intersection of Route 78 and Machia Road. Op 1 stated that while traveling west on Route 78, coming down the Highgate Hill, she was braking due to the excessive snow and ice that was built up on the roadway surface. The operator stated that she was traveling very slow, approximately 20 mph, and began to slide on the ice. While sliding down the hill, her vehicle turned sideways and slowly slide into the side of the building. The officer observed the roadway to be very icy and snow covered. When the vehicle collided with the building, it also collided with a support beam for the porch above where the vehicle came to rest.
