# Office of Highway Safety

## Road Safety Audit Review

<b>Town:</b>	Berkshire	<b>Date Reviewed:</b>	September 11, 2015
<b>Route:</b>	VT 118, Richford Rd and Water Tower Rd	<b>Mile points:</b>	S0302: 2.65 S0307: 4.10

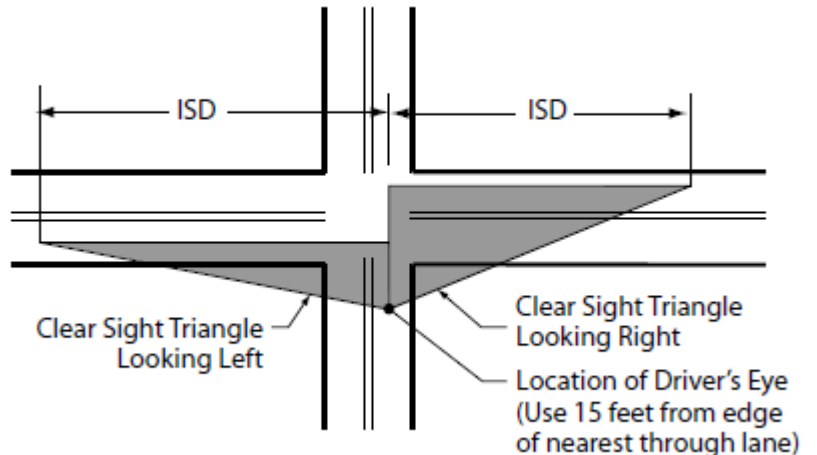
Note, Intersection Sight Distance (ISD) for 35 mph is 390 ft, for 40 mph, 445 feet and 555 ft for 50 mph as per AAHSTO.

Provide a clear sight triangle by removing any obstructions that are located inside the boundaries of the triangle.
