Town:	Saint Johnsbury	Date Reviewed:	Sept 18, 2018
Route:	US 2 and VT 18 Intersection	Mile points:	VT 18 MM 0.18-0.26 (Int 0.26), US 2 MM 6.47-6.63 (Int 6.55)

RSAR Process

The location of this RSAR is the intersection of US 2 and VT 18 in Saint Johnsbury and its approaches.

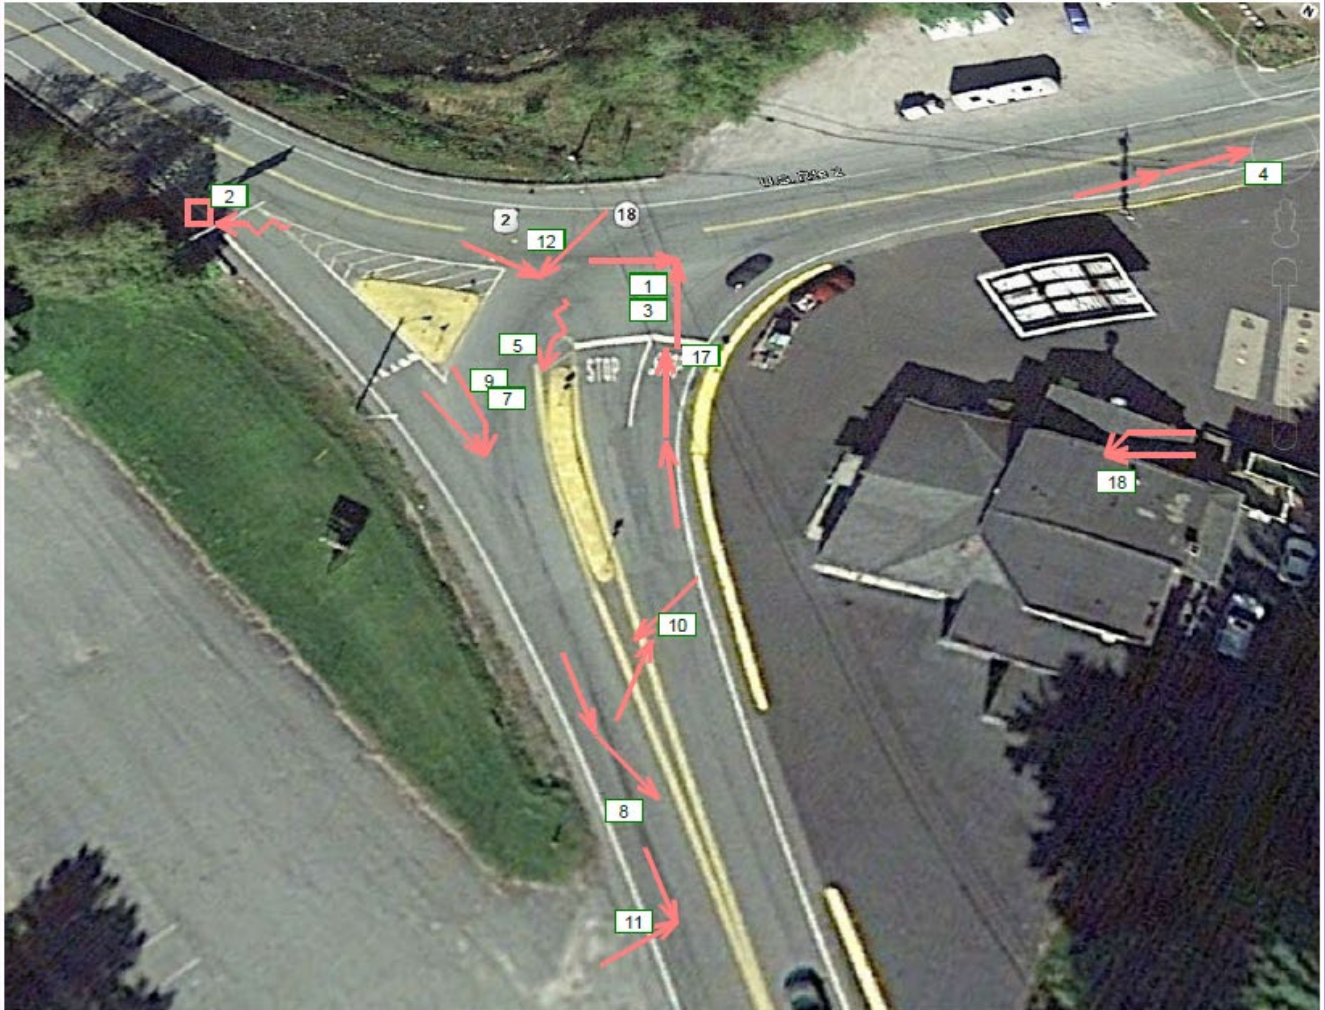
This site is a high crash location for 2012-2016 (last reported). Crashes # 17 & # 18 are from 2017 and 2018 respectively.
