# Office of Highway Safety

## Road Safety Audit Review

<b>Town:</b>	Colchester	<b>Date Reviewed:</b>	July 13, 2015
<b>Route:</b>	US 2 at Exit 17 Ramp	<b>Mile points:</b>	US 2: 1.86-2.11

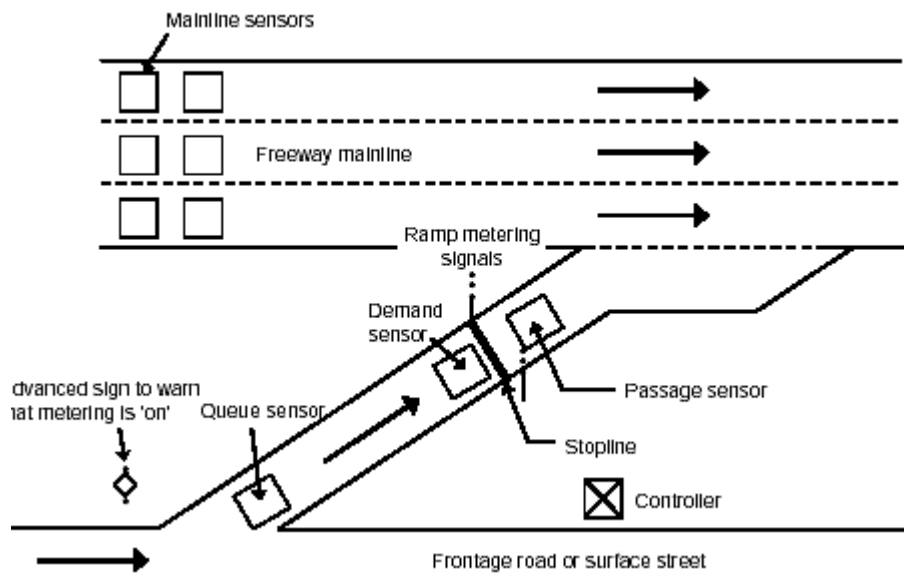
Traffic that is coming off I-89 northbound and that is continuing west on US 2 must merge with US 2 westbound traffic. Rear-end crashes at the end of the slip lane caused by the leading motorist moving and then stopping again are common. Some merging crashes are also evident.

In the mid-term, consider ramp-metering at this location. Ramp metering has been found to reduce crashes and travel time. The concept is illustrated below (source: Traffic Detector
