Office of Highway Safety

Road Safety Audit Review

Town:	Londonderry	Date Reviewed:	October 8, 2015
Route:	VT 100, Middletown Rd and Main St	Mile points:	Area of mm 2.99

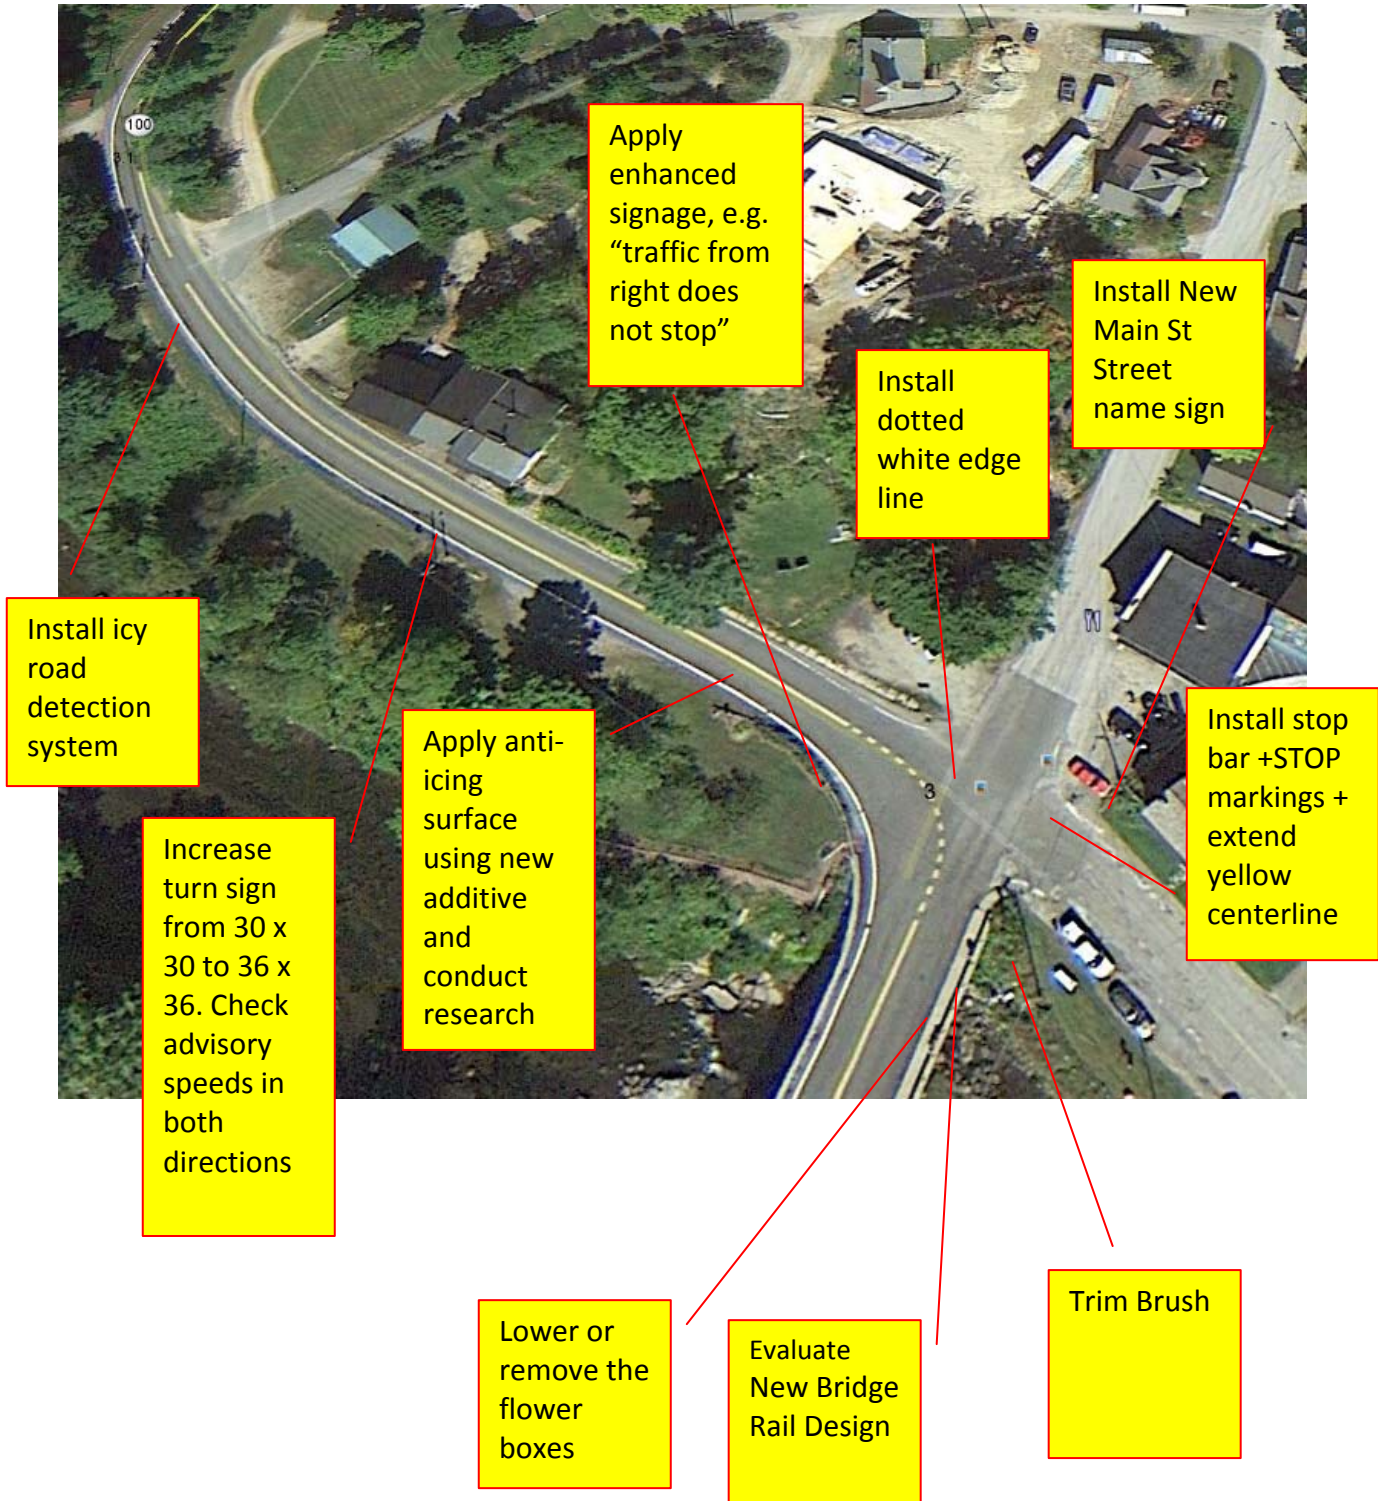
Summary of Suggested Actions

Observation	AOT Traffic Design	Town of Londonderry	AOT TSMO	AOT District	Office of Safety	AOT Structures	AOT	AOT Research	Strategy	Outcome Agree/ Disagree	Planned Completion Date	Comments
<p>1ST Concern</p> <p>Poor corner sight distance when stopped on the Main St approach and looking towards the VT 100 northbound approach (including difficulty to see oncoming traffic when approaching the intersection due to the bridge railing).</p>		X		X					<p>Short Term Actions (up to a year)</p> <p>Install a stop bar (4 ft from edge of road) and the “STOP” word markings on the Main Street Approach.</p> <p>Extend the double yellow centerline up to the new stop bar (include the change in the annual markings plan).</p>			
	X			X					Trim brush in southeast quadrant, including along sign posts.			
	X								Consider removing or lowering the flower boxes.			
							X		<p>Mid to Long Term Actions</p> <p>Evaluate the possibility of designing and installing a new railing that would be less compact.</p>

Observation	AOT Traffic Design	Town of Londonderry	AOT TSMO	AOT District	Office of Safety	AOT Structures	AOT	AOT Research	Strategy	Outcome Agree/ Disagree	Planned Completion Date	Comments
<u>2ND Concern</u> Southbound VT 100 vehicles that continue on Main Street are not yielding to traffic that is coming from VT 100 northbound (i.e., coming from the right).			X						Short Term Actions (up to a year) Increase the size of the modified turn signs which show intersecting roads from 30" x 30" to 36" x 36" (via work order).			
			X						Install a dotted white edgeline extension through the intersection to supplement the yellow extension (via work order).			
		X							Install a "Main St" street name sign above the stop sign on Main St.

Observation	AOT Traffic Design	Town of Londonderry	AOT TSMO	AOT District	AOT Office of Safety	AOT Structures	AOT Research	Strategy	Outcome Agree/ Disagree	Planned Completion Date	Comments
	X		X		X			Warn motorists that the road surface is icy using a dynamic ice warning system with icy conditions detected using a non-intrusive road surface sensor (via work order, HRRR project or HSIP project).			
Further consideration of 1 st and 2 nd concerns.			X					VT 100 SB motorists are expecting traffic from the right to stop when crossing. Traffic on Main St has a hard time seeing oncoming traffic from the left after stopping. Evaluate the extent of these conditions and the potential application of all-way stop control.
