Road Safety Audit Review

Town:	Arlington	Date Reviewed:	September 21, 2016
Route:	VT 313 Warm Brook Rd Intersection	Mile points:	VT 313: 7.19 Warm Brook: 0.00

The location of this RSAR is the intersection of VT 313 and Warm Brook Road (MC0171) in Arlington.

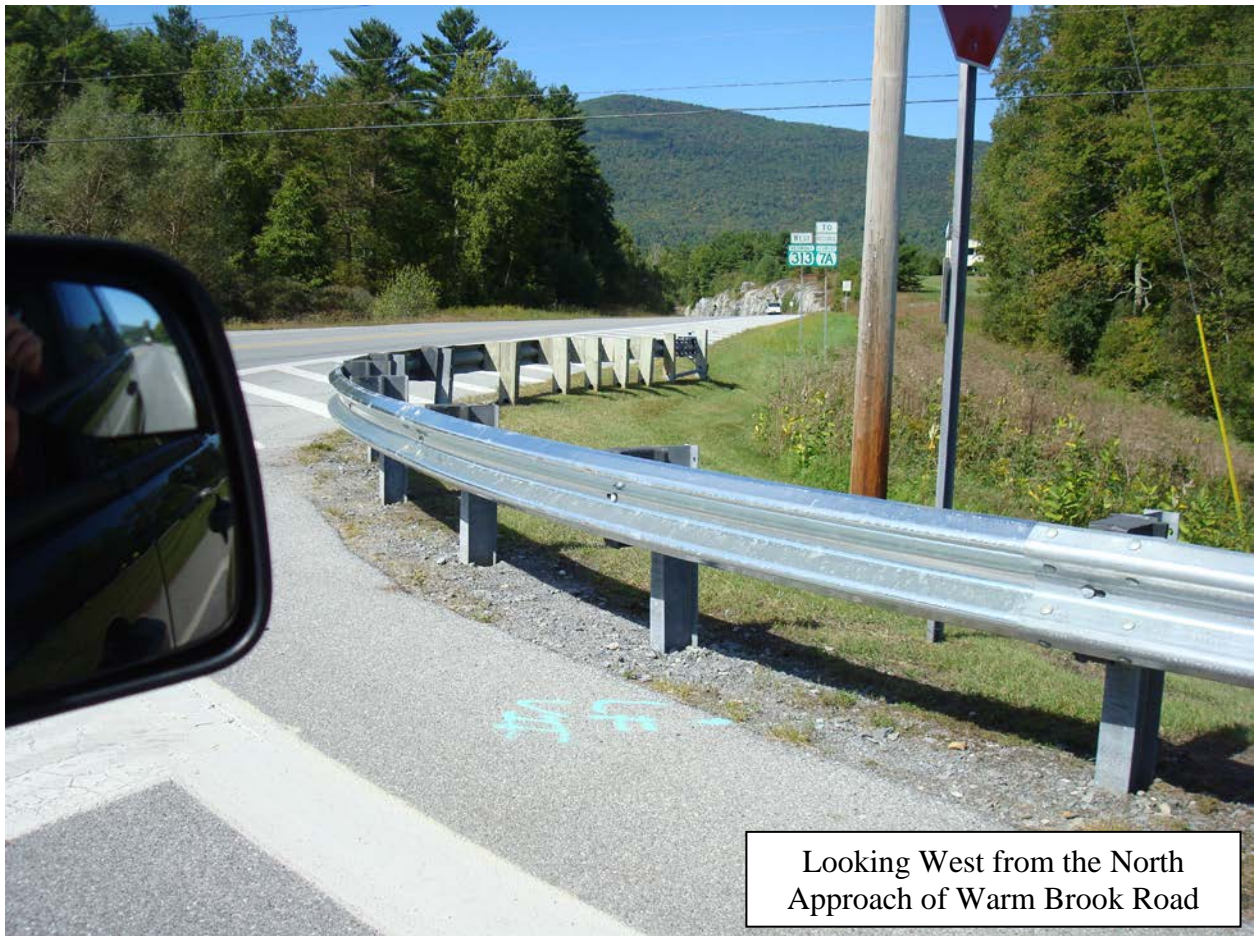
Supplemental corner sight distance information was provided by Sgt Robert Zink of the Vermont State Police. Sgt. Zink observed that telephone poles on the southeast and the northwest corners of the intersection could obstruct the view of VT 313 oncoming traffic if a motorist was stopped in a way that the poles were in her/his field of vision. Specifically, when stopped on the Warm Brook Road south approach, as west vehicles traveled past 1200 feet from the intersection, they became obstructed by the telephone pole until about 393 feet. Similarly, when stopped on the Warm Brook Road north approach, a west vehicle would be no longer visible until 263 feet.

The partial visibility obstructions that are caused by the telephone poles at the intersection could be an issue at times.
